Торіс	91-18-15TT - Apple Car-Play Initialization Failure	
Market area	United States 444 Volkswagen of America, Inc. (6444)	
Brand	Volkswagen	
Date	November 16, 2018

Apple Car-Play Connection Initialization Failure

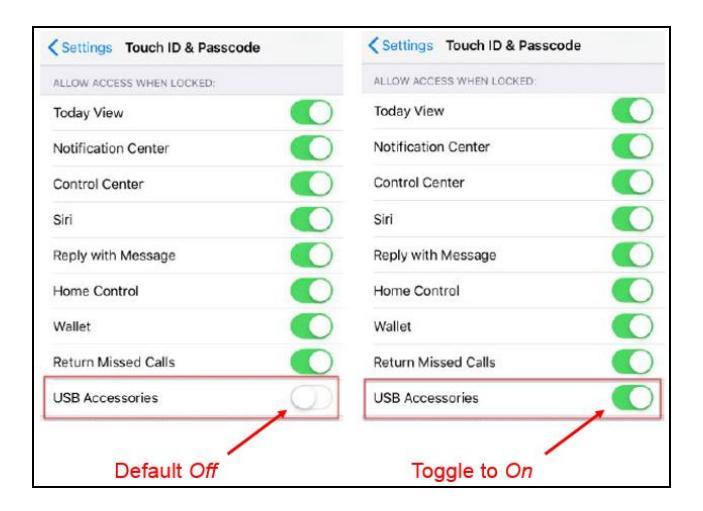
Beginning with iOS 11.4.1, customers attempting to use Car-Play may experience an initial failure of the feature to initialize after plugging in their device. This condition will occur if the device has not been unlocked for one hour prior to connecting to the vehicle. Simply unlocking the device will then permit normal operation.

However, it is possible to prevent this initial lockout from occurring by performing the following steps in the device:

- Enter the Settings menu in the iOS device.
- Select Touch ID & Passcode.
- Enable (toggle on) the USB Accessories feature.
