Technical Service Bulletin

Subject:	ect: STRONG SHOCK WHEN SETTING MRCC	Bulletin No.: 15-001/20
		Last Issued: 01/09/2020

APPLICABLE MODEL(S)/VINS

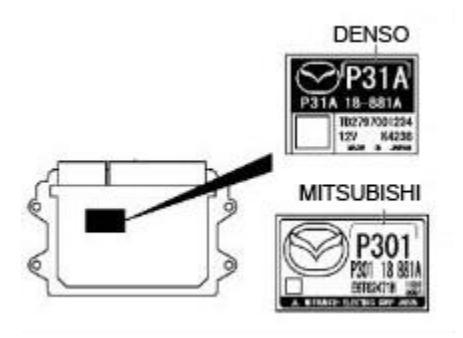
PCM Identification

Some customers may complain about a shift shock and/or an engine RPM increase when setting the Mazda Radar Cruise Control (MRCC) system with no DTCs being stored.

NOTE: This concern only occurs on vehicles equipped with a PCM manufactured by MITSUBISHI.

This is caused by improper control logic of the PCM allowing the engine RPM increase for an instant right after setting the MRCC. To correct this issue, the PCM software has been modified. Customers having this concern should have their vehicle repaired using the following repair procedure.

2. Verify if the PCM in the subject vehicle is manufactured by MITSUBISHI.

3. Reprogram the PCM using the Mazda Diagnostic And Repair Software (MDARS). Refer to "MDARS - ECU Reprogramming Procedure". **NOTE:**
