## Technical Information Bulletin

### Section

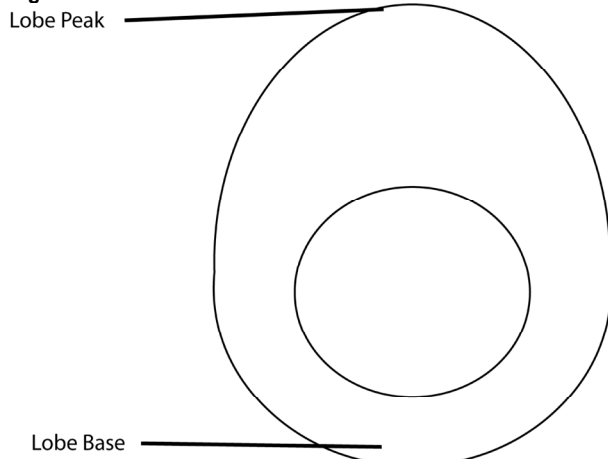
3. Start a TCS365 case. See the TCS365 Case Creation Guide section below for instructions to create the case. Attach the Camshaft

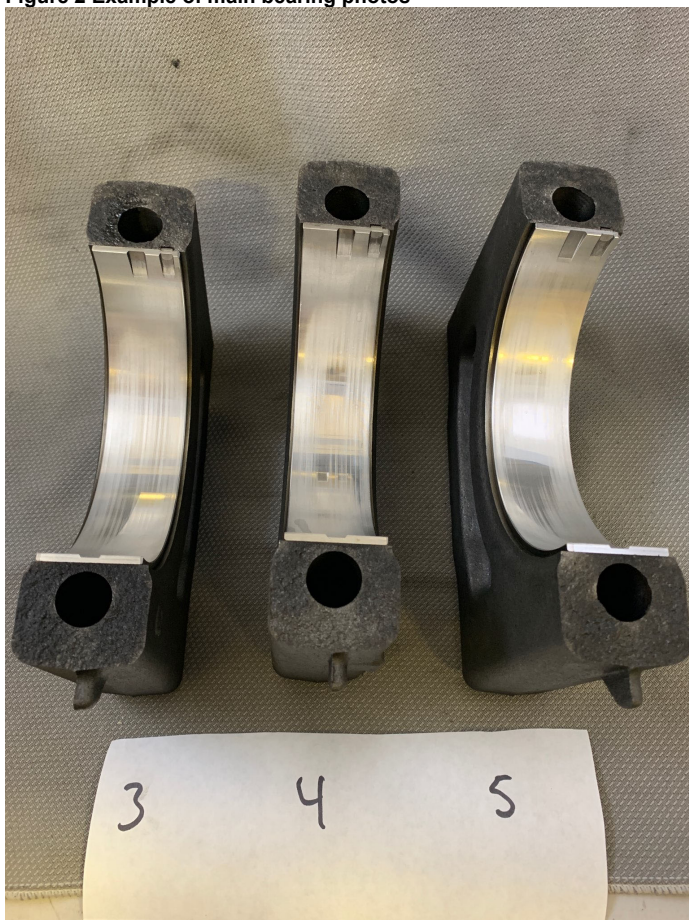
## Unit Pump to High Pressure Fuel Rail Lines

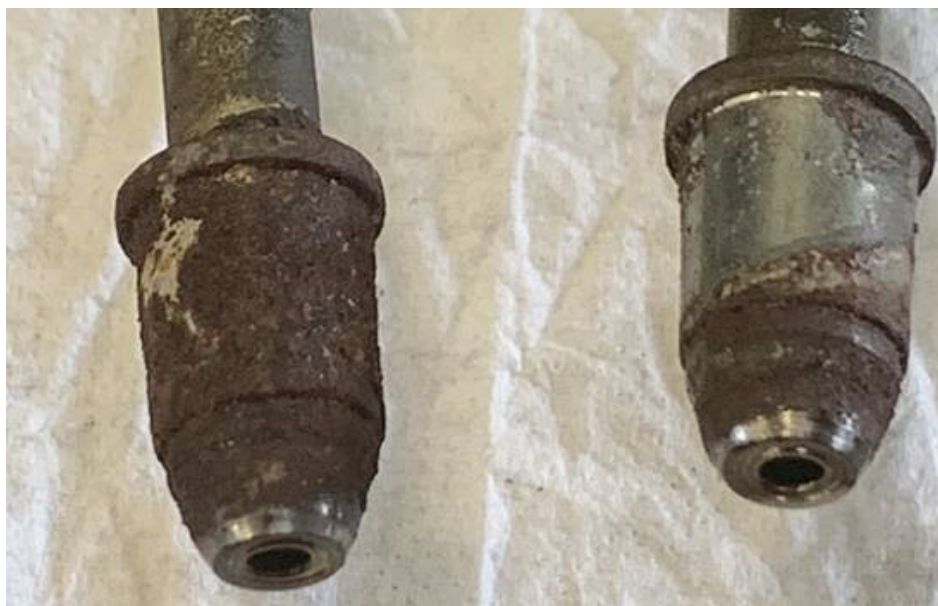
## TCS365 Case Creation Guide

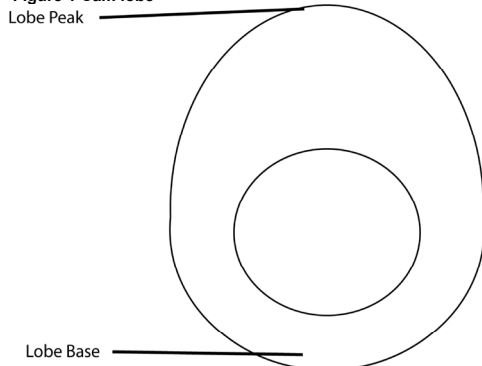
3. Start a TCS365 case. See the TCS365 Case Creation Guide section below for instructions to create the case. Attach the Camshaft Inspection Photo Guide to the case. The VSC will analyze the camshaft lobe photos and inform you of the next repair step.
  - If VSC directs you that the camshaft is ok, reassemble the engine per RMI and replace the engine oil filter and fill with new oil.
  - If VSC directs you to inspect the lower main bearings, continue with this procedure.
4. Remove Main Bearing Cap numbers 3, 4, and 5.
  - a. Remove the oil pickup tube from the fixing frame.
  - b. Remove the fixing frame from the engine block.
  - c. Remove the oil pump.

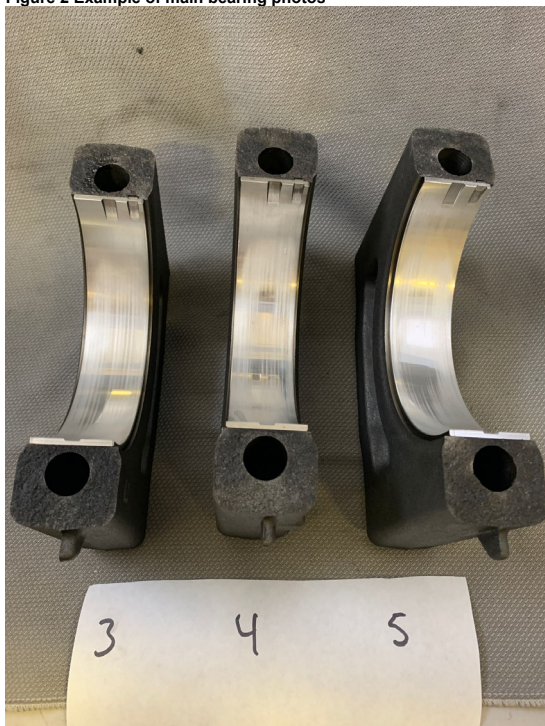
#### **Unit Pump to High Pressure Fuel Rail Lines**

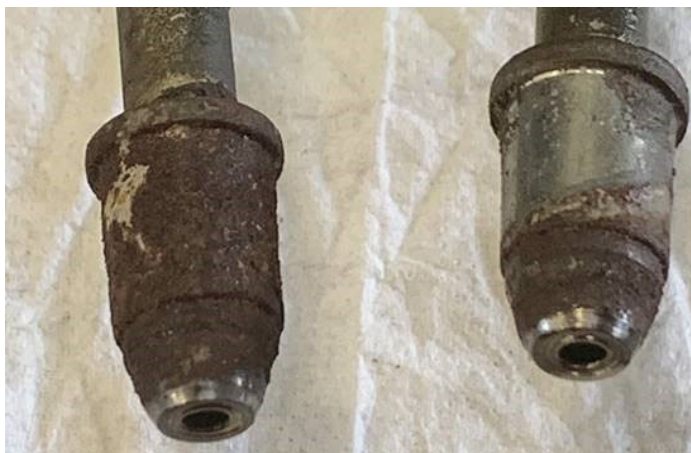
#### **TCS365 Case Creation Guide**
