SA-O13/20 - 2020 CX-30 SERVICE CAUTIONS FOR NEW AND REVISED FEATURES         I12159       Recommend Change         MUMBER: SA 013/20       Manage Document         ANUMER: SA 013/20       Service Alert supersedes the previously issued builetin(s) listed below. The changes are noted in Red text.         Trevious Service Alert supersedes the previously issued builetin(s) listed below. The changes are noted in Red text.         Trevious Service Alert supersedes the previously issued builetin(s) listed below. The changes are noted in Red text.         Previous Service Alert supersedes the previously issued builetin(s) listed below. The changes are noted in Red text.         PPLCABLE MODEL(S)/VINS         202 CX-30         SUMMARY         010 In Instructions         met-Deterrent System accidently enabled and DTC's stored.         0 to TI SIL21734 (https://portal.mazdagms3/index?page=detail&id=Sil21734)         nore text below, used for M6SS search function         ungar Alam         Ungar Alam         105261         105261         1055115         1055815         1055816         1055817         1058849         1058849         1058849         1058849         1058847         105816

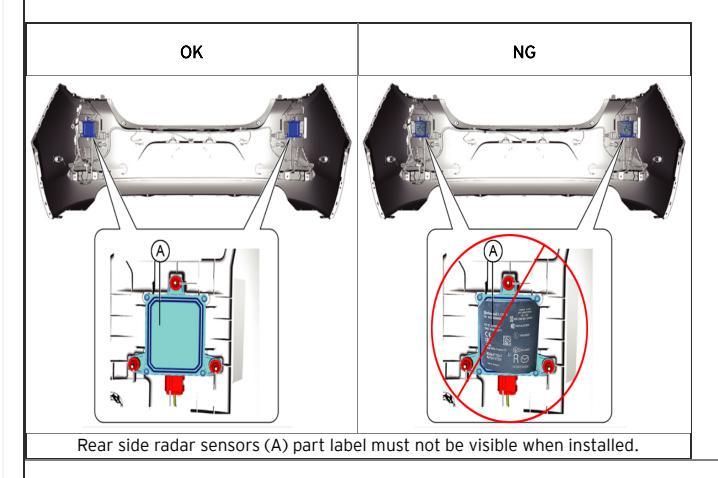
- BSM system indicates vehicle on the opposite side.
- i-ACTIVSENSE indicator ring will not turn green
- Rear Cross Traffic Alert (RCTA) does not work
- Rear side radar sensor aiming may fail
- TPMS DTC(s) stored

## This may be caused by BSM rear side radar sensor(s) installed facing the wrong direction.

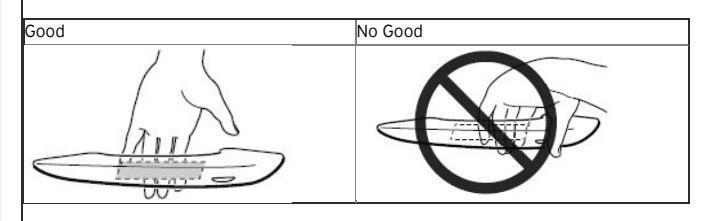
Doors cannot be unlocked using the outside door handle touch sensor

The door handle touch sensor system may not operate normally under the following conditions:

1. The front passenger (without key) grabs and holds the outside door handle before the driver (with key) touches the drivers outside door handle unlock touch sensor. 2. The driver touches the sensing area of the door lock touch sensor and the sensing area of the door release touch sensor at the same time.
