Reference: NTB20-013

February 26, 2020

KICKS; NO START/DRIVABILITY ISSUES, BATTERY LIGHT ON, AND/OR MIL ON DURING FREEZING TEMPERATURES

APPLIED VEHICLE: 2018-2019 Kicks (P15)

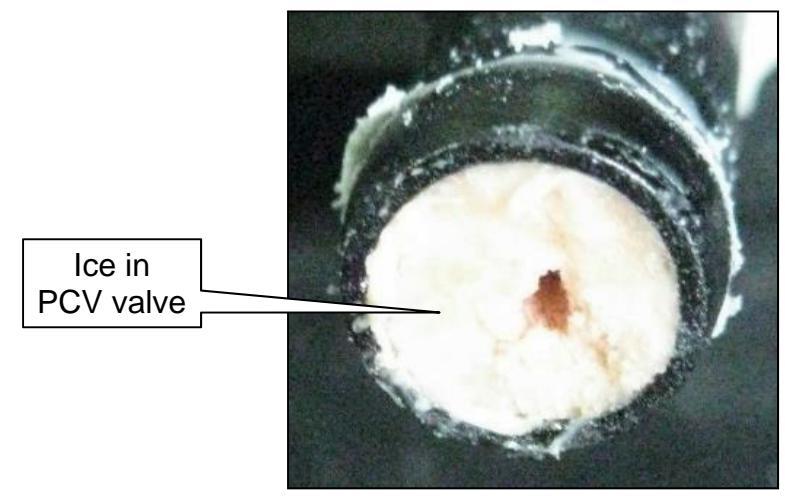
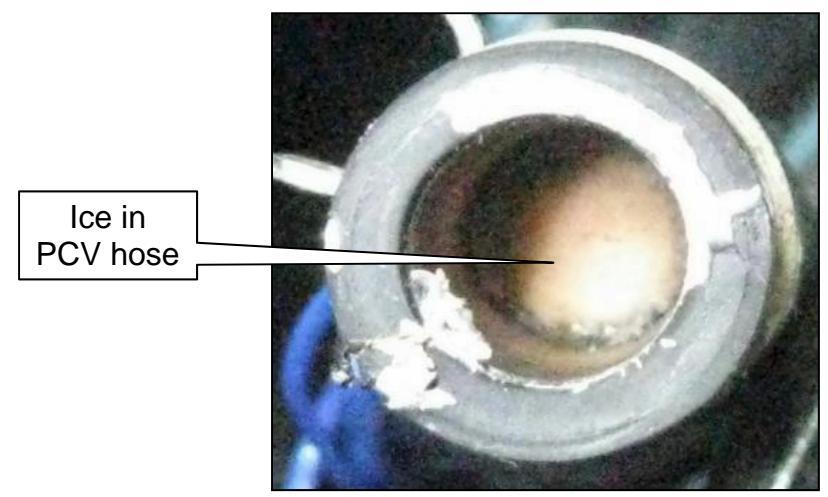
Examples of Ice Contamination

One or a combination of the following during temperatures below -10°C/14°F and ice is found inside the PCV hose or PCV valve:

- The engine hesitates or stops running. •
- The starter cranks the engine normally but the engine will not start. •
- The MIL is ON with DTC P2004 (TUMBLE CONT/V) and/or P0101 (MAF • SEN/CIRCUIT-B1).
- The battery light is ON. •
 - The engine oil level gauge (dipstick) is backed out of the oil level gauge guide (dipstick tube) and oil is found on the generator (alternator).
- The battery voltage is too low to start the engine.

Replace and install the parts listed in **PARTS INFORMATION** on page 6.
