SIM 64 01 16

2020-02-25 WATER INGRESS IN FOOTWELL AREA FROM A/C CONDENSATE DRAIN

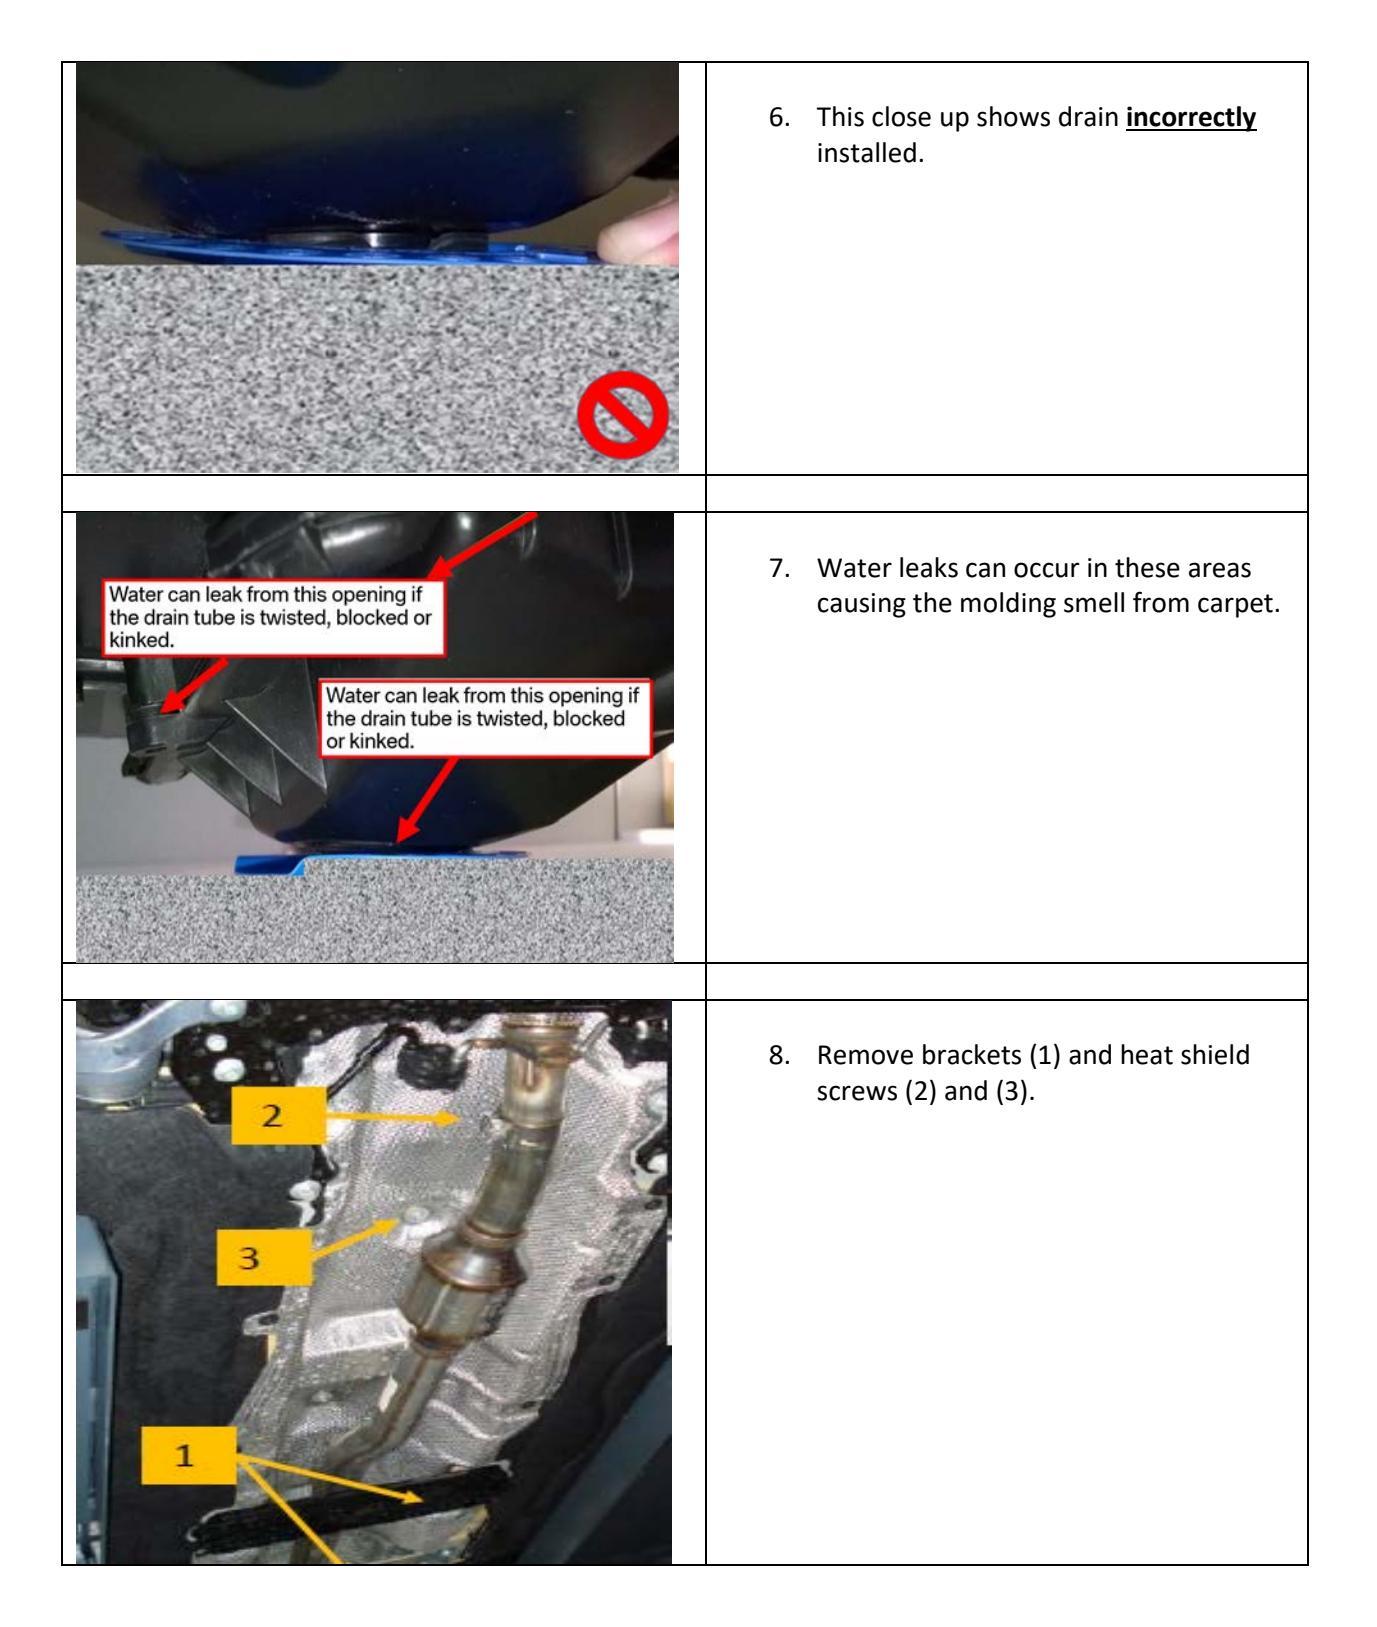
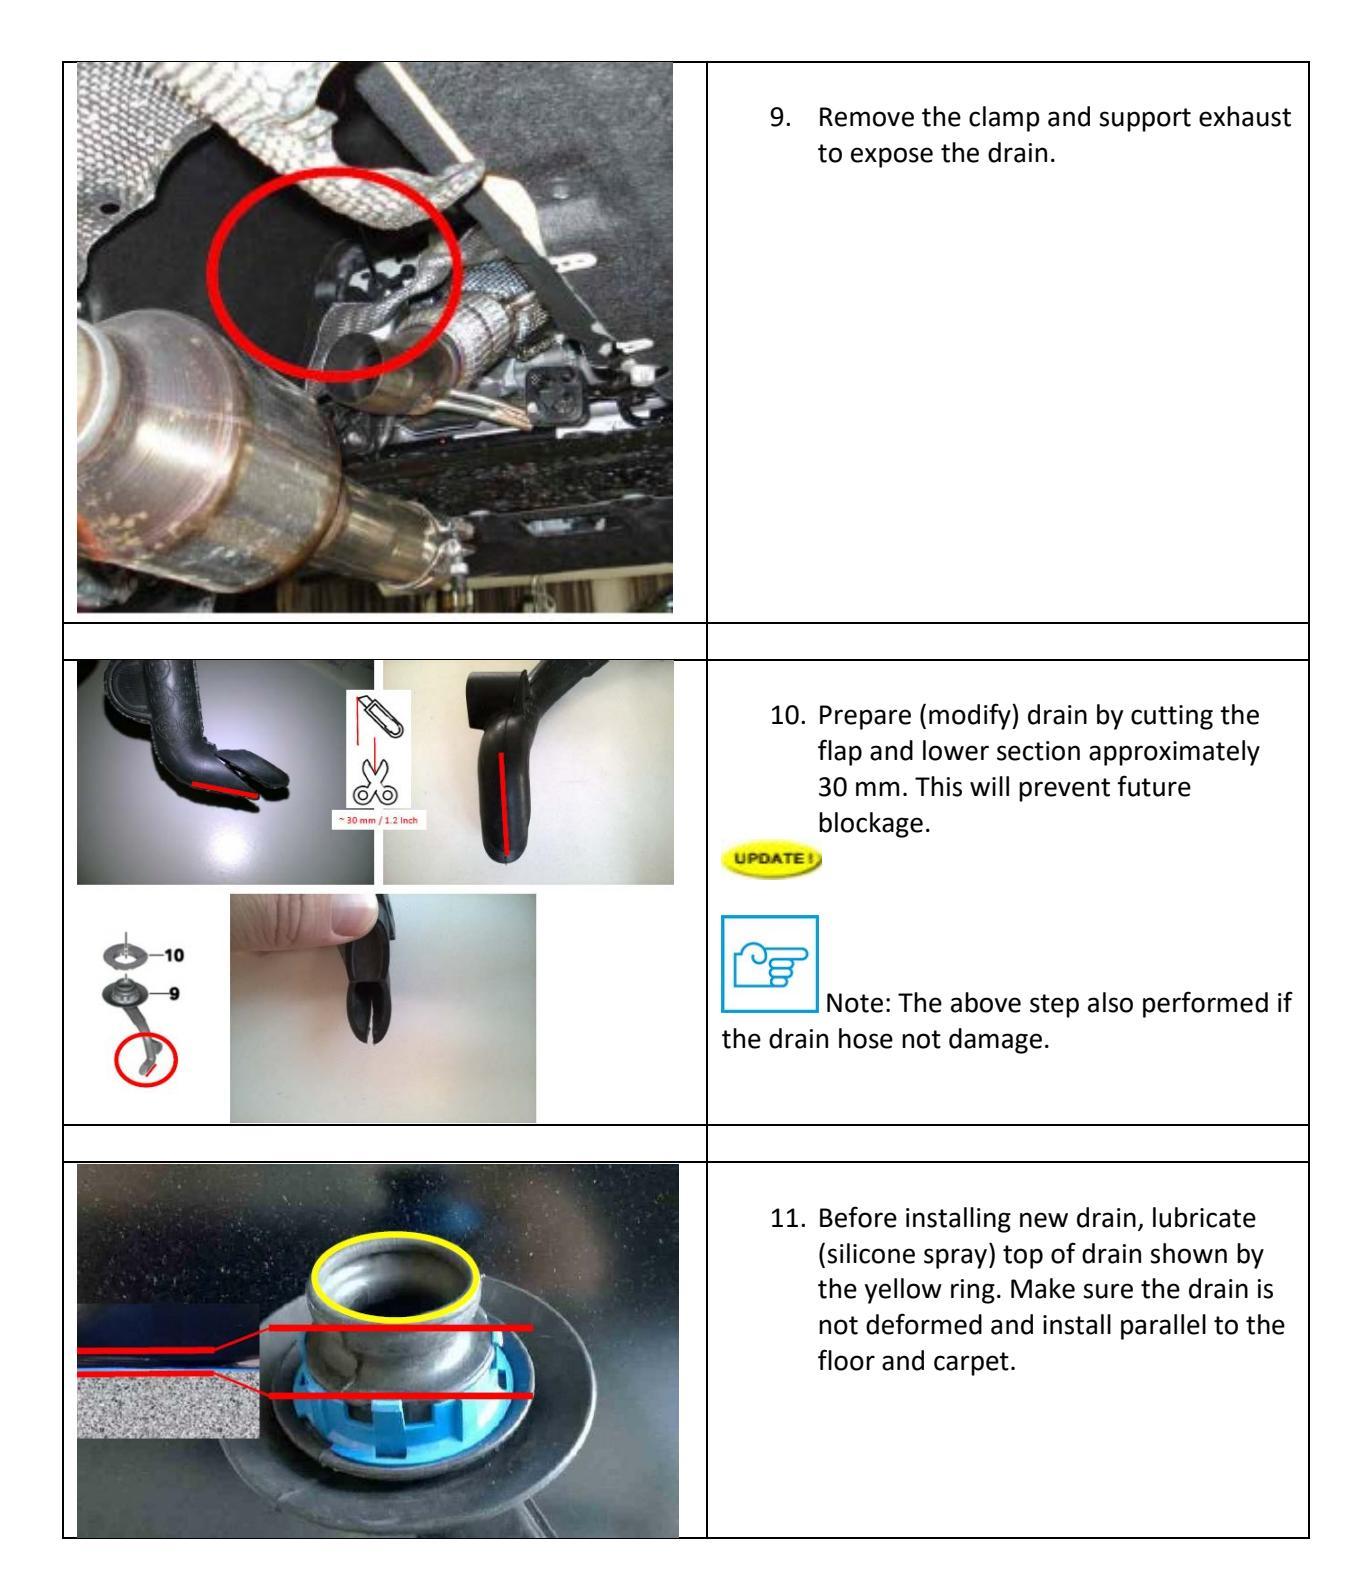
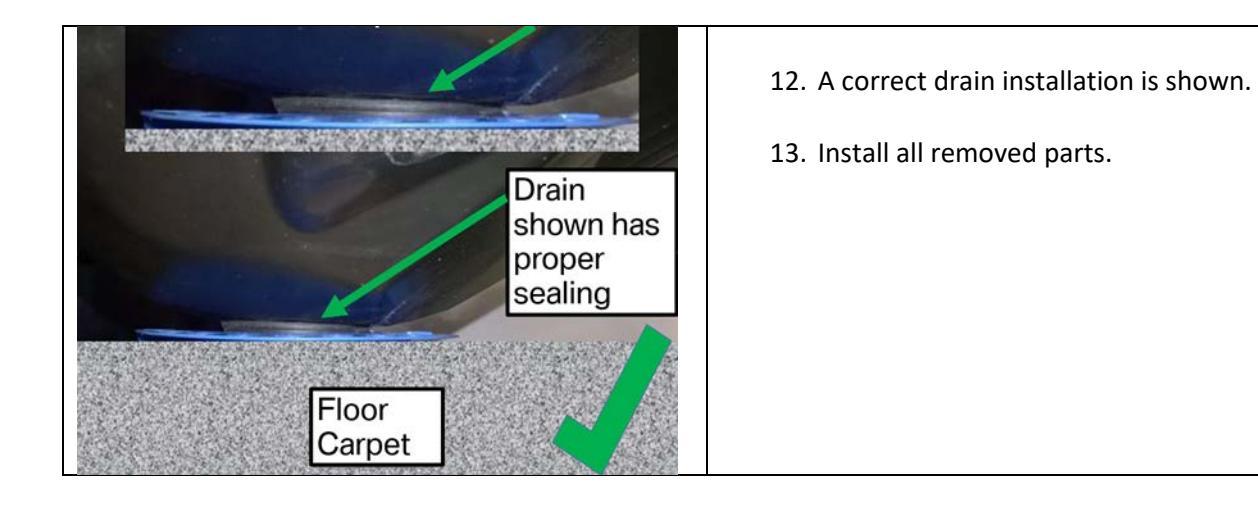
Use Repair Instruction 51 45 and remove center console trim in both sides. Release screw (1). Release side center console trim panel (2) from retaining clips (3). Feed out side center console trim panel (2) from guides (4) and remove.
 Locate IHKA housing A/C condensate drain by removing passenger side console foot well trim. Press carpet down using a nylon lever to expose drain.
5. If drain is twisted or deformed it must be replaced.
