SS 1034670 Fault Code VRDU 524127/9 - Lost Communication with the MPC

Fault Code VRDU 524127/9 - Lost Communication with the MPC

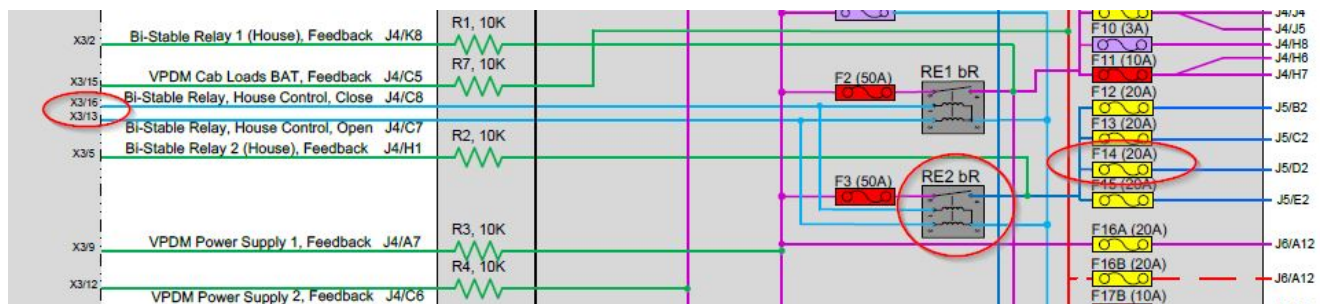
Note that it is possible for battery voltage to be acceptable, but the sSAM voltage still too low. This can happen if there is too much voltage drop between the batteries and sSAM - i.e. power or ground connection issues (loose, corroded, etc.)

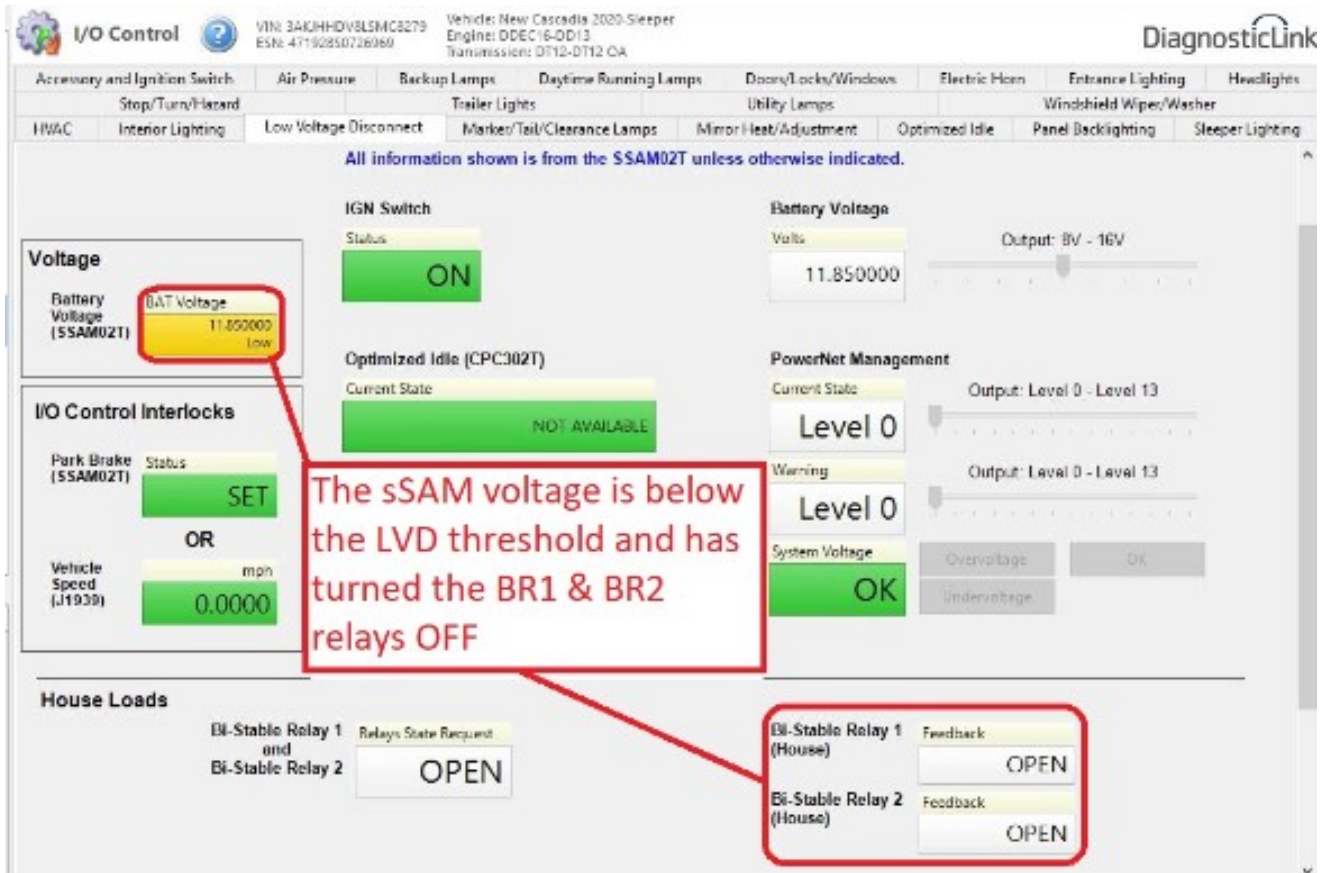
Also refer to MPC wiring diagram G06-95288-000.
