Service Bulletin

Bulletin No.: 18-NA-073

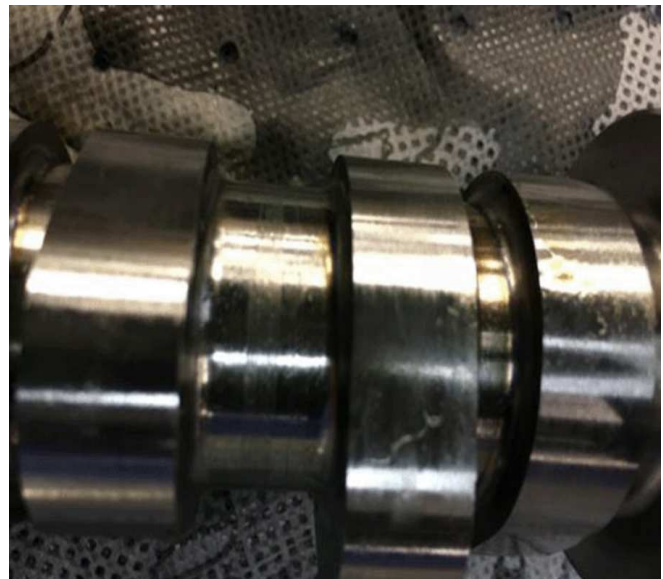
Review the following:

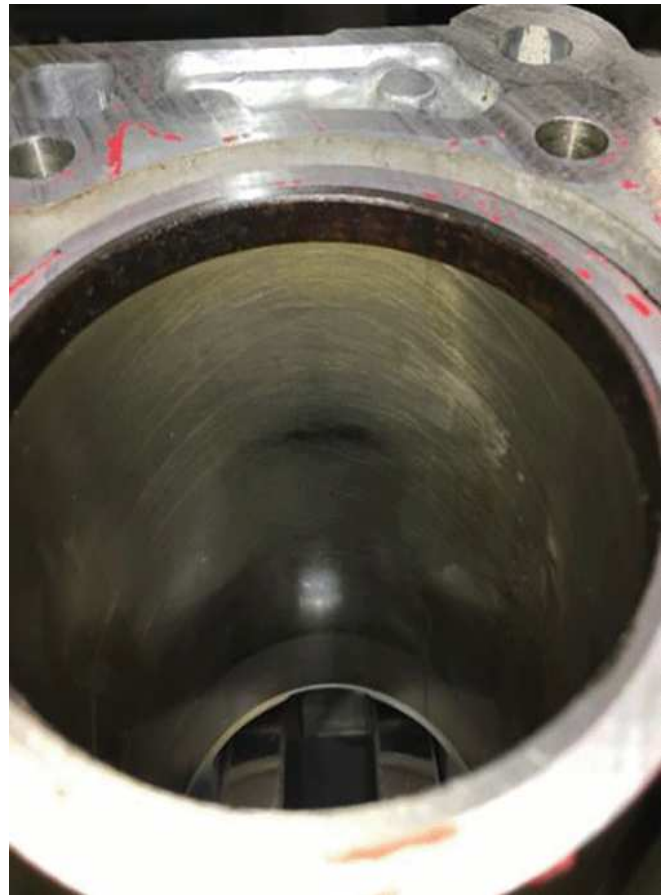
Review the following:

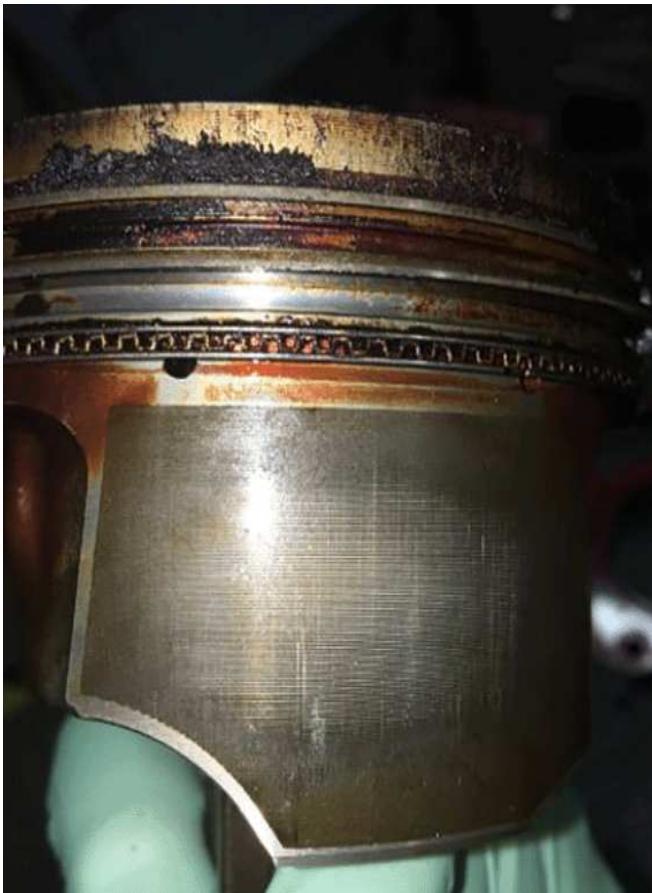
Review the following:

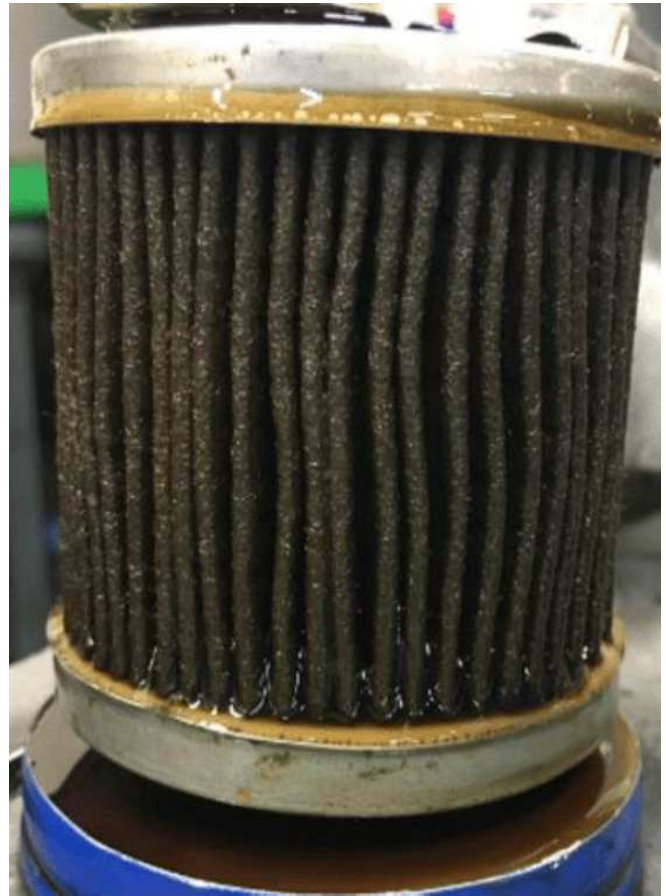
Review the following:
