68-17-02TT - Driver or Passenger Vanity Light Inoperative

| Applicable Vehicles | | | | | | | |
|---|---|---|---|---|---|--|--|
| Atlas | 2018-2019 | All | All | CA_JC000001 | CA_KC512994 | | |

| Revision Table | | | | | | |
|---|---|---|--|--|--|--|
| 2049850/2 | 3/27/20 | 68-17-02TT | To include model year 2019 with a VIN range. | | | |

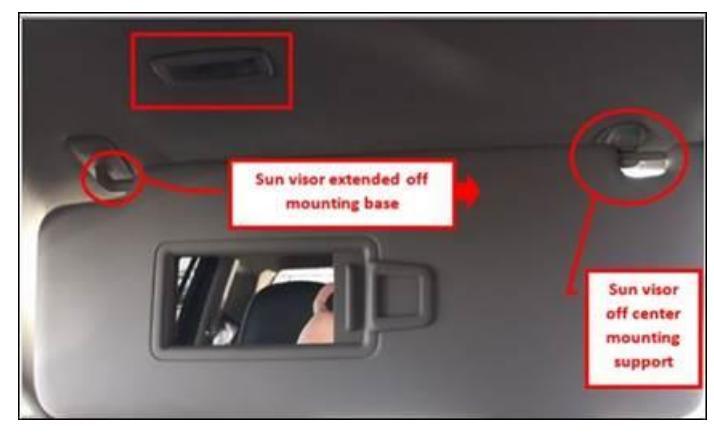
A common failure is the sun visor is not seated all the way towards the extension rod mounting base as shown in figure 1.

Figure 1. **Incorrect** – Sun visor extended away from the mounting base, vanity light inoperative

The conditions explained in figure 1 commonly happen after the sun visor is positioned to block sun light coming through the door window, and then moved back to the forward position. If this is found to be the cause of the vanity light concern, inform the customer of the proper positioning and operation.

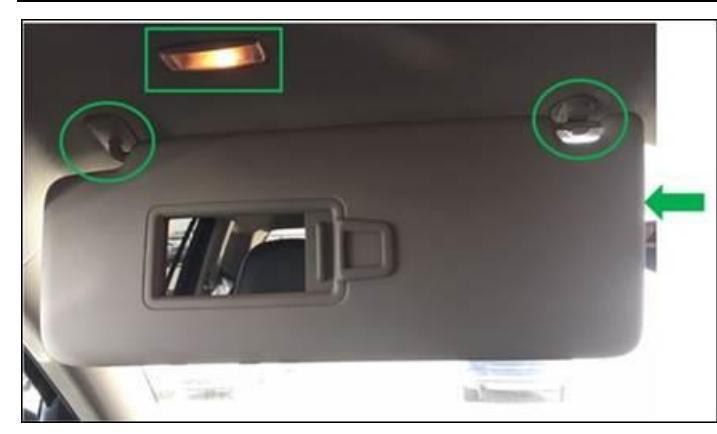
Figure 2. **Correct** – Sun visor in the correct position for vanity light operation.
