150/19_{ENU} 9110

Symptom in Vehicle Interior - Air Bubbles in Laminate of Front Display and Control Unit (PCM display): Subsequent Work on Dashboard (SY 150/19)

Model line:	Cayenne (9YA)
Model Year:	2019
Subject:	Front display and control unit (PCM display)
Symptom:	Air bubbles occur in laminate of front display and control unit (PCM display):

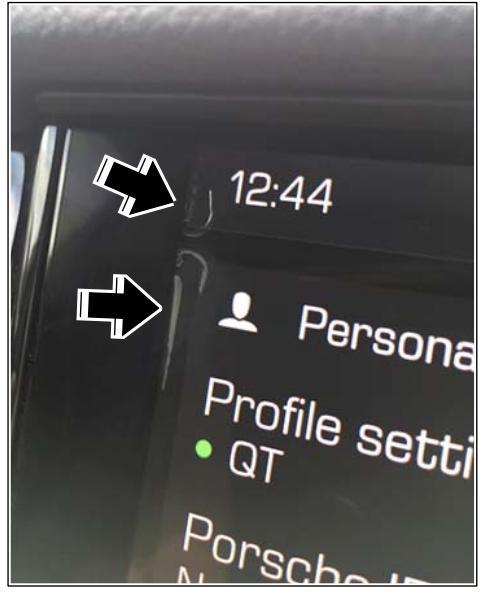
Air bubbles in the PCM display (example)

- Cause: Due to insufficient gap dimensions, the dashboard can press sideways onto the front display and control unit (PCM display).
- RemedialIn the event of a customer complaint, the top corners of the dashboard must be reworked. The front
display and control unit (PCM display) must be replaced.
