## Technical Information

164/19<sub>ENU</sub> 9198

### Complaint: FoD Update is Not Displayed/Cannot be Performed (164/19)

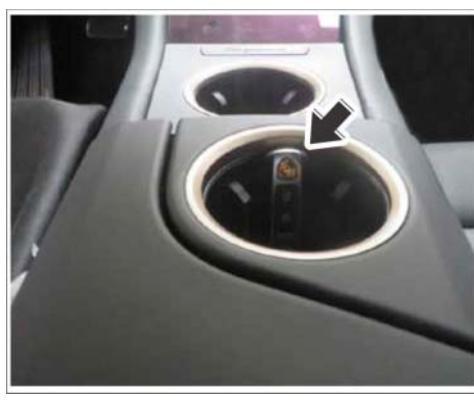
Emergency start tray

forward upright between the holding struts in the rear cupholder (**emergency start tray**) to guarantee a permanent radio link between the vehicle and remote control  $\Rightarrow$  *Emergency start tray*-arrow-.
