GROUP ELE	MODEL 2021MY Seltos (SP2)
	NUMBER 194	DATE March 2020

TECHNICAL SERVICE BULLETIN

**SUBJECT: SERVICE ACTION: FRONT RADAR DTC JUDGEMENT
LOGIC IMPROVEMENT (SA414)**

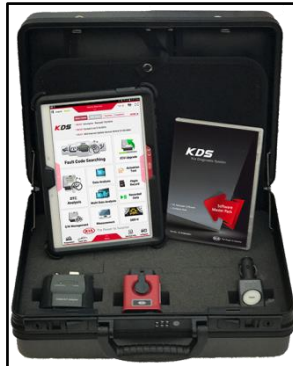
DTC C1604: ECU Hardware Error
