# Service Bulletin

### Subject: Loss of Brake Assist, Various Messages Displayed in Driver Information Center (DIC), Brake Pedal Travel and Apply May Feel Different, DTC C0024 Set

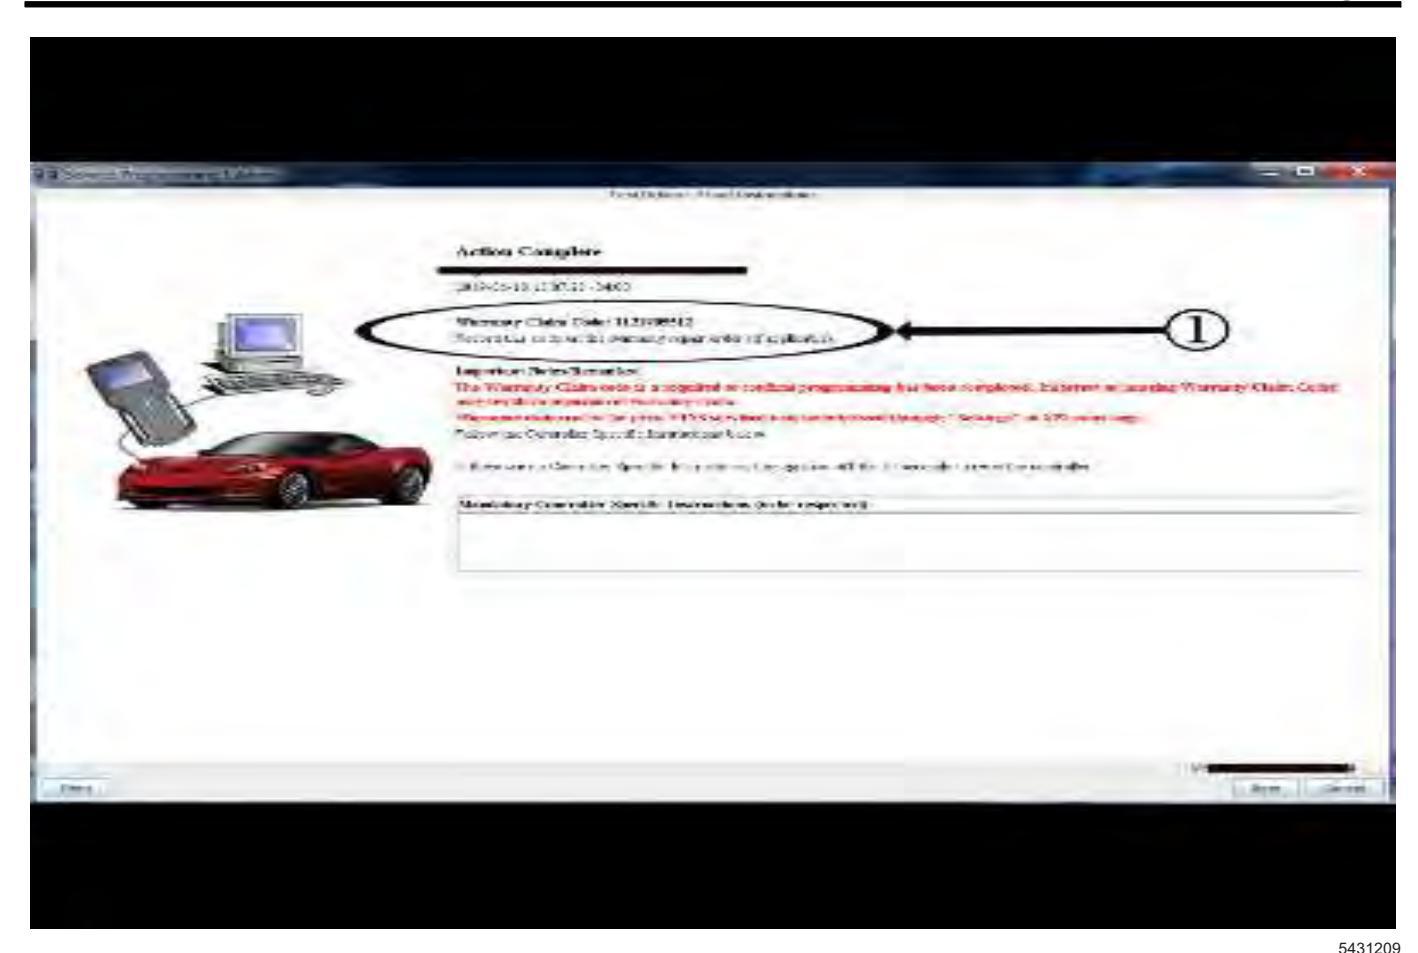
**Important:** If the Same Calibration/Software Warning is noted on the SPS screen, select OK and follow screen instructions. After a successful programming event, the WCC is located in the Service Programming

System dialogue box of the SPS Summary screen. No further action is required. Refer to the Warranty Information section of this bulletin.

**Important:** To avoid warranty transaction rejections, you **MUST** record the warranty claim code provided on the SPS Warranty Claim Code (WCC) screen on the job card. Refer to callout 1 above for the location of the WCC on the SPS screen.

1. Reprogram the Brake System Control Module. Refer to K160 Brake System Control Module Programming and Setup in SI. Then provide step-by-step instructions or refer to SI procedure.

2. Record the SPS Warranty Claim Code on the job card for warranty transaction submission.
