SERVICE BULLETIN

Classification: EM19-004a	Reference: NTB19-057a	Date: April 3, 2020
------------------------------	--------------------------	------------------------

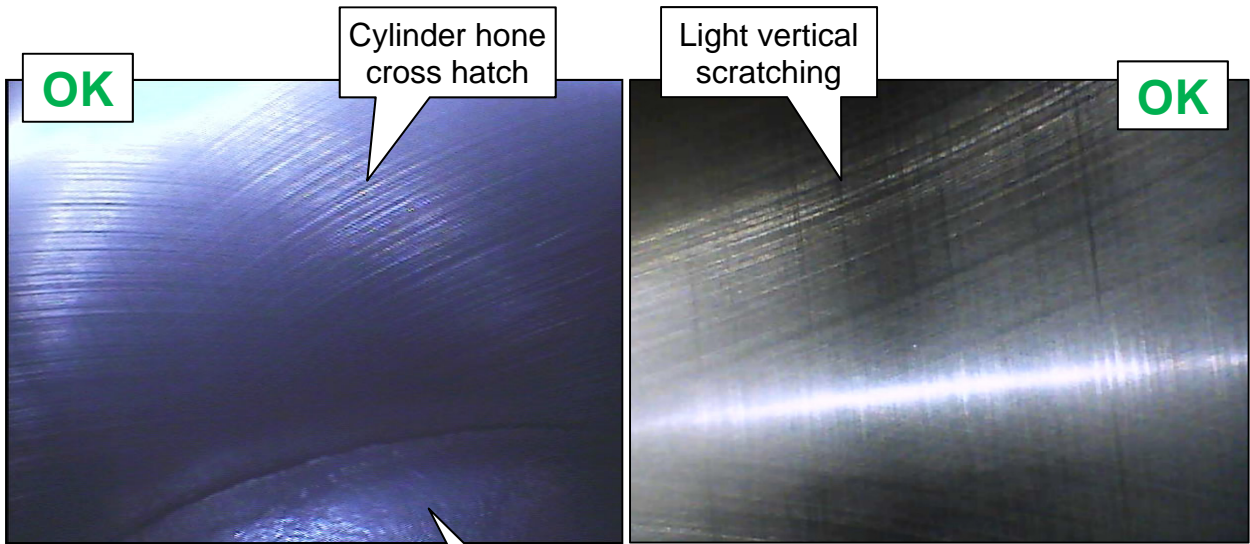
- If the cylinder wall has scuffing, replace the short engine assembly.
 - Refer to Figure 4 on page 5 for an example of cylinder wall scuffing.
 - See page 7 for warranty information.
 - Refer to the appropriate section of the ESM for short engine assembly replacement.
 - See page 6 for additional short engine assembly replacement instructions.
- If there is **no scuffing** on the cylinder wall, go to **CLAIMS INFORMATION** on the last page (for the "inspection" OP CODE). Refer to the ESM for further diagnosis.
 - Refer to Figure 2 and Figure 3 on page 5 for an example of an "OK" cylinder wall.
