94-19-01 - Exterior Lights, Moisture Accumulation

Release date: 4/21/2020

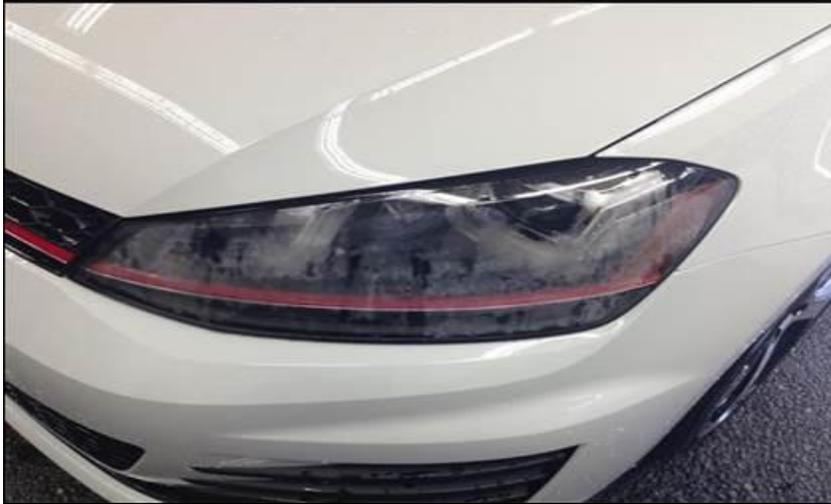
Exterior light assemblies (headlights, taillights, fog lights, turn signals) are vented and may collect moisture on their inner surfaces, depending on humidity and climatic conditions. The unfavorable condensation built up (Figure 1) visible to the customer is more common with modern exterior lights because of clear glass optics, however this condition will not have an impact on the functionality or durability of the component.

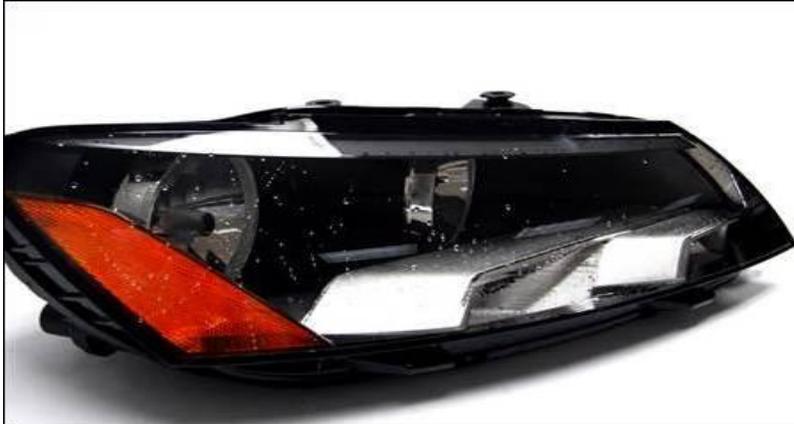
In cases where larger water droplets have formed on the inside of the lens or significant amount of water has collected at the bottom of a light assembly, Figure 2:

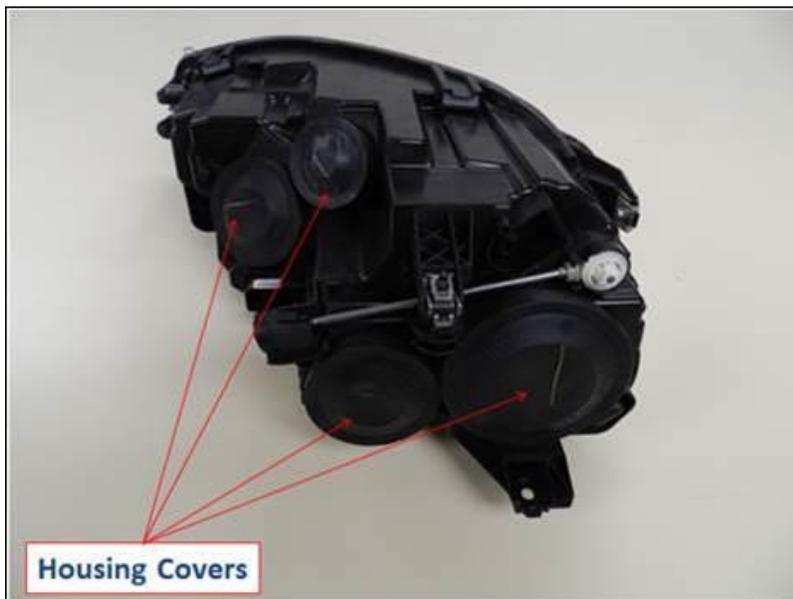
- Check that the housing covers (Figure 3), are properly installed. If the housing covers are not fully seated in place, use compressed air (less than 30 PSI) to blow out the lens and recheck for leaks.
