Dealer Service Instructions for:

March 2020

Customer Satisfaction Notification W13 Radio Connected Services

2019-2020 (MP) Jeep® Compass

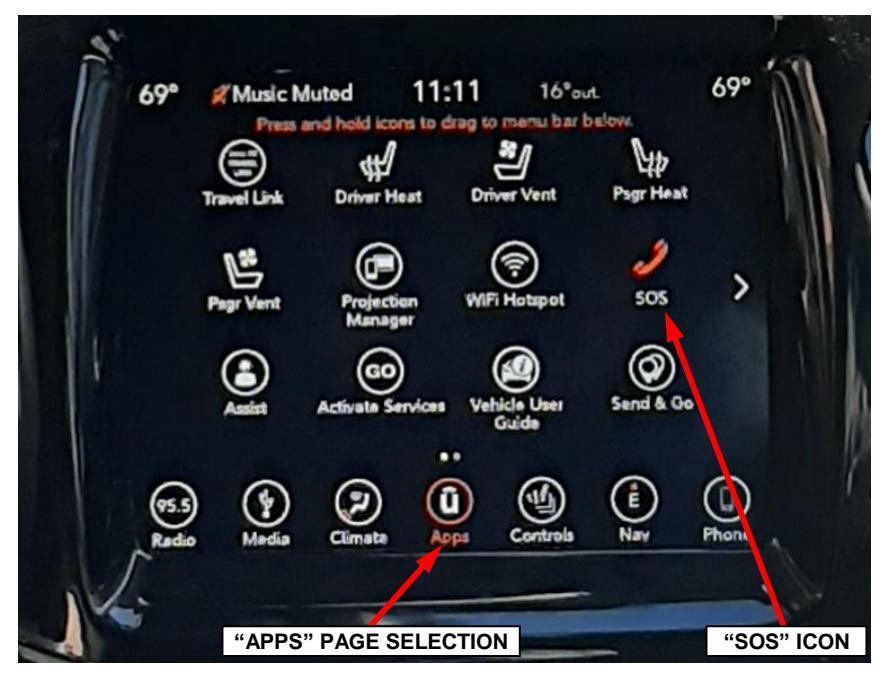
- 1. Place the ignition switch in the run position.
- 2. Turn on the radio.
- 3. On the center console radio screen, select the Apps page by pressing "**Apps**" selection at the bottom of the screen. (Figure 1)
- 4. Is the "**SOS**" icon present? (Figure 1)
 - > YES: Connected Services are enabled. No further action is required.
 - > NO: Perform the Repair Procedure in order to enable Connected Services.

Figure 1 – Connected Services Enabled

- 21. On the center console radio screen, select the Apps page by pressing "**Apps**" selection at the bottom of the screen.
- 22. Verify that the "SOS" icon is now present (Figure 1).
