Document ID: IK0800475
Revision: 12
Created: 1/29/2014
Last Modified: 5/22/2020
Author: Charles Schroeder

Title: Radio Diagnostics and Information

Applies To: All Vehicles

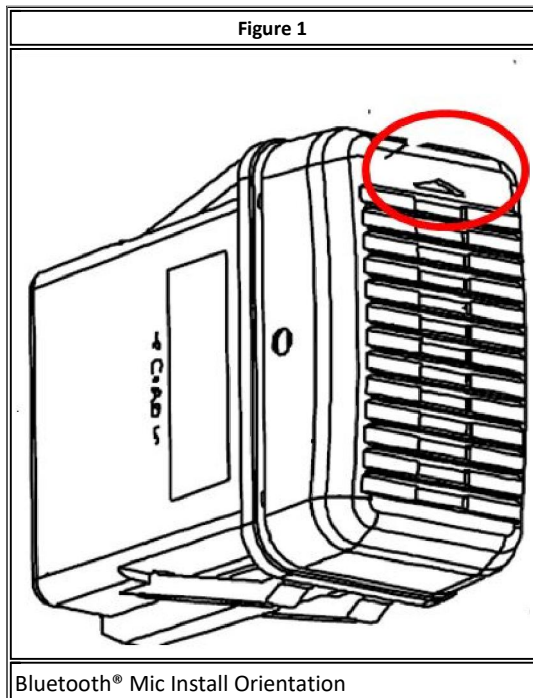
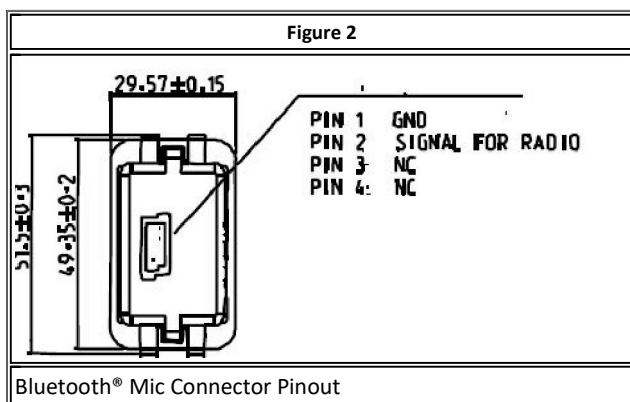
The Bluetooth® Mic must be installed with the arrow on the Mic facing toward the front of the vehicle or the performance will be drastically impacted. See Figure 1.

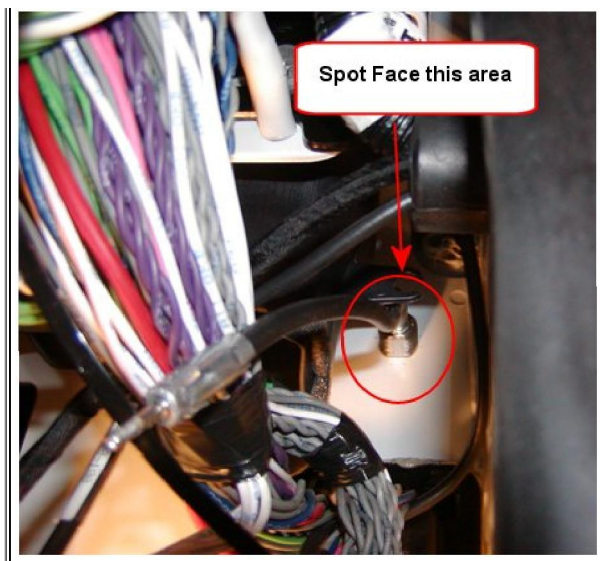
Figure 3 below shows location near the passengers kick panel under the IP. Builds after mid-December have the area spot-faced.

1. Cant identify XM radio ID#
 - To identify XM ID perform the procedure below:
 - Select XM as source, then tune to channel 0 , "RADIO ID" label alternates with the SXM radio eight-digit code.
 - **NOTE:** Some customers have had trouble activating the radio. This has been found to be due to misinterpretation of the radio ID. It's easy to mistake a "Q" for a "0"
 - Example: 9904248G should be 99Q4348G
2. Poor AM/FM reception
 - Resolution:
 - If poor radio reception is experienced, the mounting location needs to be spot-faced from the inside of the cab.
 - Remove the Nut and Star washer
 - Use a die grinder and remove the paint (spot face) around the antenna base. You do not need to remove the antenna.
 - Apply dielectric grease to the spot faced area.
 - Re-install the star washer and nut.

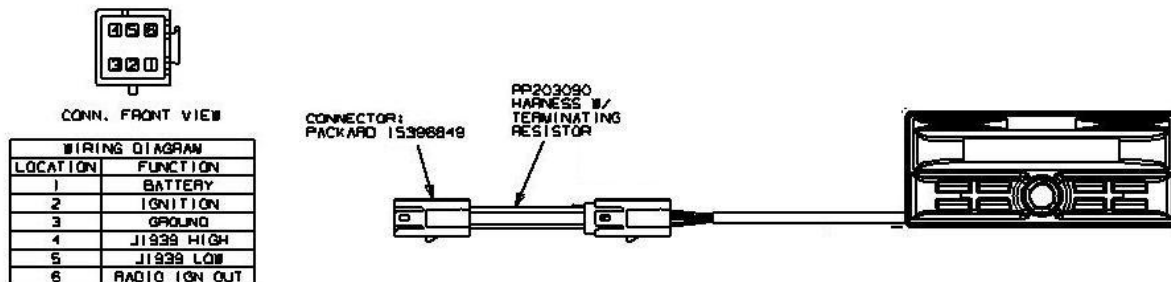
- With no power applied, there should be 60 Ohms of resistance between the circuits. If this is not correct, there may be an open circuit or missing terminating resistor. The terminating resistor for the remote is in a jumper harness between the sleeper radio control and the truck harness. (See picture below)
 - With power, there should be approximately 2.5 Vdc on each data link circuit.
 - Note: The voltages should not match
 - If problems persist or reoccur, it may be necessary to relocate the terminating resistors so that one is as close to the radio as possible and the other is as close to the remote control as possible.
6. If all else fails it may be necessary to replace the remote or the radio.

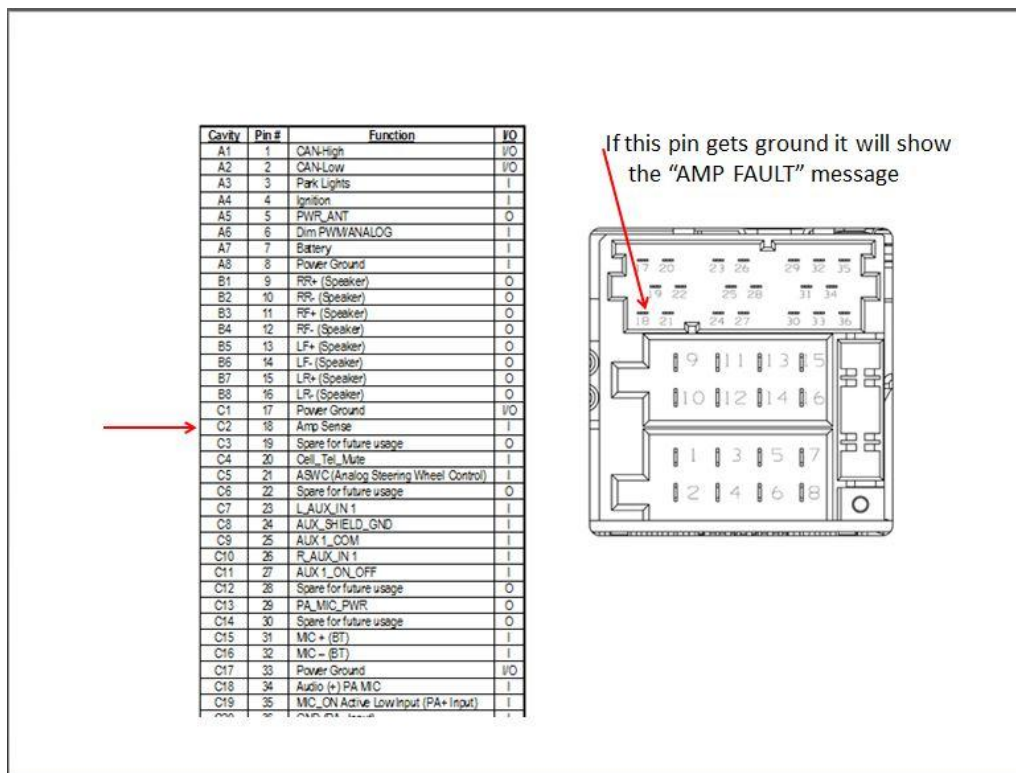
FIGURE 1

The radio will display this fault if the amp sense circuit is grounded. Check the circuit for a short to ground(Figure 1). As a last resort, the amp itself might be faulty.
