## UPDATE FROM WARRANTY OPERATIONS

## D-20-08 Addition of 2.4L Multiair Engines to the Powertrain Service Center (PTSC) Pre-Authorization Program

# New Heat Tabs on Engines and Intake Manifold Replacement Guidelines

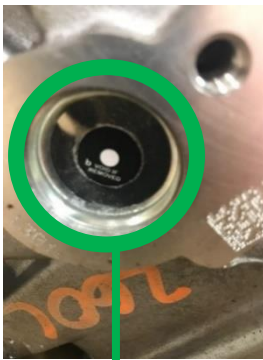
All Remanufactured Engines are equipped with Heat Tabs. Heat tabs can be found on the back of heads and in a core cup plug. If heat tabs are white, then the engine has not been overheated. If the heat tabs are pink, the engine coolant temp has reached 255°F. If the heat tabs are red, the engine coolant temp has exceeded 255°F. This will cause the heads to warp and leak coolant. Examples of heat tabs are below. The root cause of the overheat condition must be addressed. Engines only

Normal White Sensor

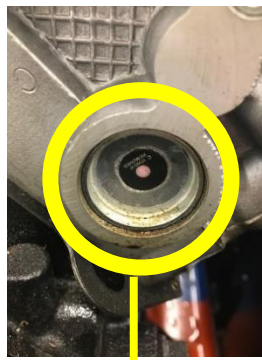
overheat from a lack of coolant which causes the heads to warp. The cause of the overheat condition must be identified. If the component is not covered by a warranty, then the overheated engine cannot be claimed as a warrantable repair. Also, a non-covered component that causes a covered component to fail, will cause the covered component to no longer be covered. Engines returned with indications of an overheat may be charged back in full.

Overheated Pink Sensor  
255°F Coolant Temp

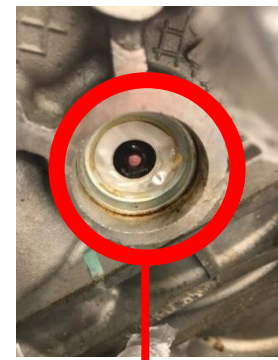
Overheated Red Sensor  
+255°F Coolant Temp

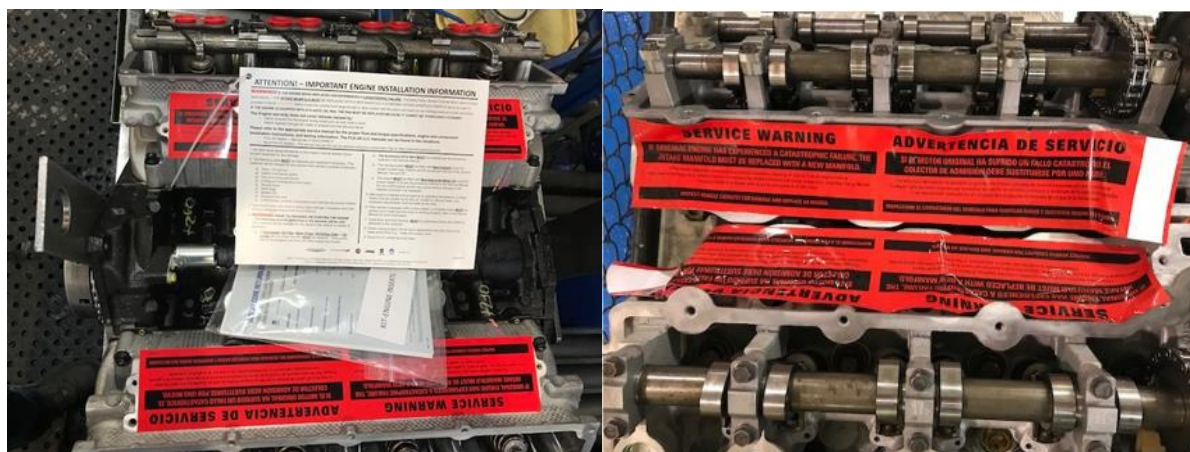
If an engine suffered a catastrophic failure and is equipped with a plastic intake manifold, the intake manifold must be replaced during engine replacement. Remanufactured engines come with protective intake port warning tape (see below) that advises of this requirement. Engines

returned with debris in the combustion chambers from a previous engine replacement may be charged back in full for failing to install a new intake manifold during the first replacement.
