SUBJECT:			No:	SR-20-002	
SEAT BELT -	DATE:	May 2020			
			MODE	SEE BELOW	
CIRCULATE TO:	[X] GENERAL MANAGER	[X] PARTS MANAGER	[X] PARTS MANAGER [X		
[X] SERVICE ADVISOR	[X] SERVICE MANAGER	[X] WARRANTY PROCESS	) R	[X] SALES MANAGER

This Safety Recall Bulletin provides instructions for inspecting the 2<sup>nd</sup>-row RH-side (passenger side) seat belt shoulder anchor. If necessary, the seat belt will be replaced.

Certain 2020 Outlander vehicles Certain 2020 Outlander PHEV vehicles

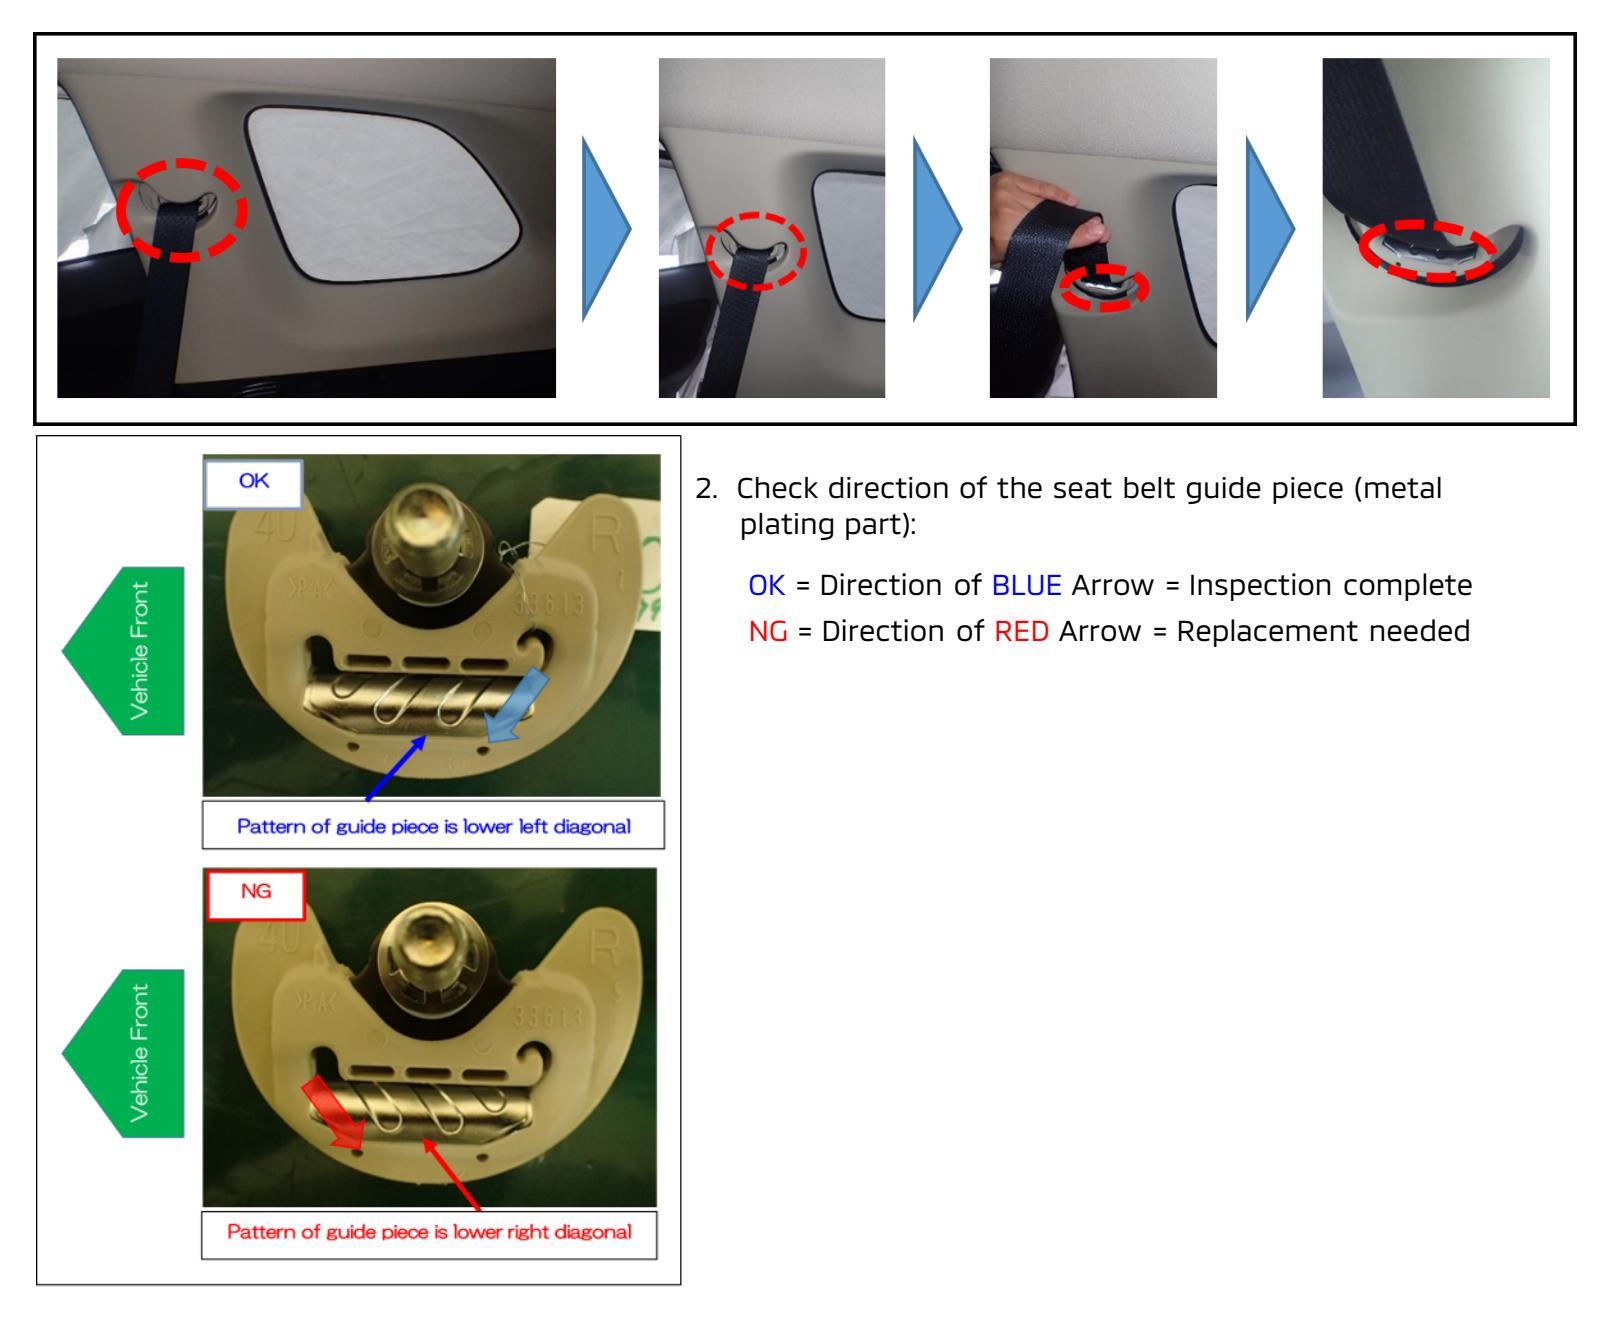
Due to inappropriate manufacturing process at the supplier, the guide piece (which is a component part of the second row seat belts' anchorage) for the left side seat belt was mistakenly assembled with the right side seat belt, causing seat belt restraint efficiency for vehicle occupants to decrease in a vehicle collision, increasing the risk of injury.

1. Turn over the belt at shoulder anchor part of the rear right side seat belt.

1. The replacement procedure will require the removal of the seat and various trim components. Please refer to the applicable service manual for removal and installation instructions.

Description	Part Number	
REAR SEAT BELT OUTER RH	7000D540XA
