# **Technical Service Bulletin**

#### 90 Instrument cluster layout of the Audio virtual cockpit plus cannot be changed

90 20 57 2060195/1 July 15, 2020.

Model(s)	Year	VIN Range	Vehicle-Specific Equipment
Audi e-tron quattro	2019 - 2020	All	Audi virtual cockpit plus

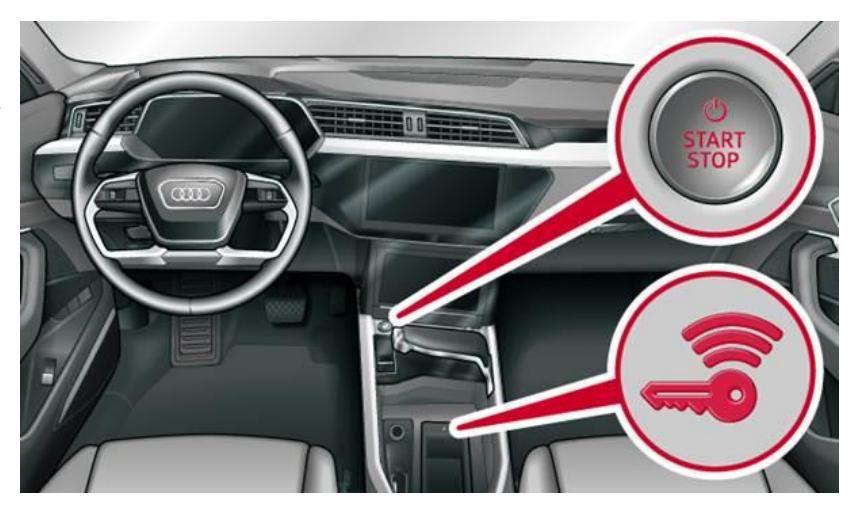
*Figure 1.* Center console in the Audi e-tron quattro with a mark for the vehicle key (example).

If the message "...hold the vehicle key on the transponder..." appears, place the vehicle key fully on the provided mark of the center console (Figure 1), until the update starts in the Audi virtual cockpit plus.

Keep the key in this position until the update is completed.
