# Technical Service Bulletin

FUEL-FILLER LID PANEL IS DEFORMED

Bulletin No.: 09-023/20

Last Issued: 08/13/2020

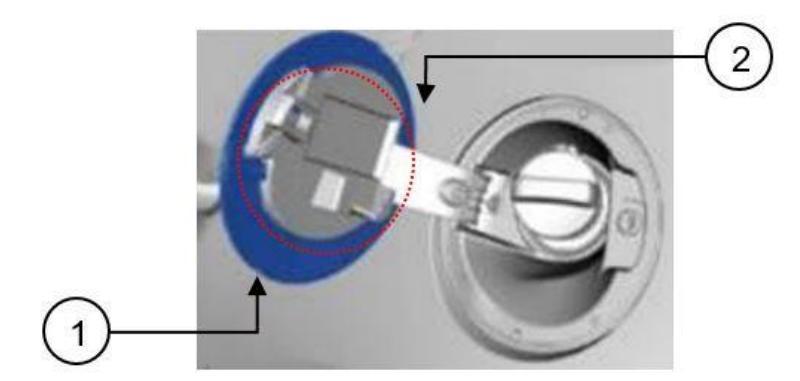
Some vehicles may exhibit a deformed fuel-filler lid panel (1) attached to the fuel-filler lid box, resulting in a poor appearance.

This concern is caused by the lid box not having enough water drainage capability which leads to the accumulation of water inside it. The water then freezes in cold weather and expands or the inner side of the lid panel absorbs the water and swells from long exposure, deforming the lid panel. To eliminate this concern, the shape of the fuel-filler lid box has been modified to have better drainage capability.
