Service Action Code: 90M9

Subject	Emergency Call Function					
Release Date	August 27, 2020					
Affected Vehicles	Country	Beginning Model Year	Ending Model Year	Vehicle	Vehicle Count	
	USA	2019	2019	E-TRON	1,758	
	CAN	2019	2019	E-TRON	194	
	Check Campaig action. Elsa is ✓ Camp	gns/Actions scre the <u>only</u> valid ca paign status mu	een in Elsa on ti impaign inquiry st show "open.'	he day of repair to verify that a VIN qual & verification source. ,	ifies for repair und	der this
	the s	a snows other o ame time the ve	hicle is in the w	orkshop for this campaign.	an also be comple	ted at
Problem Description	In rare cases, it may not be possible to activate the emergency call function due to the license not being transferred. In addition, the user management menu in the MMI is greyed out and it is therefore not possible to log in as a key user.					
Corrective Action	Check and, if necessary, enable emergency call function operation.

Subject: Service Action 90M9 - Emergency Call Function

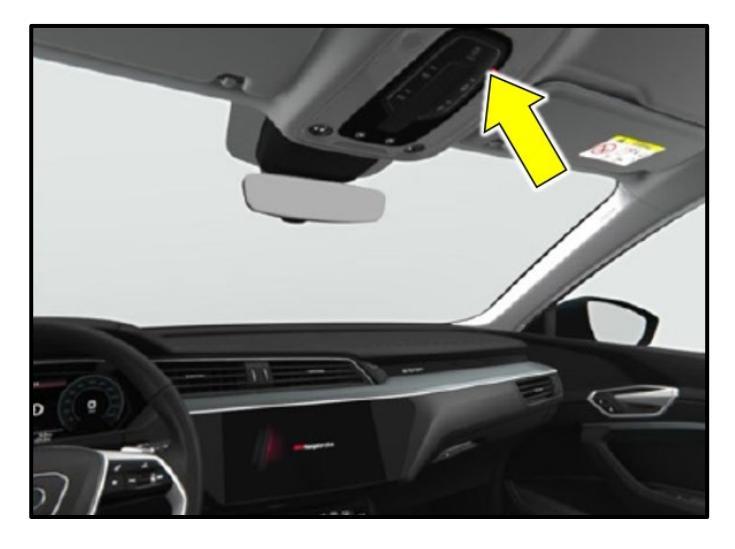
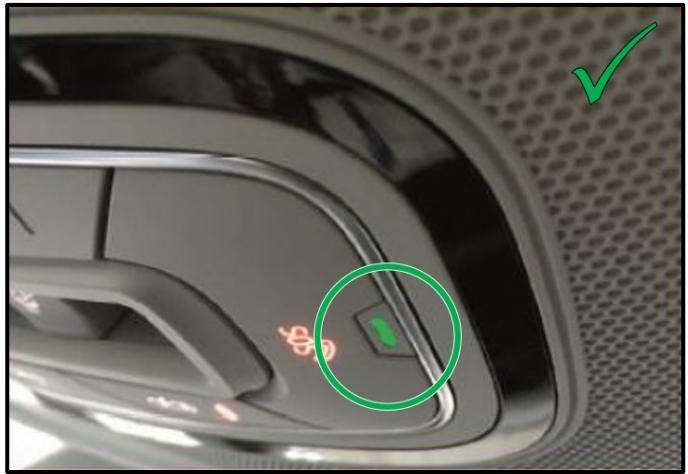
Section B – Check Emergency Call Function Operation

- Ensure a mobile network connection is available.
- Check the status of the LED for emergency call button <arrow>.

- If the LED lights up continuously GREEN (does not flash):
 - No further work is required.
 - Proceed to Section E.

- If the LED lights up in RED:
 - Diagnosis must be performed using Guided Fault Finding.
 - Diagnosis and repair of faults causing the RED light will NOT be covered under this action.
 - Once the faults are resolved, reevaluate the status of the LED and follow the inspection steps outlined in this action.
- If the LED is not illuminated:
 - Proceed to Section C to check measured value IDE12238.

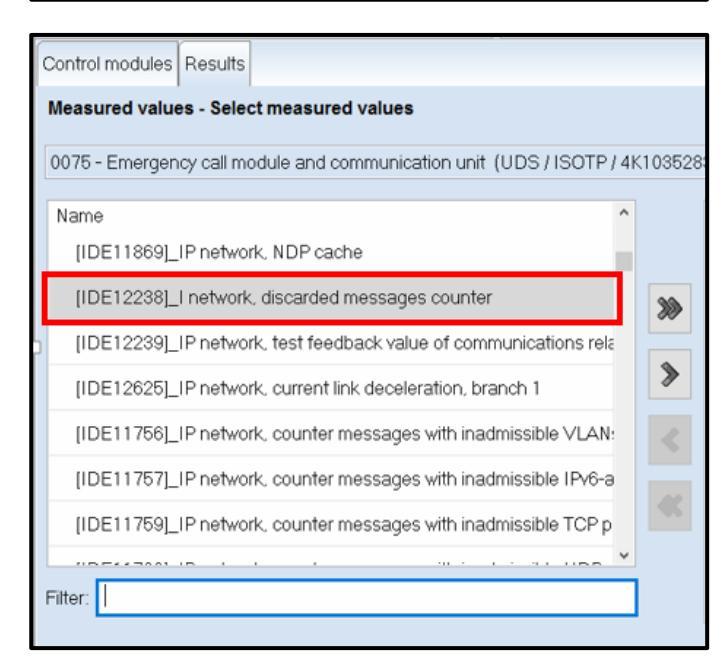
Section C – Checking and Evaluating Measured Value IDE12238

- Evaluate the reading in the "Value" column.
- If there is a value present (including "0" as shown):
 - Proceed to Section D to perform a terminal 30 reset on the gateway control module.
- If measured value IDE12238 is NOT available (no value present):
 - The Gateway control module requires replacement.
 - See ELSA Repair Manual: Repair manual > Electrical System > Electrical Equipment > 97 Wiring > Control Modules > Data Bus on Board Diagnostic Interface J533, Removing and Installing
 - After replacing the gateway control module, Proceed to Section E.

- Attach the GRX3000VAS Tester/Charger (or equivalent) IN POWER SUPPLY MODE to the vehicle battery charging posts.
- Perform the operation using Vehicle Self Diagnosis via OBD.
- Highlight 0075 Emergency call module and communication unit <arrow 1>.
- Select *Measured values* from the drop down menu <arrow 2>.
- Click the green arrow <arrow 3>.
- Select measured value "IDE12238_I network, discarded messages counter"
