## UPDATE FROM WARRANTY OPERATIONS

## FIXED FIRST VISIT IMPROVEMENT

## All Vehicles - All Model Years - A/C Refrigerant Lines Seal Caps

## 2019 - 2021 JL/JT Weather Seal Replacement

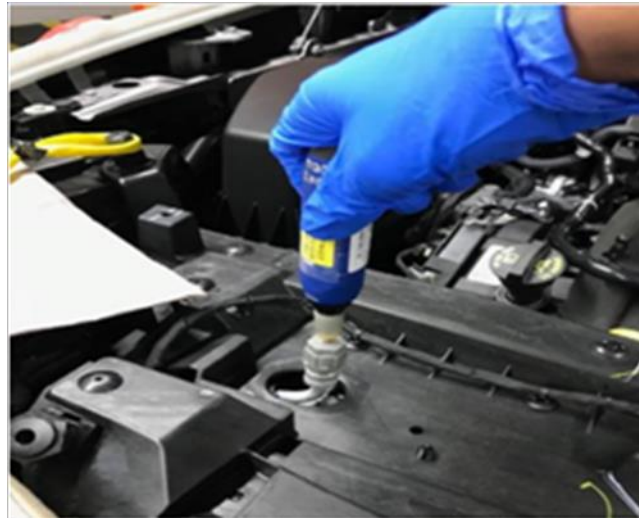
Typical cap and an optional tool, or an inch/pound torque wrench could be used with a

TORX bit for the center of the cap.

Remove the high and low port caps to perform required vacuum and charge operations as per the described service procedure. After finishing the operations, high and low side ports caps must be installed back by using a torque tool to confirm torque is the appropriate. The torque tool can be a clicker or an inch/pound torque wrench capable to torque the cap at 2.5 in/lbs., by using the upper TORX feature on the cap.

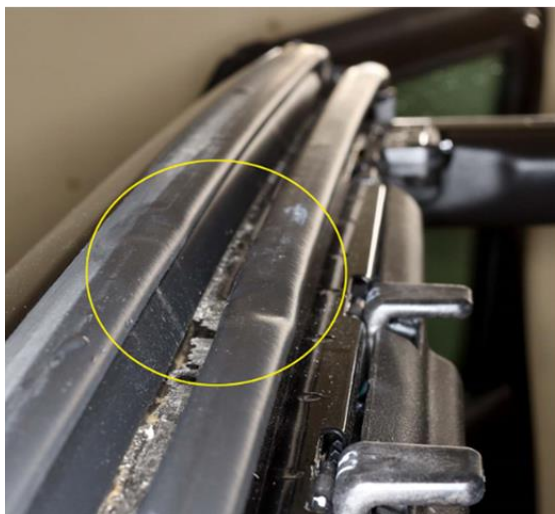
Windshield Header Seal to Center Panel Seal

Below are two examples of areas commonly referenced in narratives as a reason for replacement, where visible seal deflection is expected and considered a normal operating condition and do not contribute to water leaks or wind noise.
