SIB 52 05 20

BACKREST MISALIGNMENT OF 60/40 SECOND ROW SEAT

2020-09-09

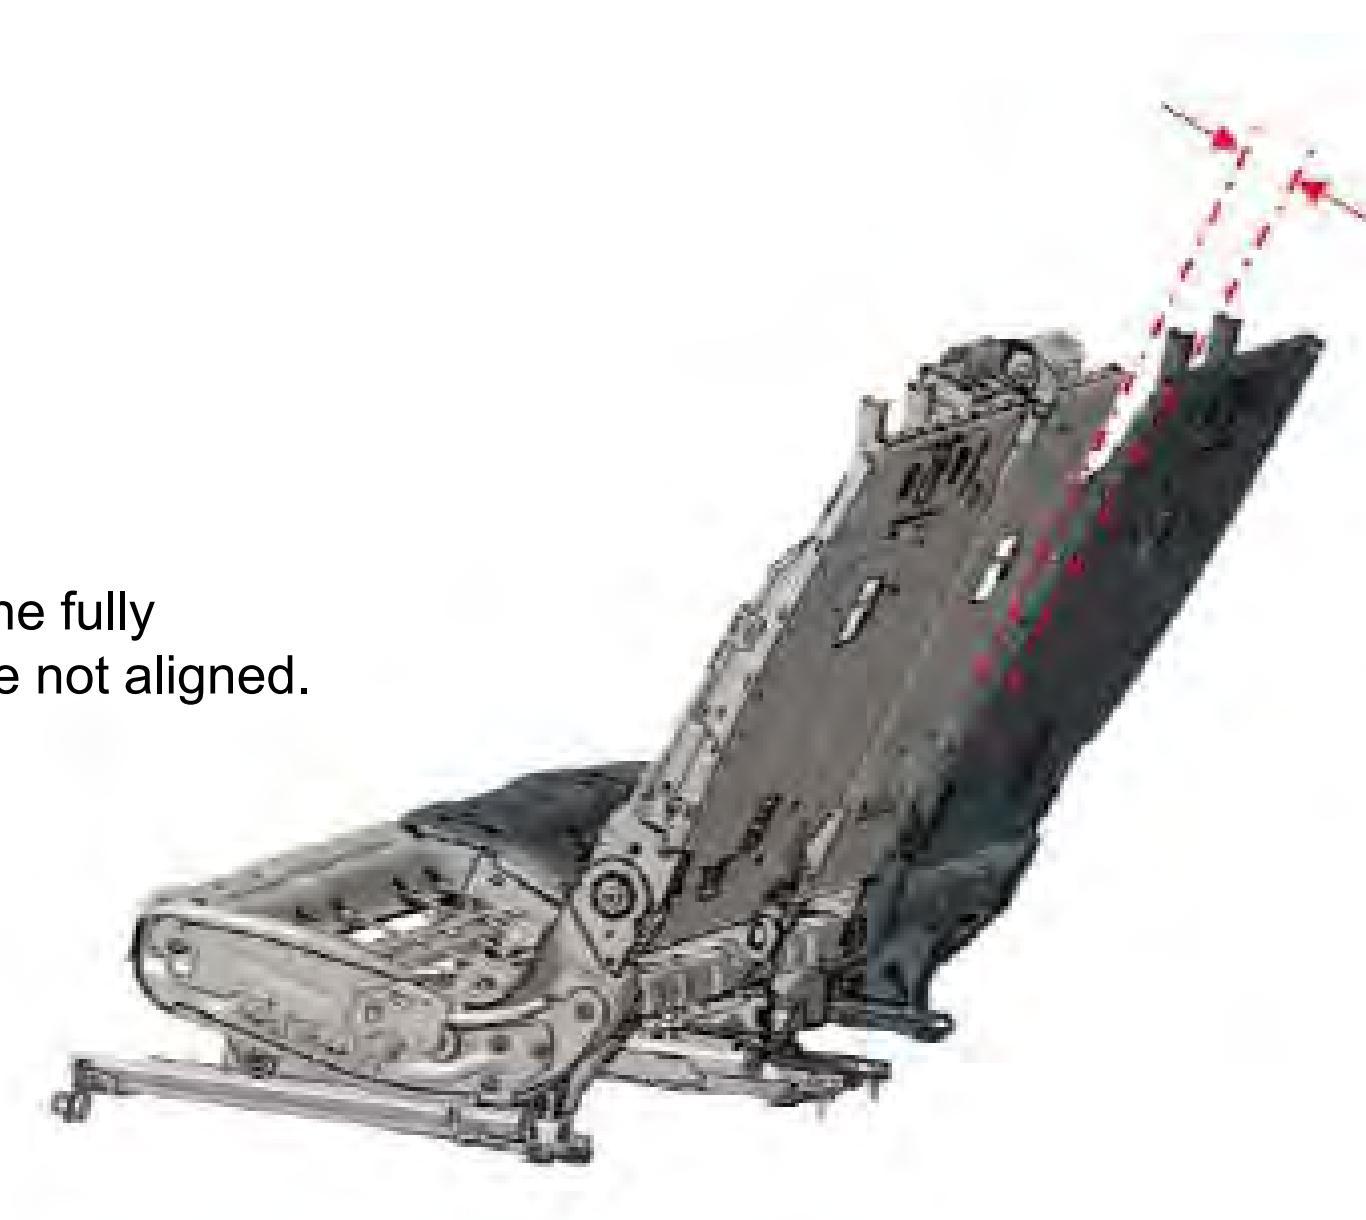
When the second row split 60/40 seats are in the fully rearward COMFORT position the seatbacks are not aligned.

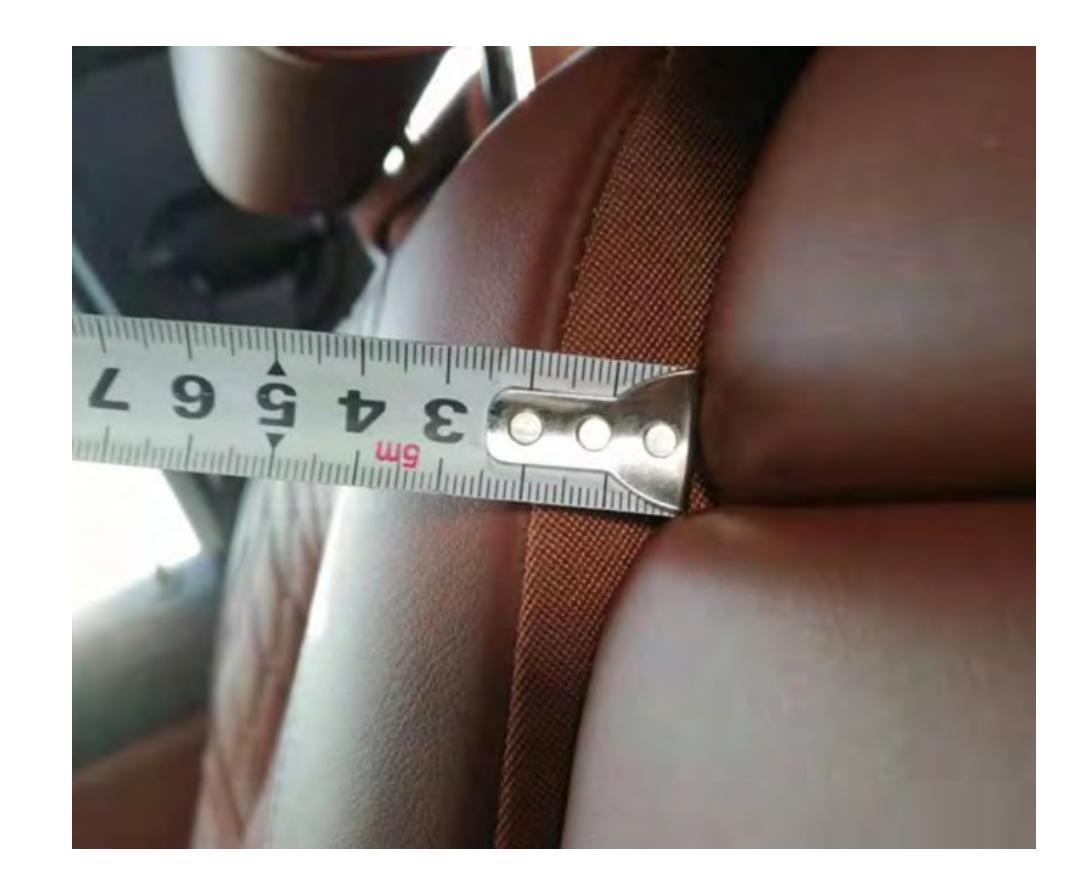
- A large misalignment can indicate the seats have not gone full travel during the previous movement, that the frame is bent or that there is an obstruction within the seat mechanism.
- Check for obstructions.
- Manually operate the seat controls (side of seat) to see if the backrest can be moved any further back.
- Repeat seat initialization test plan for 2nd row seats only.

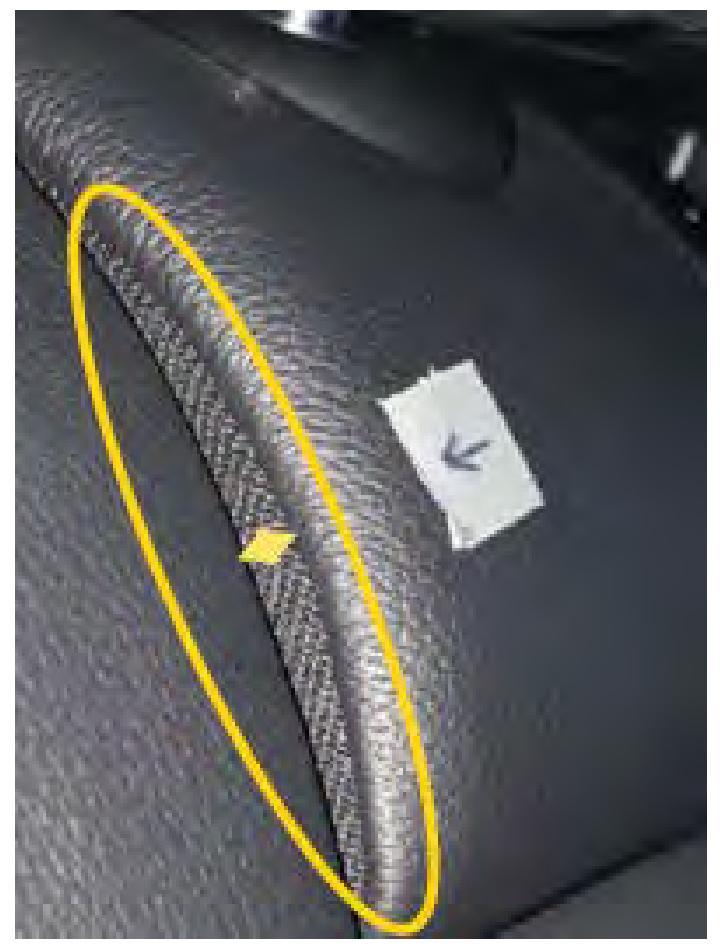
Measure the backrest offset (measurement is of the exposed fabric)

- A misalignment of under 8 mm is acceptable and within manufacturing tolerance.
- A rework of the seat should only be done if the misalignment is **greater than 8 mm**.
- <u>Small removal of material</u> and tests are required until the misalignment disappears. <u>A maximum of 2.5 mm of material can</u> be removed.
- 1mm removed at end stop is approximately 9mm movement of the backrest)
- CAUTION: If too much material is removed from the end stop the seat will no longer function properly and a replacement seat frame will be needed to restore functionality.

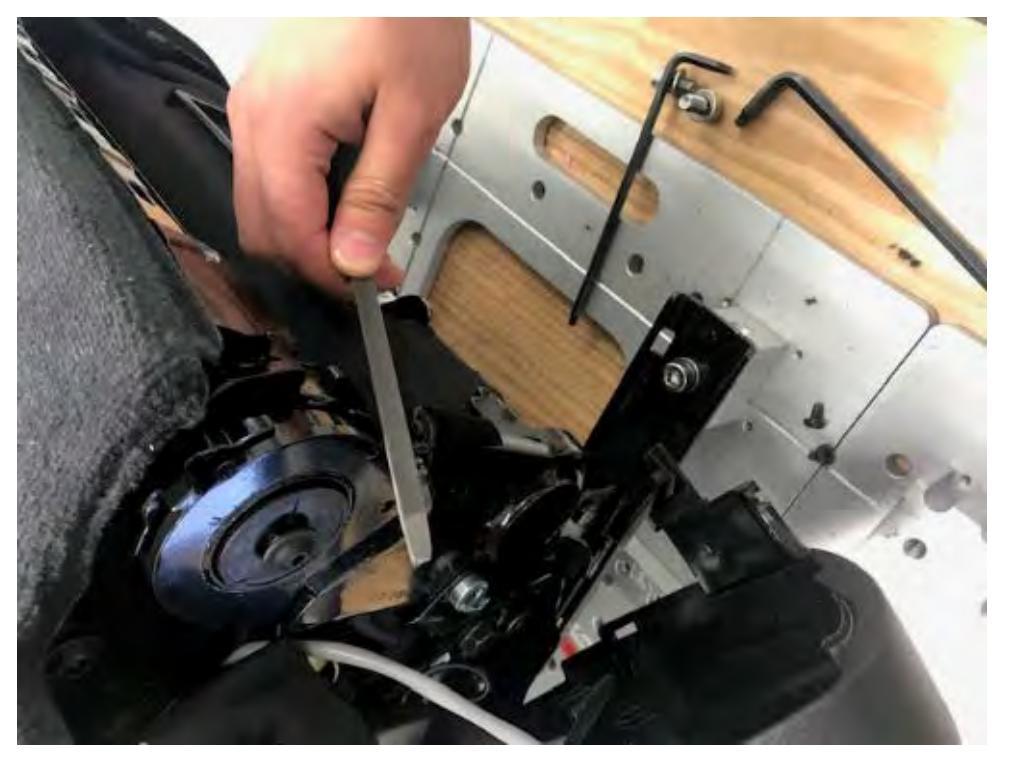
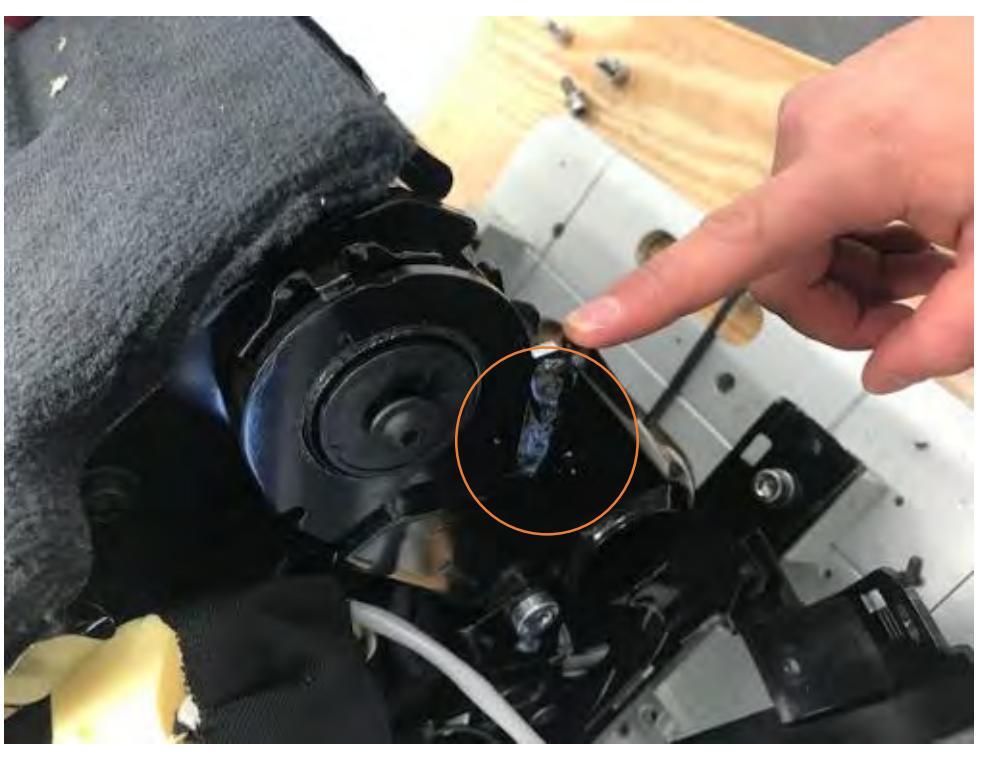
Only one end stop will be contacting, either IB or OB, this is the end stop to rework.

The seat is designed to function with only 1 end stop touching.

The amount of material to be removed is not defined, <u>small removal of material</u> and tests are required until the misalignment disappears. A maximum of 2.5 mm of material can be removed. (1mm removed at end stop is approximately 9mm movement of the backrest) This can be tested by driving the seat to the comfort position and again check the alignment. You must hook the seat up to the car and re-initialize the seat so it finds the new home position. Once you are done modifying the end stop apply a small dab of red paint to either side of the end stop so a technician in the future will know this modification has already been performed.

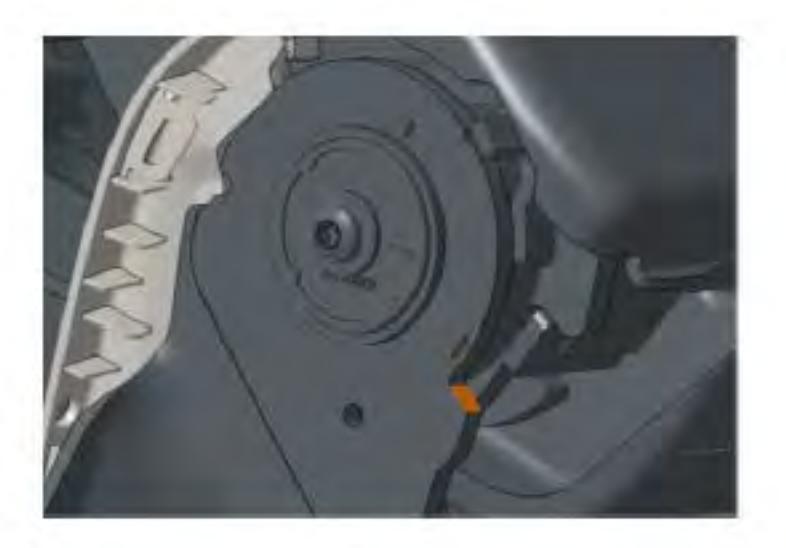
Only one end stop will be contacting, either IB or OB, this is the end stop to rework.

Remove material from the end stop on IO and OB side

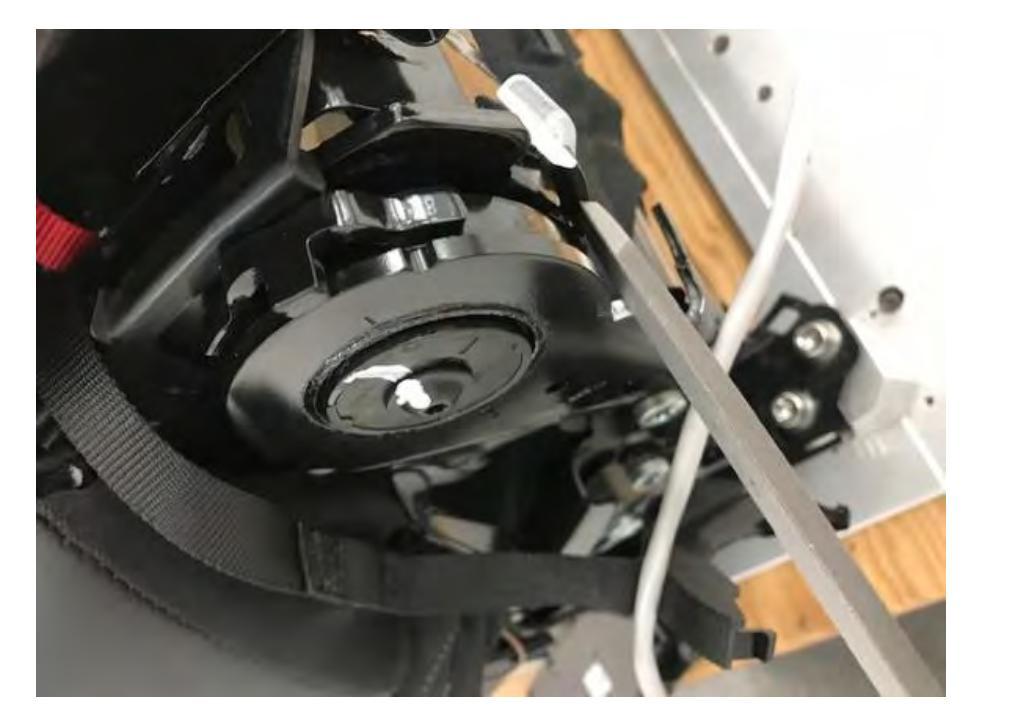
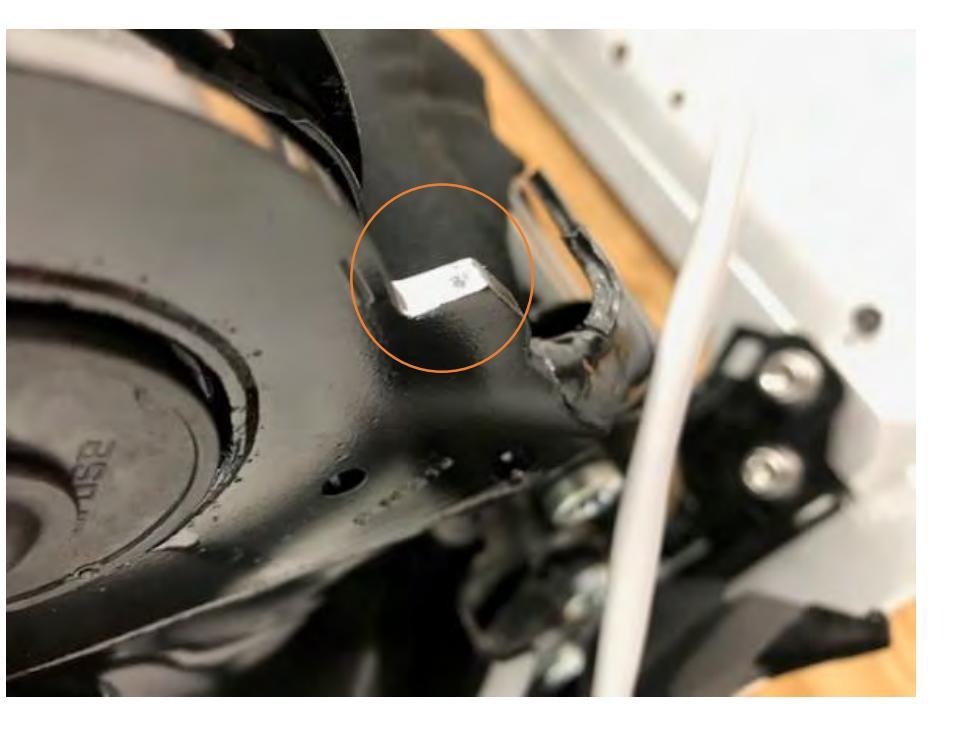
Identify the end stop and the part to be reworked, the same rework as the 40% is necessary for the 60%.

The amount of material to be removed is not defined, <u>small removal of material</u> and tests are required until the misalignment disappears. A maximum of 2.5 mm of material can be removed. (1mm removed at end stop is approximately 9mm movement of the backrest)

This can be tested by driving the seat to the comfort position and again check the alignment. You must hook the seat up to the car and re-initialize the seat so it finds the new home position. Once you are done modifying the end stop apply a small dab of red paint to either side of the end stop so a technician in the future will know this modification has already been performed.

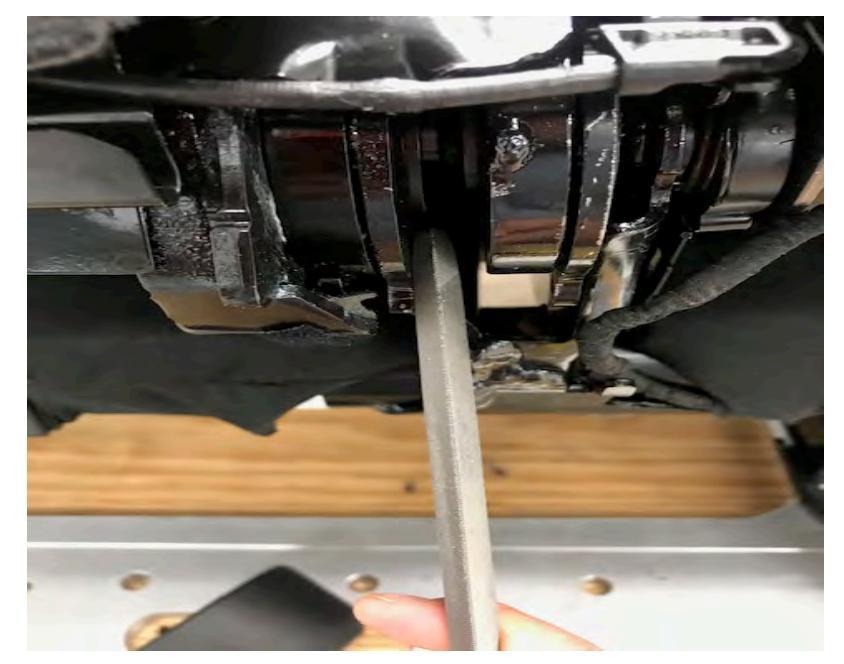
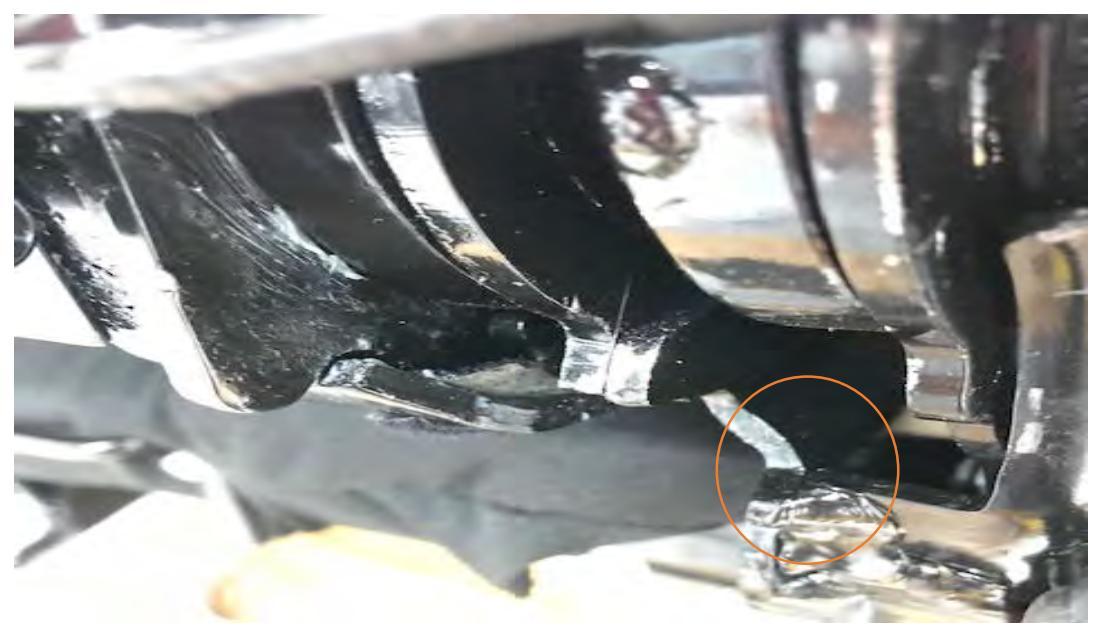
Once the hooks are released pull out the part and identify the IB end stop to be reworked.

The amount of material to be removed is not defined, <u>small removal of material</u> and tests are required until the misalignment disappears. A maximum of 2.5 mm of material can be removed. (1mm removed at end stop is approximately 9mm movement of the backrest) This can be tested by driving the seat to the comfort position and again check the alignment. You must hook the seat up to the car and re-initialize the seat so it finds the new home position. Once you are done modifying the end stop apply a small dab of red paint to either side of the end stop so a technician in the future will know this modification has already been performed.
