Dealer Service Instructions for:

Customer Satisfaction Notification W11 Radio Connected Services

2020 (BV) Jeep® Renegade

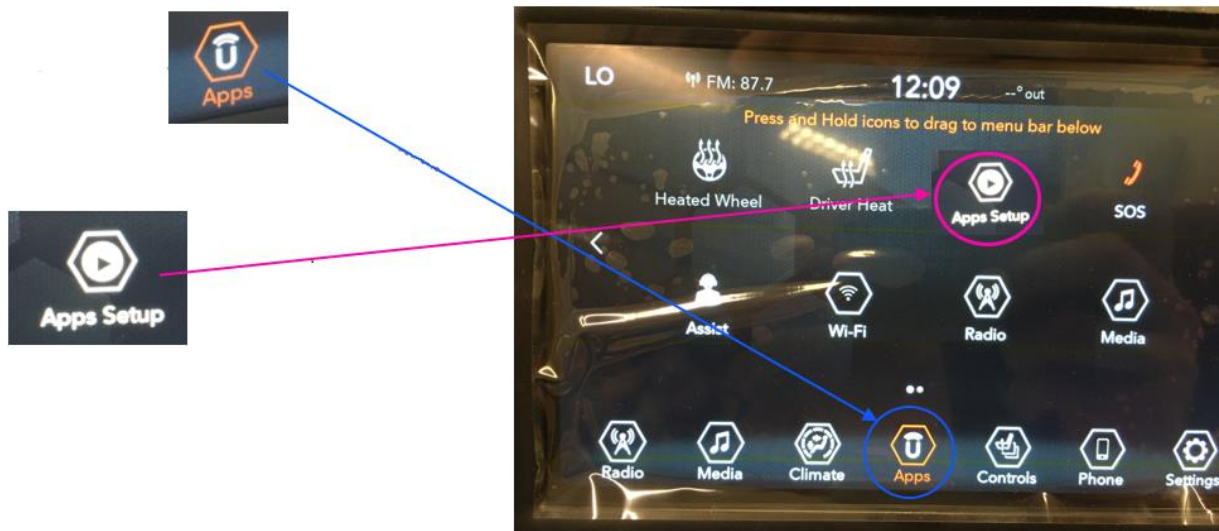
Figure 3 – Select Apps Button

1. Place the ignition switch in the run position.
2. Turn on the radio.
3. On the center console radio screen, select the Apps page by pressing **“Apps”** selection at the bottom of the screen (Figure 3).

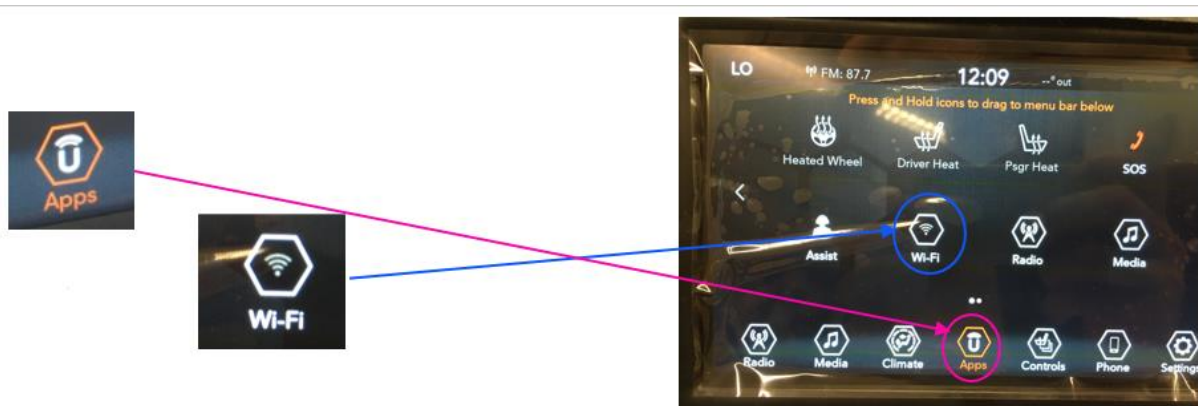
Figure 4 – Select Apps and Settings Buttons

1. On the center console radio screen, select the Apps page by pressing “**Apps**” selection at the bottom of the screen (Figure 4).

2. Scroll through the screen to locate and press the “**WiFi**” button (Figure 4)
3. Push the “**Setup WiFi Hotspot**” button (Figure 5).
