133/20 ENU WLH2

# WLH2 - Checking Threaded Joint on Engine Support and Reworking it if Necessary (Workshop Campaign)

Model Line:	911 (992)
Model Year:	2020
Subject:	Engine support
Information:	There is a possibility that the screws on the engine support were not tightened to the prescribed tightening torque on the affected vehicles.
	If this is the case, noises can come from the engine compartment while driving.
Remedial Action:	Check threaded joint on engine support and rework it if necessary.
Affected Vehicles:	Only vehicles assigned to the campaign (see also PCSS Vehicle Information). There are 5 vehicles affected by this campaign.

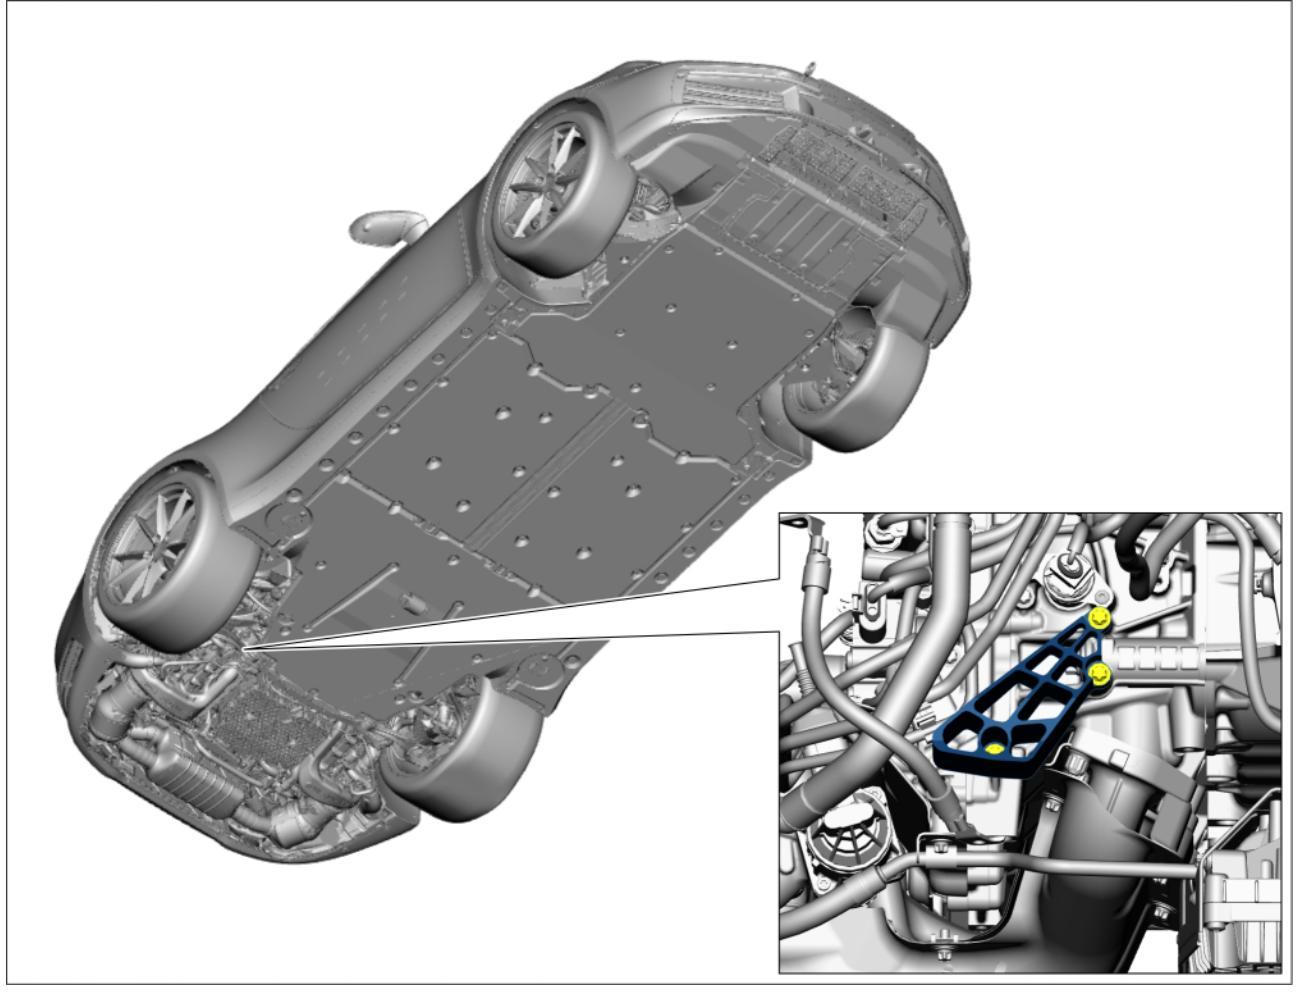
Installation position of engine support

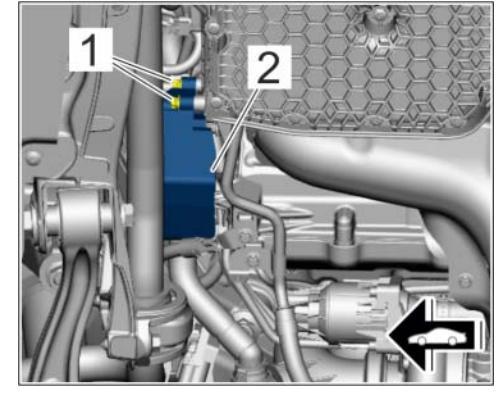
2 Check whether the engine support ⇒ Checking threaded joint on engine support -2- is screwed securely. To do this, shake the engine support and check that the two visible screws are installed securely ⇒ Checking threaded joint on engine support -1-.

Assessment		Action required	
(√)	Engine support is screwed securely.	End of action required.	
	• Engine support cannot be moved.	$\Rightarrow$ Continue with <b>Step 7</b>	
	Screws look OK.	[Invoicing: Scope 1]	
(X)	Engine support is <b>not</b> screwed securely.	Engine support must be screwed using new screws.	
	• Engine support can be moved.	$\Rightarrow$ Continue with <b>Step 3</b>	
	or	[Invoicing: Scope 2 or Scope 3]	
	Screws do not look OK.
