2021 M2 LOW COOLANT LEVEL

2021 M2 LOW COOLANT LEVEL Jul 20, 2020 6:16 PM

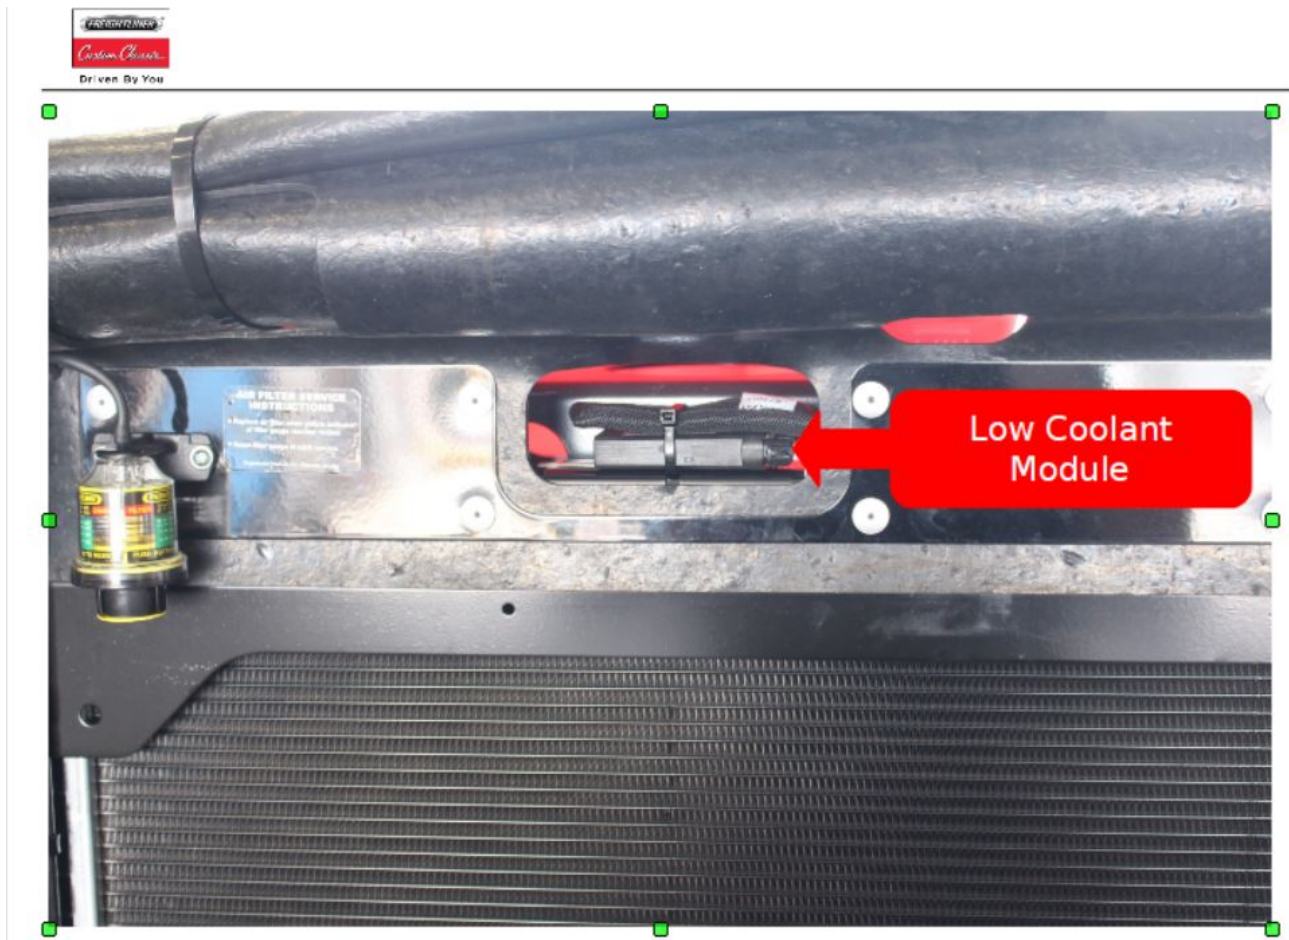
Had a RV in our shop recently. The tech was working with FCCC on a LCL code. Pretty sure both tech and support were following cummins diag and harness. After 6 hours they ended up overlaying the circuit from the Sensor to the ECM because it was open. But if either glanced at a LCL schematic, they would have noticed a little module between the two. Replaced the little black credit card shaped module and fixed it.

This one?

Yep! Medallian? Converts a 5 volt signal into a a/c voltage that goes into the coolant and that voltage changes when touching coolant.

can be coding due to voltage in the coolant. But 99.9% of the time a new LCL sensor and module fixes it.
