Mazda North American Operations Irvine, CA 92618-2922

CONNECTED VEHICLE SYMPTOM TROUBLESHOOTING

Service Alert No.: SA-031/20

Last Issued: 11/30/2020

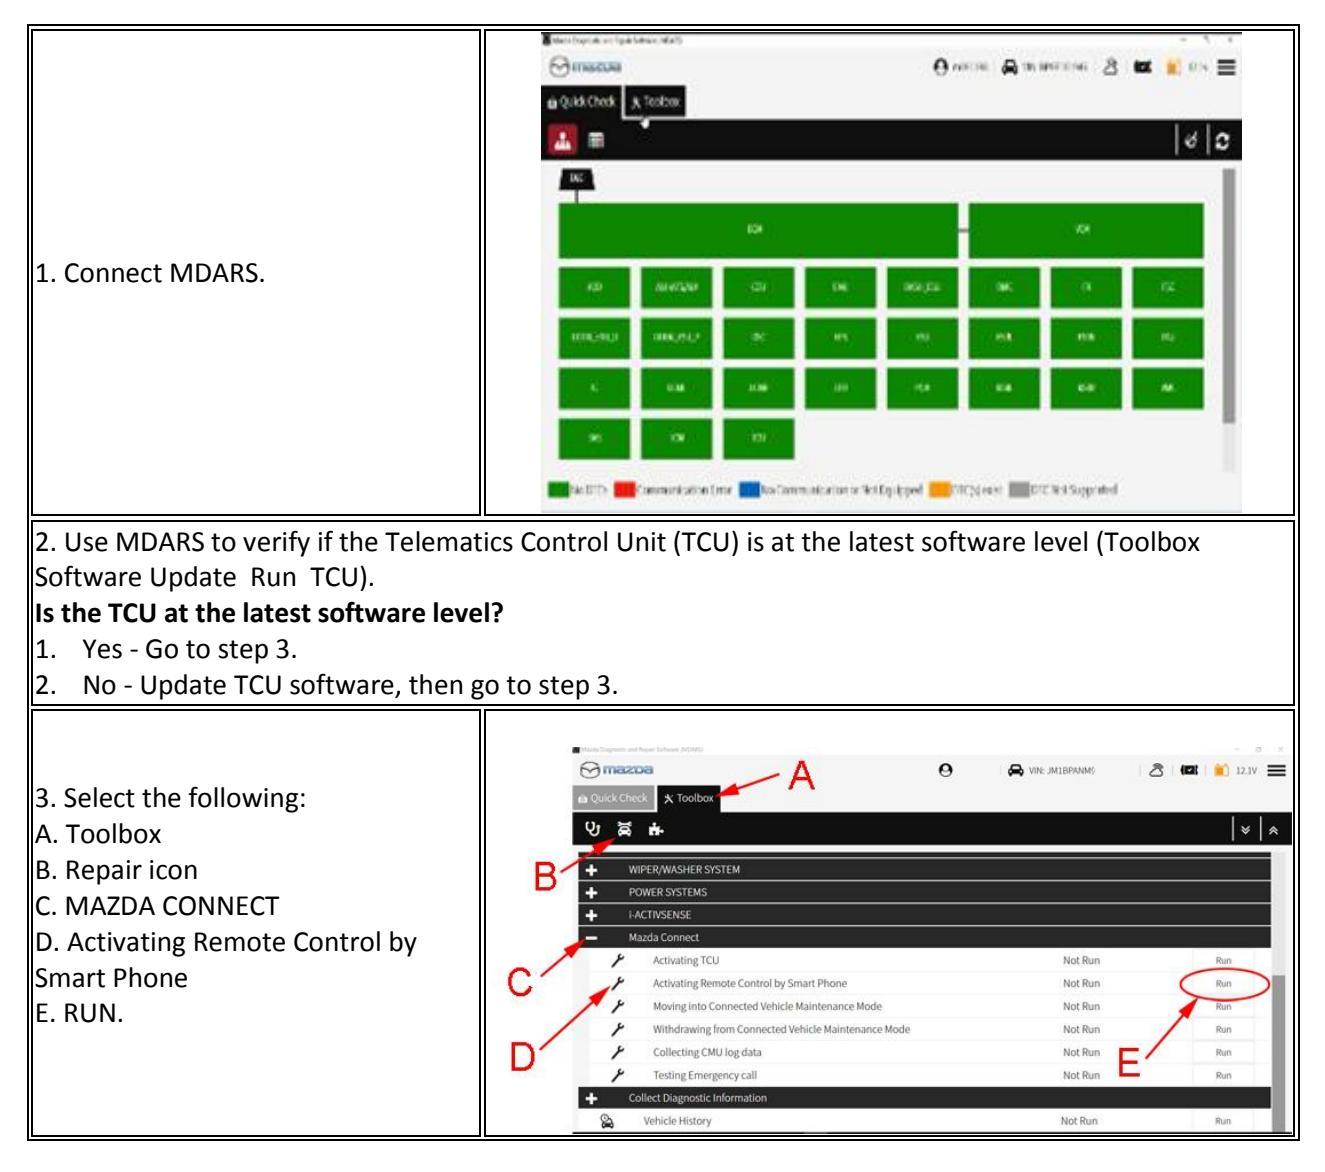
Activating Remote Control by Smart Phone

NOTE: This procedure cannot be performed if the key transmitter power saving function is enabled. See SA-040/20.
