Case Number: S1923000044 Rev D

Symptom/Vehicle Issue: Dust Intrusion Or Air Leak In Cab

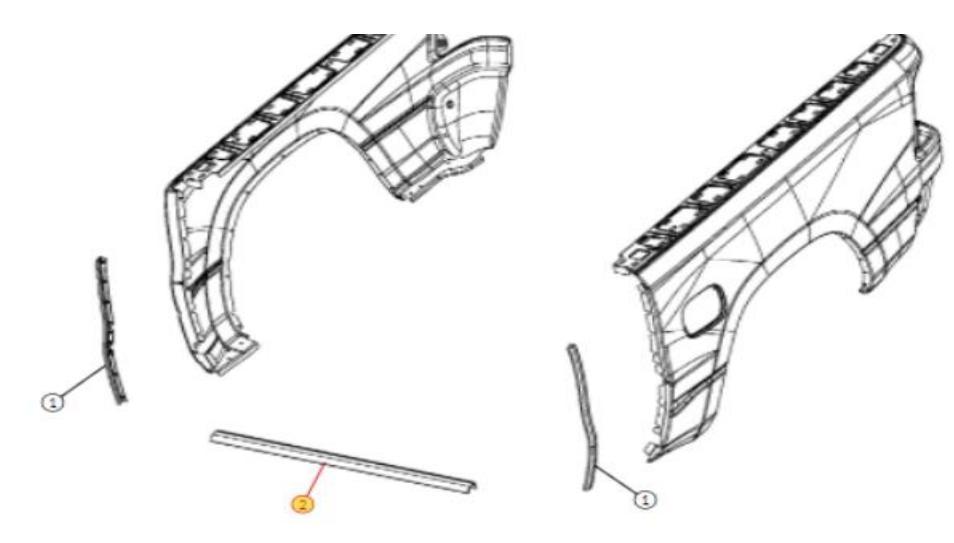
Discussion: Owner may complain of fine dust entering the cab even with windows rolled up. Verify the cab body exhausters are functioning and do not have deformed rubber flaps. Verify the rear cab to bed horizontal seal is in place (Fig 1). If missing the air flow under the truck may promote dust intrusion and cab wind noise. A possible air leak in the driver or passenger C Pillar and along the rear cab floor (Fig 2 and 3) may cause dust intrusion.

Fig 1 Cab to bed seal item #2

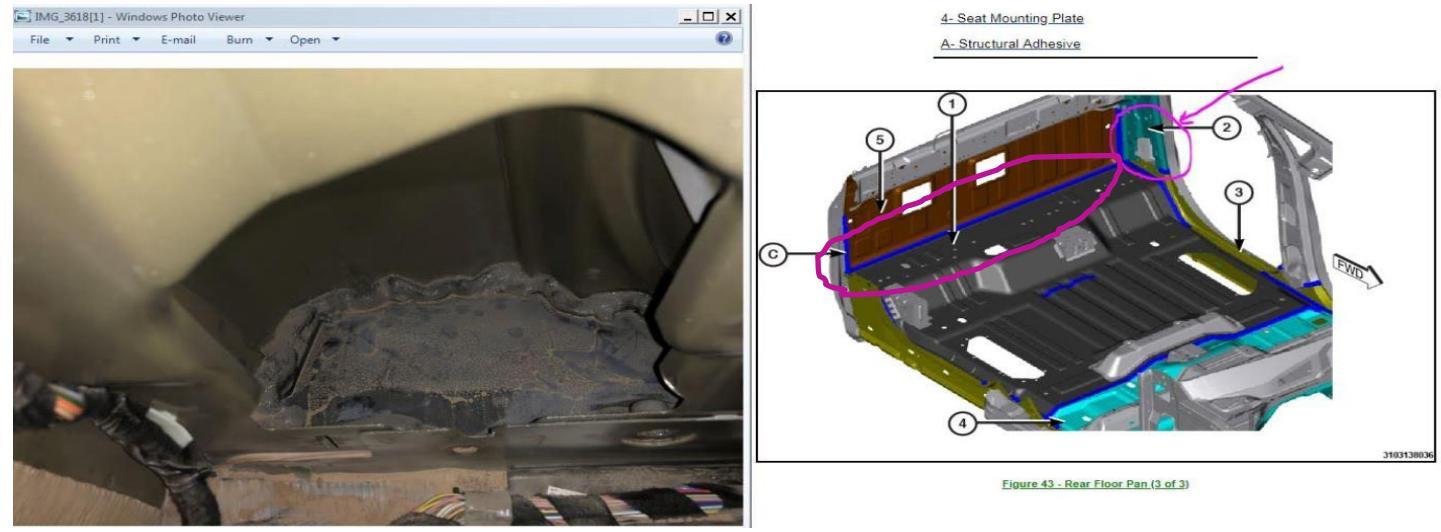
Fig 2

Note- Passenger side shown. Drivers side similar and should also be inspected.

The area shown in fig 1 is a pocket in the C Pillar. There is a foam blocker installed in the pocket. The blocker edges are meant to seal against the pillar. If there is a poor seal an air leak will result that could pull dust in to the interior if the vehicle is driven in dusty road conditions. If the blocker or cab sealer has gaps– careful application of rtv or seam sealer can be used.

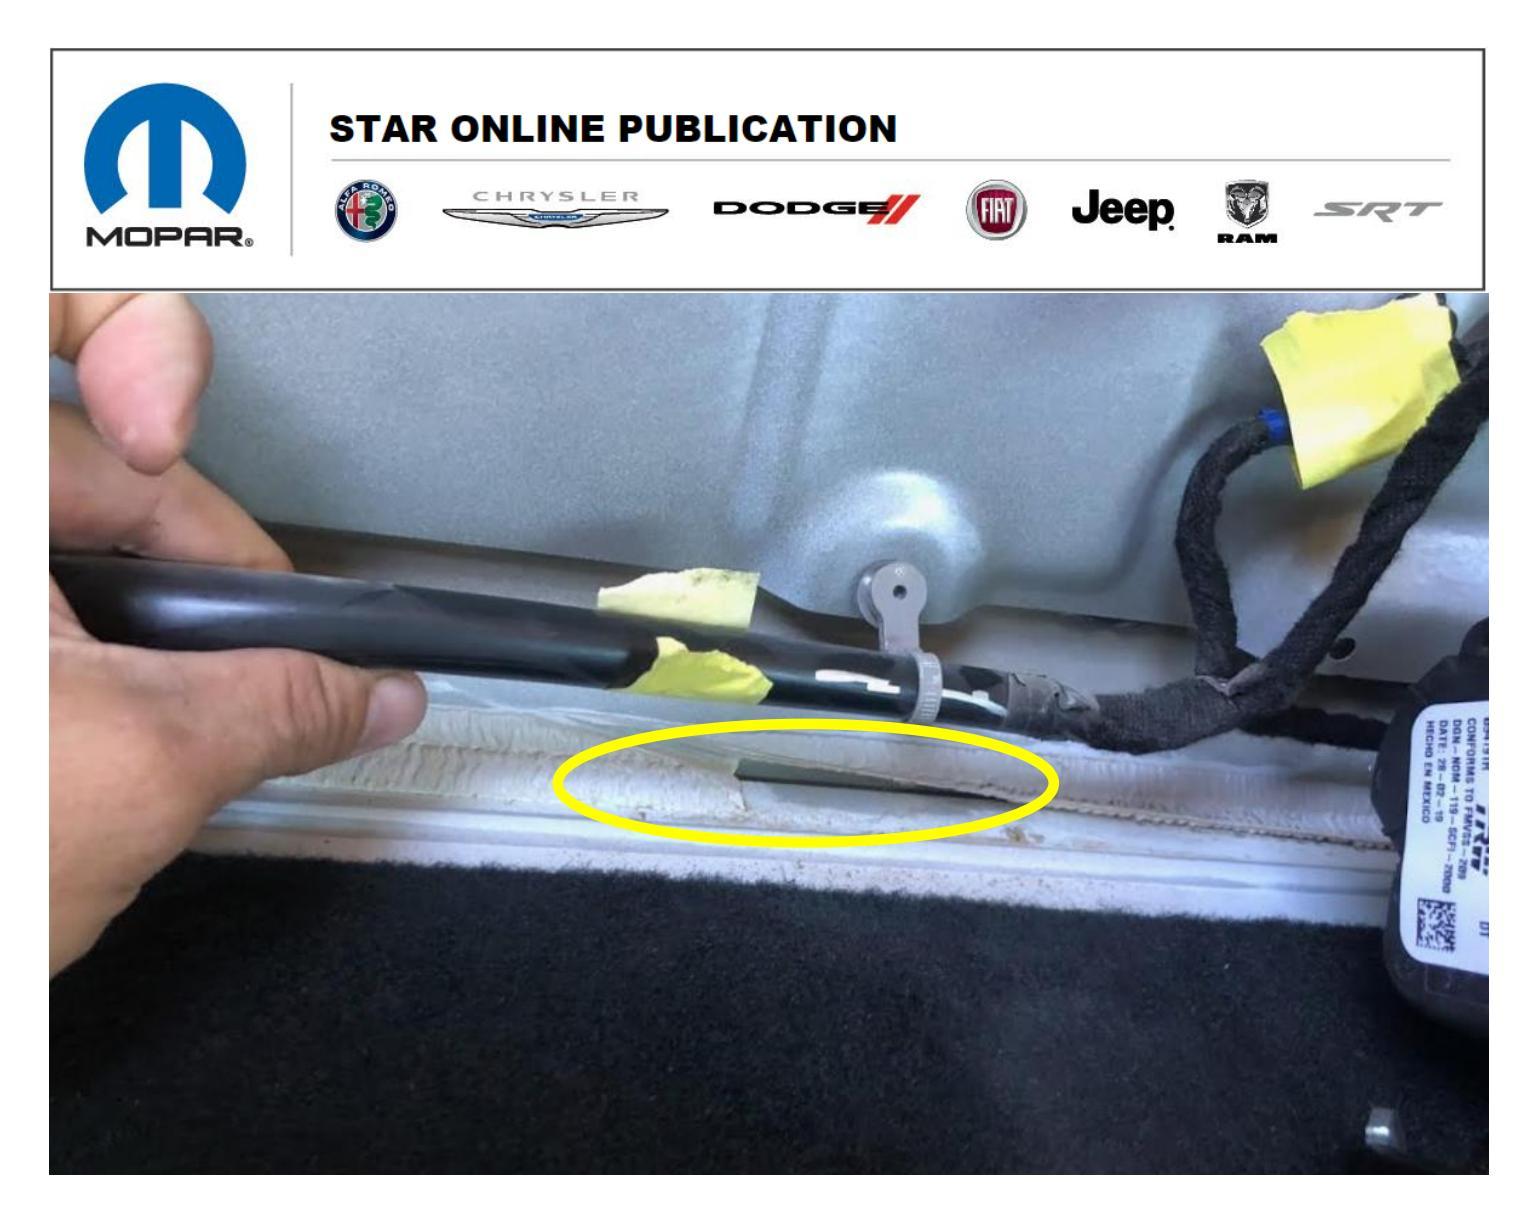
Fig 2. Rear cab floor to bulkhead sealer. Sealer gap shown circled.
