50 Water ingress into the longitudinal member and footwell

50 20 05 2060335/3 December 18, 2020. Supersedes Technical Service Bulletin Group 50 number 20-02 dated November 10, 2020 for reasons listed below.

Model(s)	Year	VIN Range	Vehicle-Specific Equipment
A6, A6 Avant, A6 allroad, and A7	2019 - 2021	All	Not Applicable

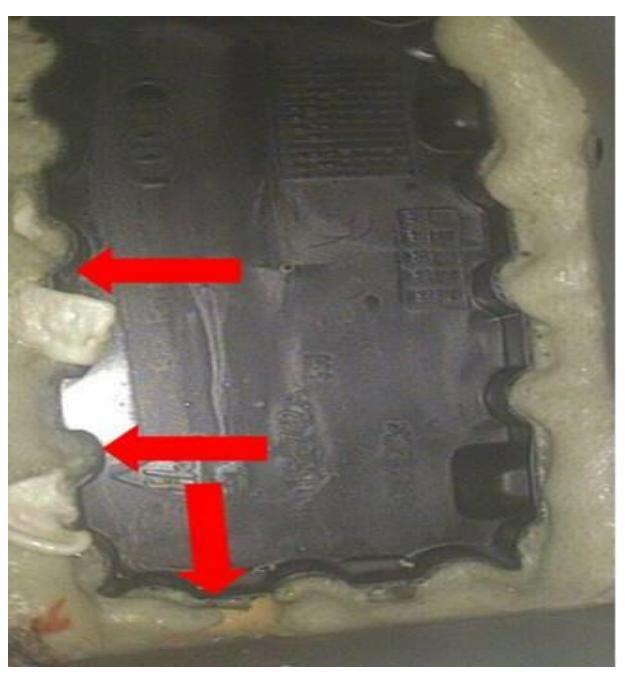
1. The cause for the water ingress is due to incorrect bonding of the sound absorber inside of the longitudinal member (Figure 1).

sound absorber inside the longitudinal member

Figure 1. The exact location of the water intrusion.

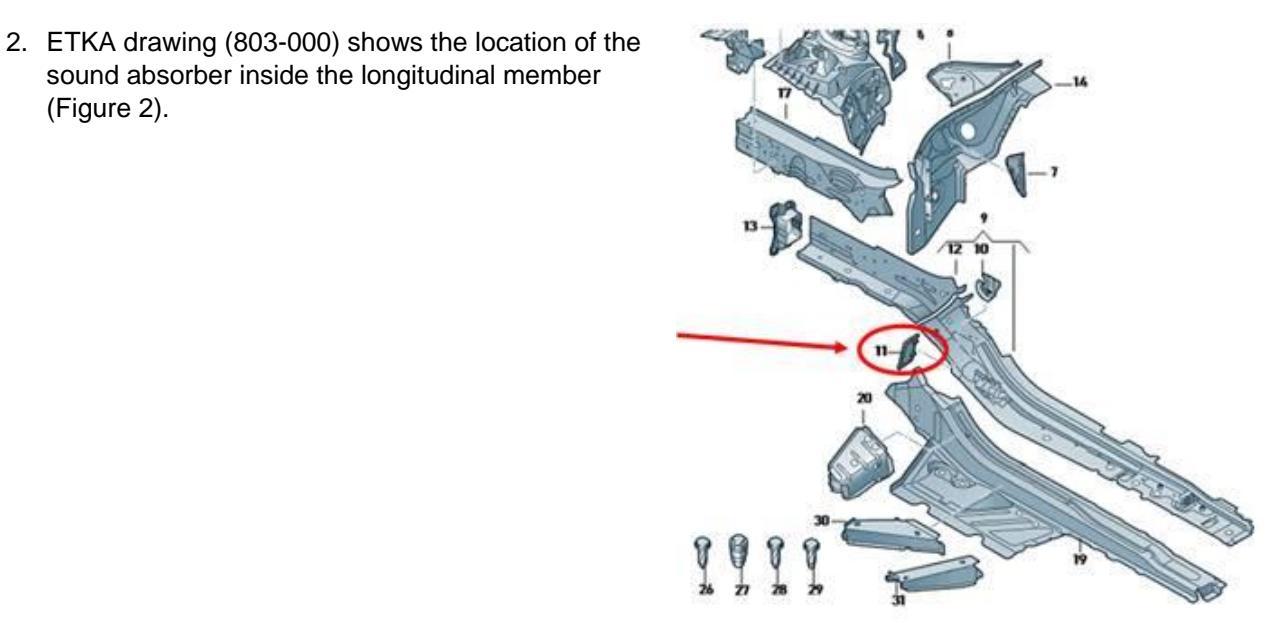
Figure 2. ETKA drawing (803-000) showing the location of the sound absorber.

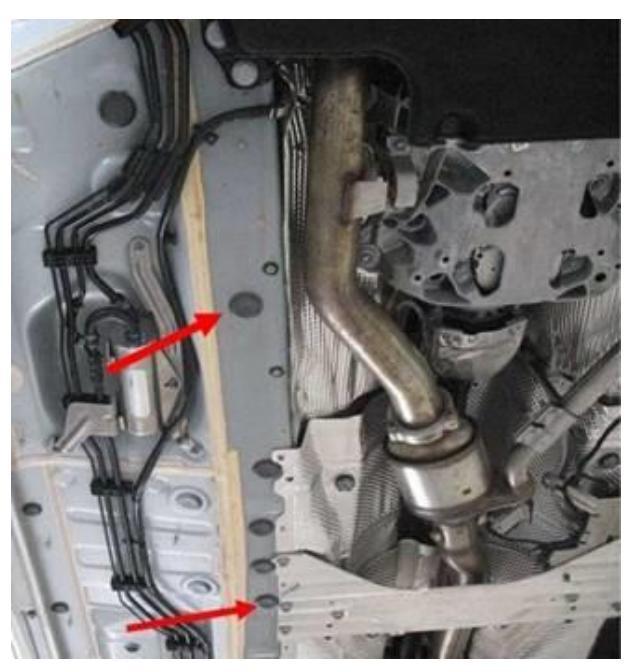
To check the water ingress in the footwell, remove plug 1 and 5 on the longitudinal member's lower right and left.

If there is a water leak from the lower longitudinal member after removing the plugs, this sealing measure is to be performed on the affected side. Check this on both sides. Repair both sides if necessary.

Figure 3. Plugs in the longitudinal member.

3. Remove any necessary underbody covers to gain access to the longitudinal member plugs (Figure 3).

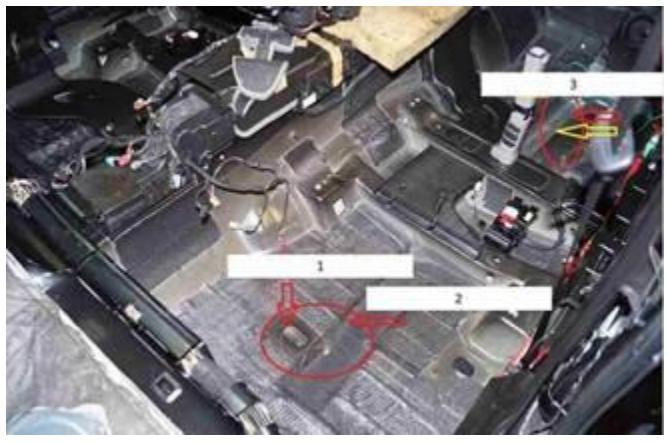
Check the electrical connectors under the floor covering for corrosion. If corrosion is found these are to be repaired according to the Elsa repair manual.

Figure 4. Areas where water enters the cabin.

5. If the water intrusion is found in the interior after lifting the floor covering, the floor covering is to be propped up and the interior thoroughly dried.

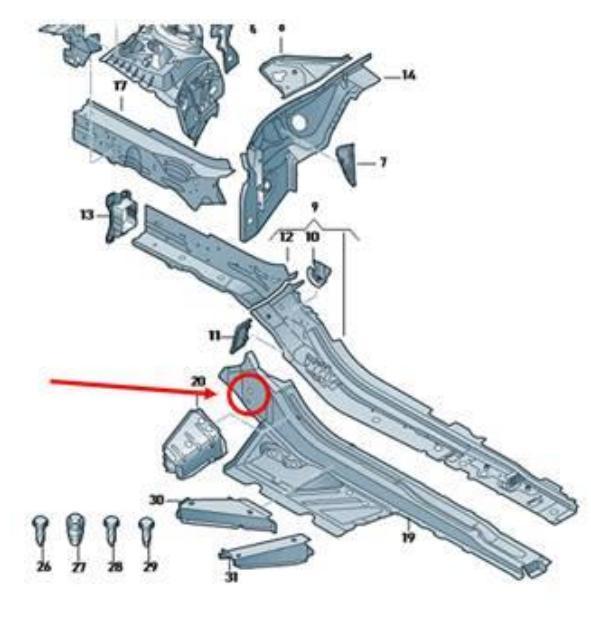
Figure 6. ETKA drawing (803-000) showing the location of the openings in the wheelhouse.

2. ETKA drawing (803-000) shows the location of the openings in the wheelhouse where the borescope is to be inserted and where the repair is performed (Figure 6).

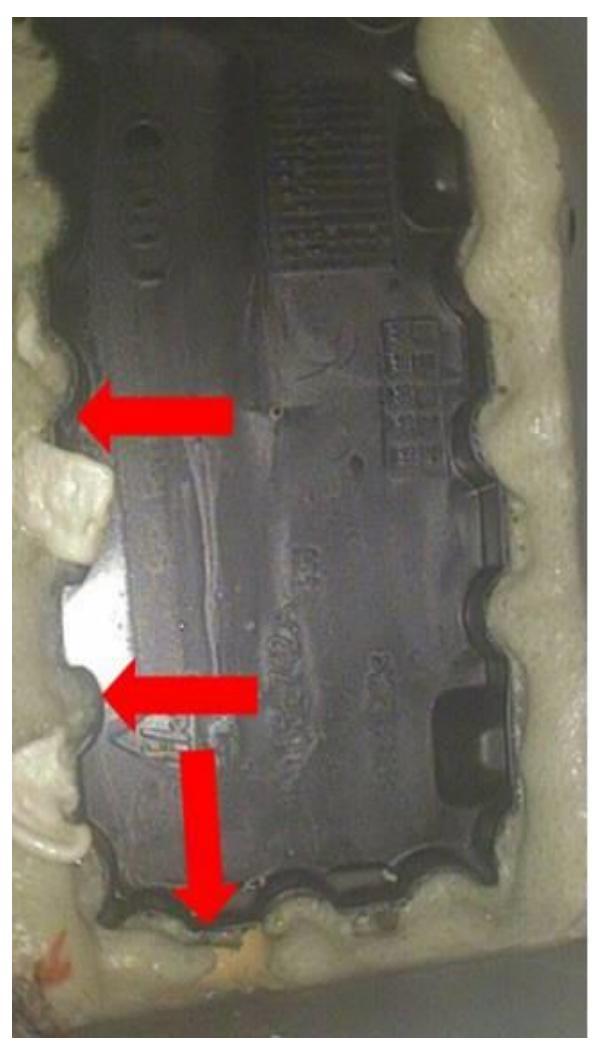
Figure 7. Sound absorber to be completely sealed off.

The sound absorber is to be completely sealed in the longitudinal member with 1k adhesive sealant D 511 500 A2 (or alternatively Loctite 5510) (Figure 7).

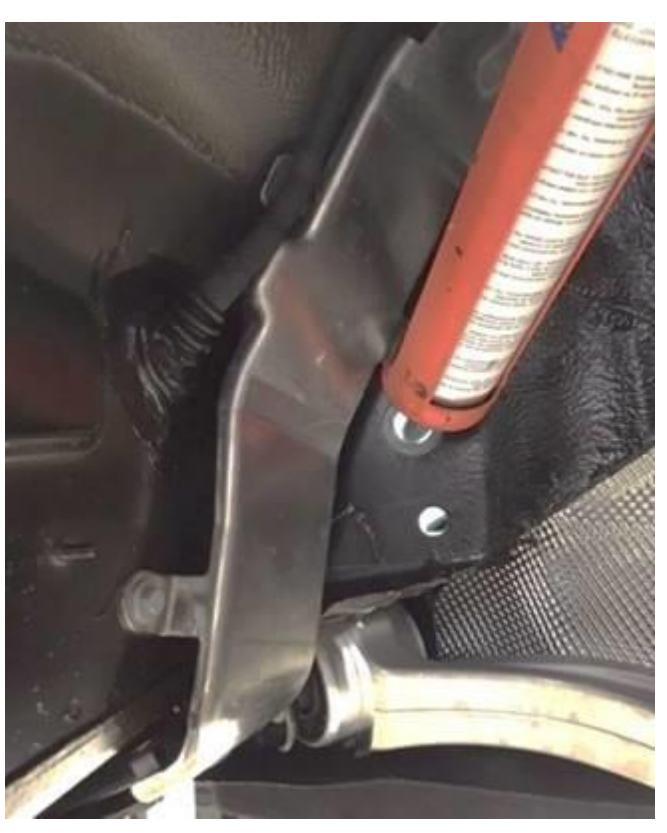
Figure 8. Sealant application.

Inject 1k adhesive sealant D 511 500 A2 (or alternatively Loctite 5510) using the VAG1628 (or equivalent) through the opening shown in Figure 6 onto the sound absorber (Figure 8).

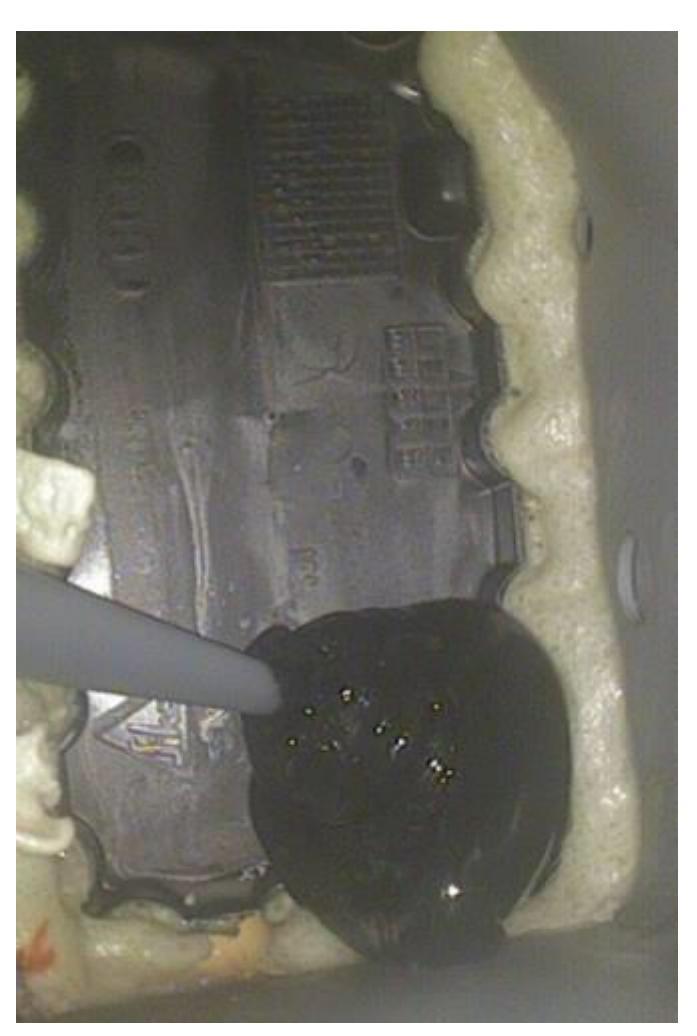
Figure 9. Applying sealer.

5. Apply an amount of sealer sufficient to cover the surface and perimeter of the sound absorber (Figure 9).

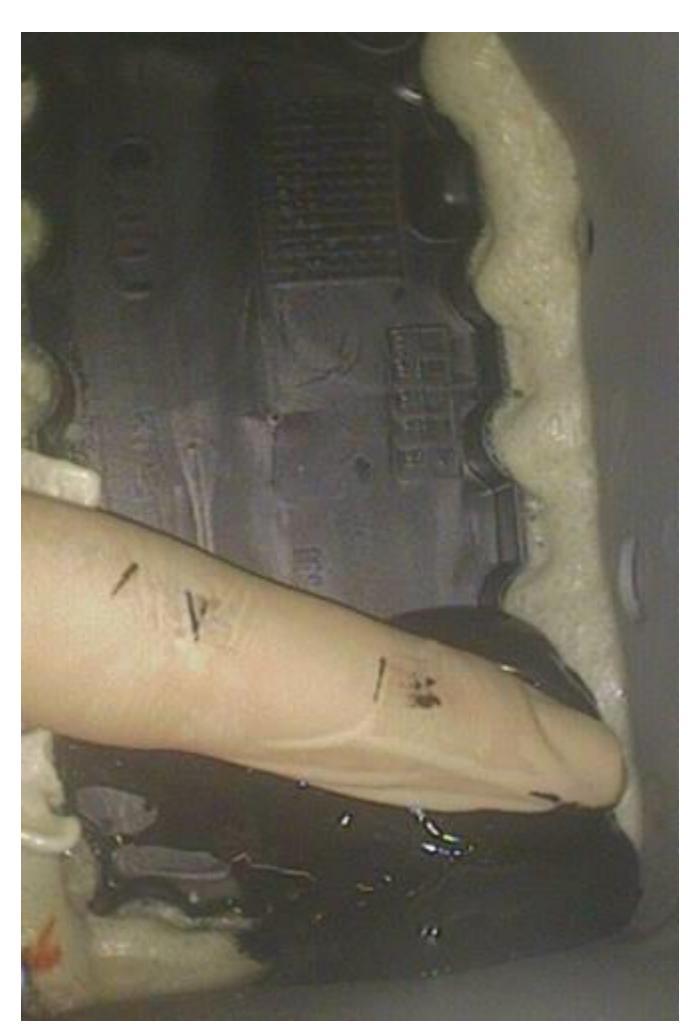
Figure 10. Distributing sealer over the web plate.

6. Spread the sealer using your gloved finger (Figure 10).

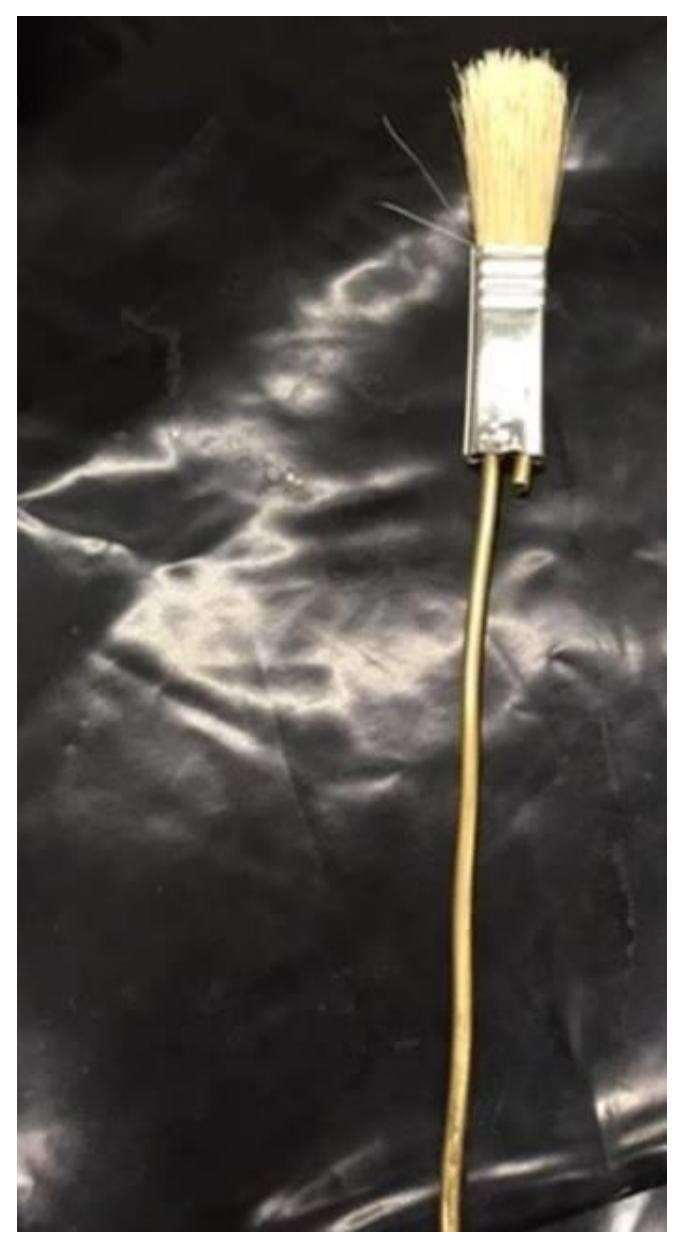
Figure 11. Modified brush.

7. Alternatively, a brush can be fashioned to distribute the sealer as shown in Figure 11. If this is the method chosen, ensure that no brush fragments are left inside the longitudinal member.

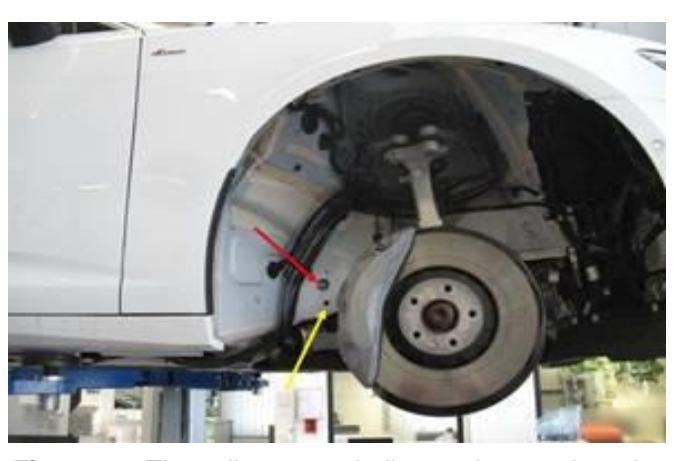
Figure 12. The yellow arrow indicates the opening where the borescope will be inserted to inspect the completeness of the sealant application.

Insert a borescope to confirm visually complete sealer coverage. The borescope can be inserted in the hole indicated with a yellow arrow (Figure 12).

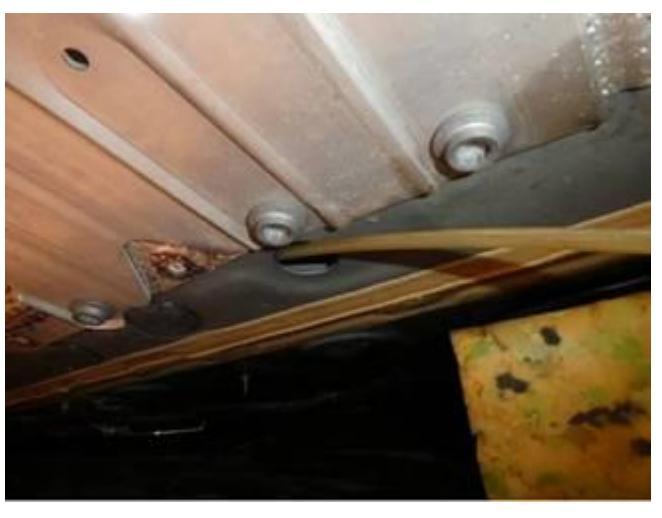
Figure 14. Conservation wax application.

After the sealing procedure is completed and the sealer has fully cured, coat the inside of the longitudinal member with cavity preservative D 330 KD2 A1 through the opening shown (Figure 14).

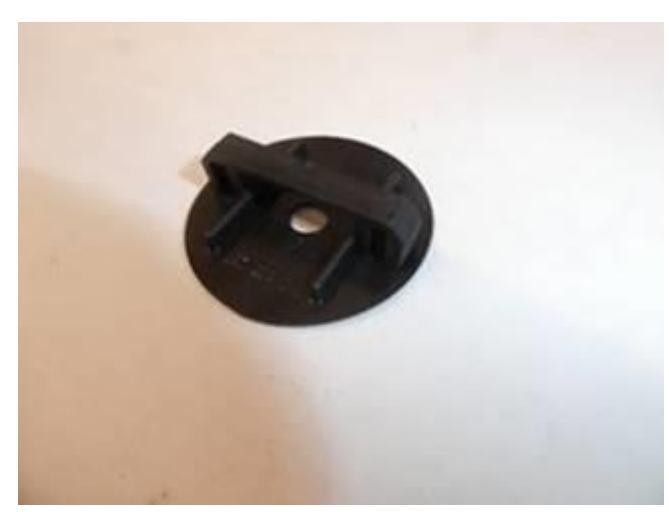
Figure 15. New longitudinal member plugs with integrated drain.

11. After cavity conservation is carried out, the

integrated drain (Figure 15).

removed plugs 1 and 5 on right and left are to be replaced with plugs 8K0 805 267 with an
