# **Technical Service Bulletin**

#### 91 MIB2+ Standard: the MMI screen is fuzzy, blurry or flickering

91 20 46 2061031/2 December 16, 2020. Supersedes Technical Service Bulletin Group 91 number 20-19 dated October 15, 2020 for reasons listed below.

Model(s)	Year	VIN Range	Vehicle-Specific Equipment
Q3	2019 - 2020	All	MIB2+

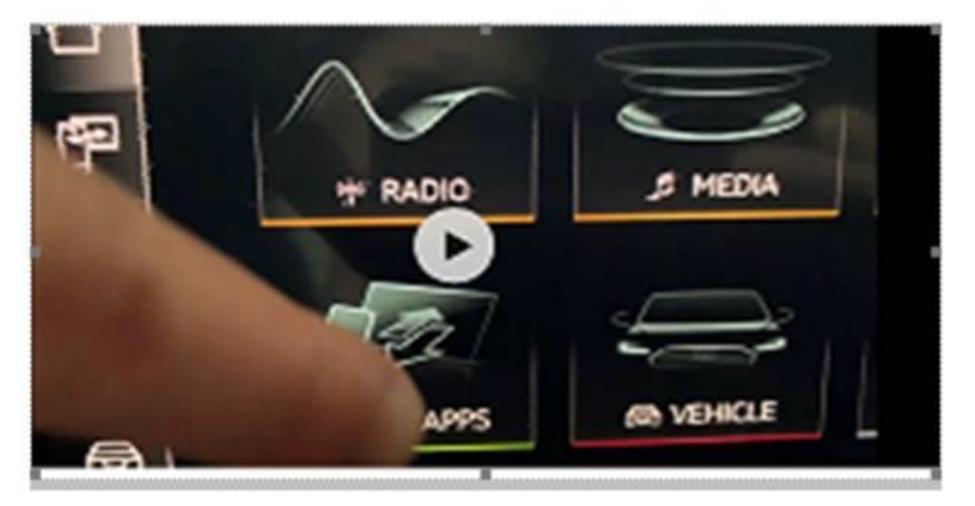
• The MMI screen picture appears fuzzy or blurry (Figure 1).

Figure 1. The MMI screen is fuzzy.

A software bug in the display driver can cause the screen to become permanently fuzzy.

- 1. Please take photos of the customer concern and upload them into DOC-IT with the repair order. Photos should:
  - Have a date stamp and VIN reference.
  - Be taken in focus and with sufficient light.
- 2. Replace the information electronics control module, J794 (address word 005F).
