## UPDATE FROM WARRANTY OPERATIONS

## FIXED FIRST VISIT IMPROVEMENT

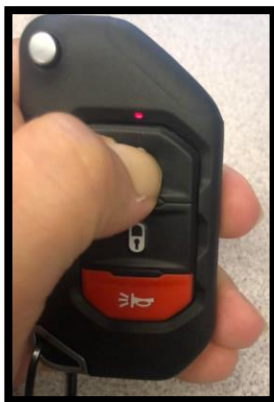
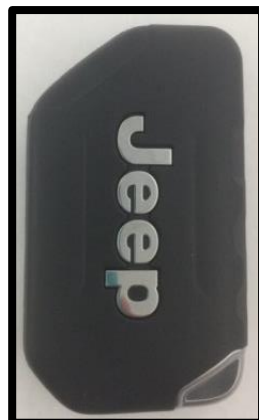
- 1) Verify if the FOB is a JL or JT flip key fob: the only kind of key fob supplied with these vehicles is shown in Figure 1 and 2. If the fob is of a different shape, it is not a JL or JT fob.
- 2) Check if the physical metal key is integrated into the key fob and operates the door lock cylinder; if not, this key fob belongs to a different vehicle.
- 3) The only way to know whether the coin-battery is good or bad is by visual inspection. Do not measure the coin

- (i) Check to make sure that the LED indicator blinks whenever you press any button. If it does not, service the key fob coin battery. After replacing the coin battery, verify that the LED light blinks. If it doesn't blink after replacing coin battery, service key fob.

- (ii) Also, check for any key fob/ coin battery low voltage message on the cluster. If you see such message on the cluster, then service the coin battery. After replacing the coin battery, verify that the message on cluster has gone and LED light blinks. If it doesn't blink or message still exists on cluster even after replacing coin battery, then service key fob.
- 4) When starting the vehicle with the ignition switch push button (KIN), verify that the key fob LED blinks. This verifies key fob belongs to the vehicle and is in good condition.
- 5) If key fob is still not operating, follow vehicle level diagnostics procedure.

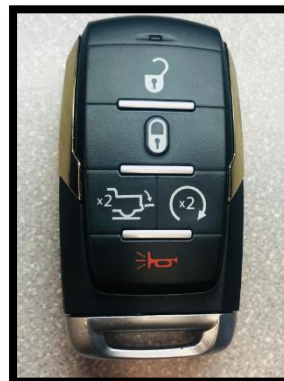
Figure: DT Key fob

Verify the FOB is a DT key fob: the only kind of key fob supplied with these vehicles is shown below. If the fob is of a different shape, it is not a DT fob.

- Check if the physical metal key is integrated into the key fob and operates the door lock cylinder; if not, this key fob belongs to a different vehicle.
- The only way to know whether the coin-battery is good or bad is by visual inspection. Do not measure the coin battery. Please look for below items before you decide to

- (i) Check to make sure that the LED indicator blinks whenever you press any button. If it does not, service the key fob coin battery. After replacing the coin battery, verify that the LED light blinks. If it doesn't blink after replacing coin battery, replace the key fob.

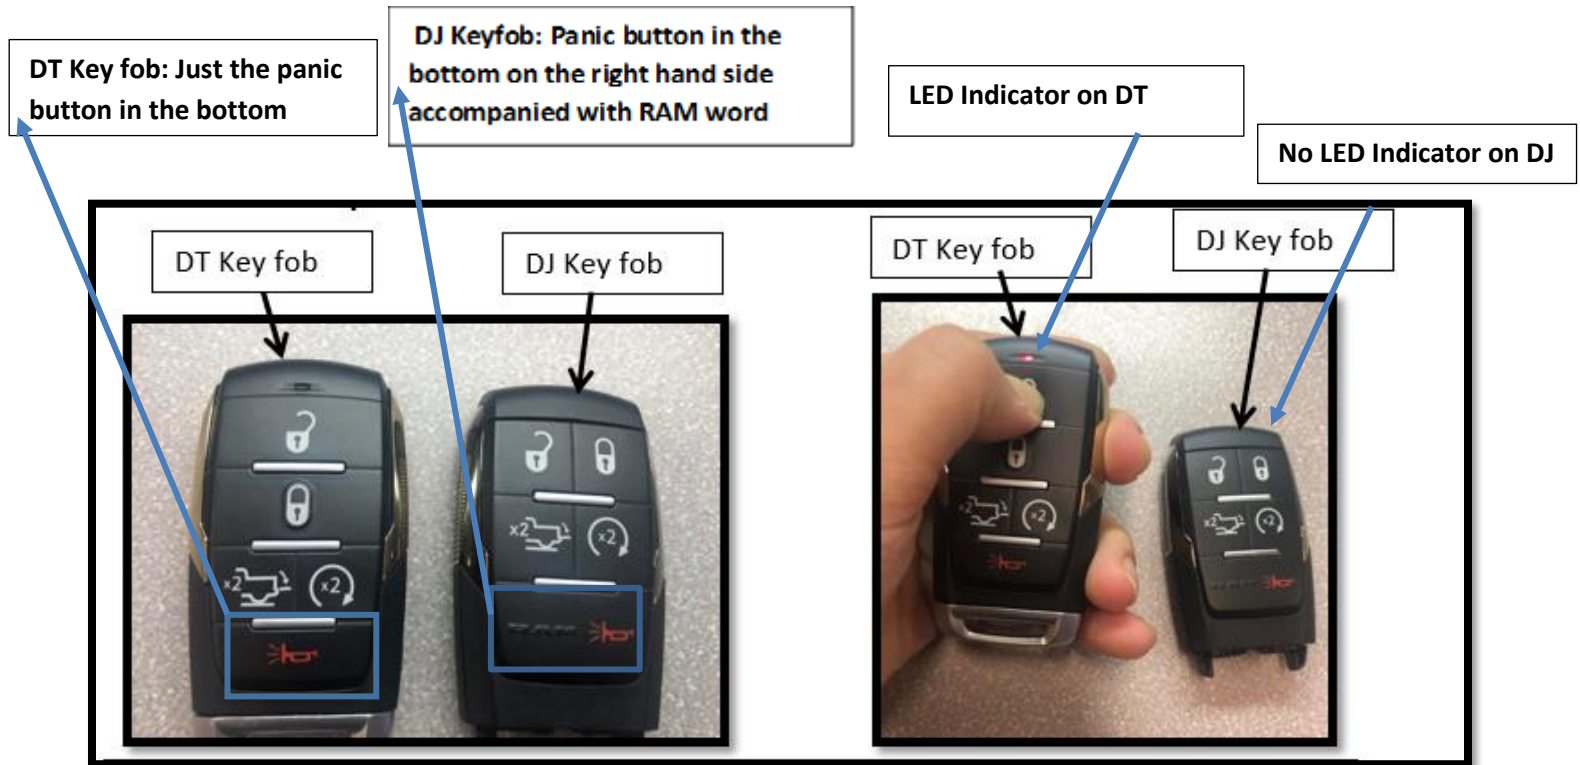
- Note: Be careful with the similar looking DJ Key fob. Look carefully for the below details to identify whether the correct DT Key fob is in the vehicle.
