GROUP	NUMBER	
	IVIINNOI	BODY ELECTRICAL 21-BE-001H		
	DATE MODEL(S)			
Technical	Service Bulletin	JANUARY, 2021	Santa Fe (TMa) Palisade (LX2)	
SUBJECT:	PALISADE (LX2), SANT	a fe (tma) tpms	S DTCS

Description: This bulletin describes the procedure to diagnose and repair tire pressure monitoring system (TPMS) DTC(s) on some 2020-2021MY Palisade (LX2) and Santa Fe (TMa) vehicles equipped

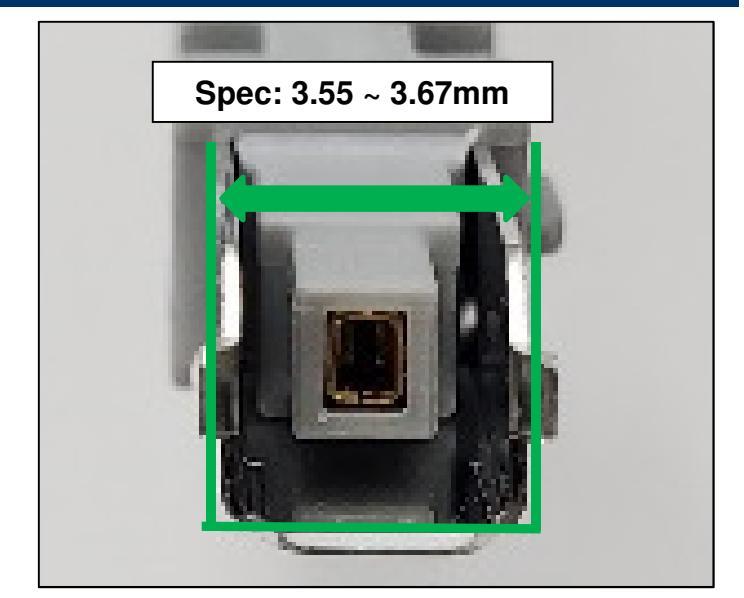
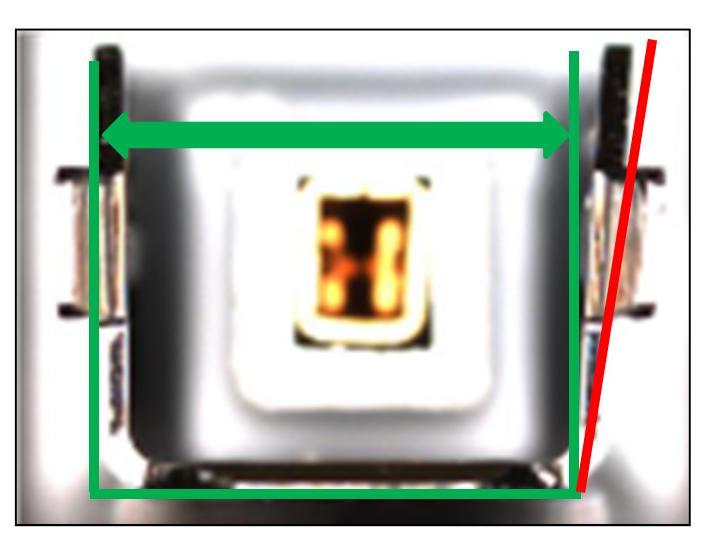
The pins are U-shaped, and should form 90 degree angles (square corners).

This is an example of the U-shape pin misshapen, and is splaying outwards (not square).

6. If necessary, reshape the pin to specification using a pair of long-nose pliers.

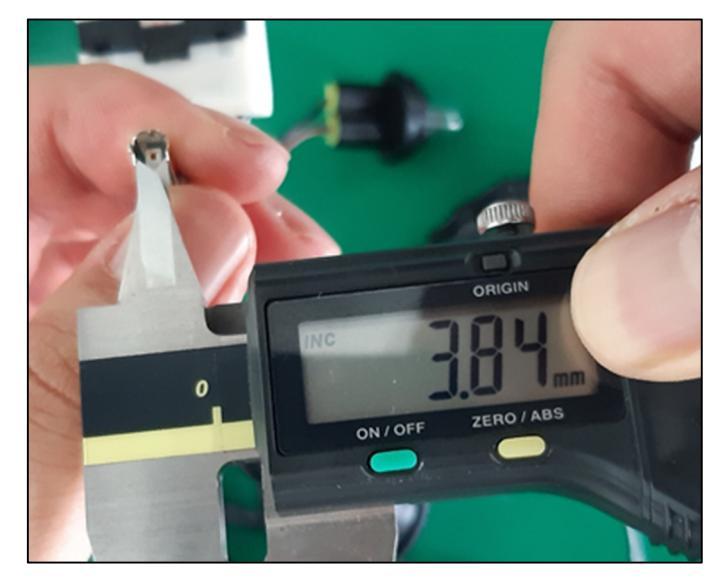
It is also out of specification when measured using a digital caliper.
