Service Bulletin

Bulletin No.: 18-NA-073

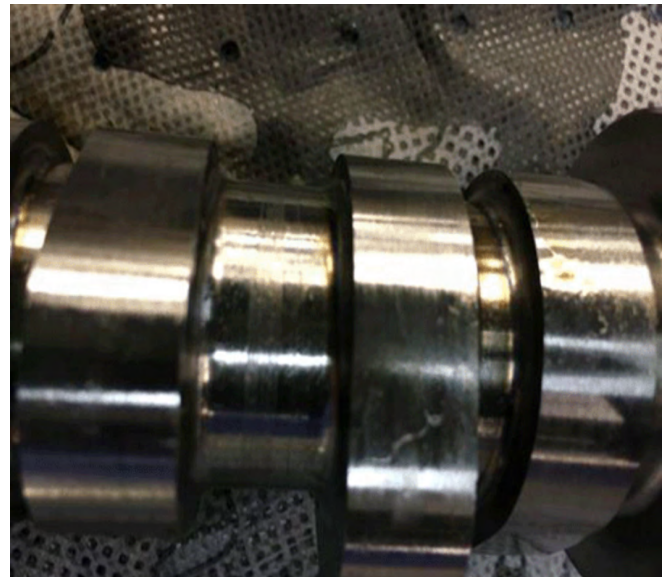
Review the following:

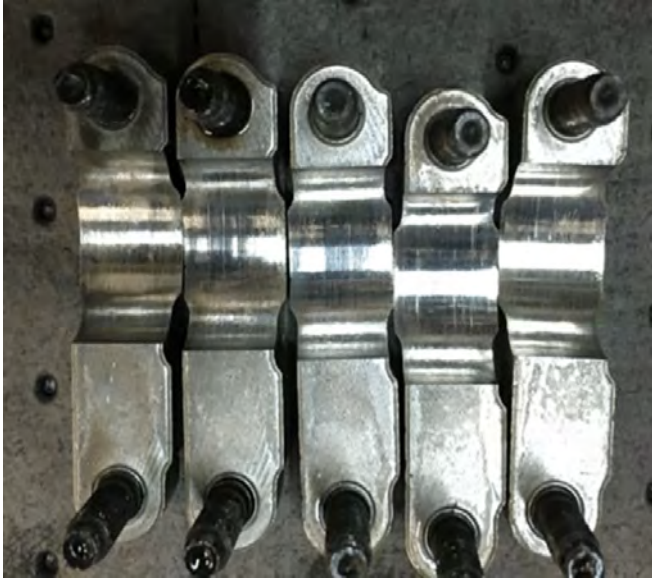
Review the following:

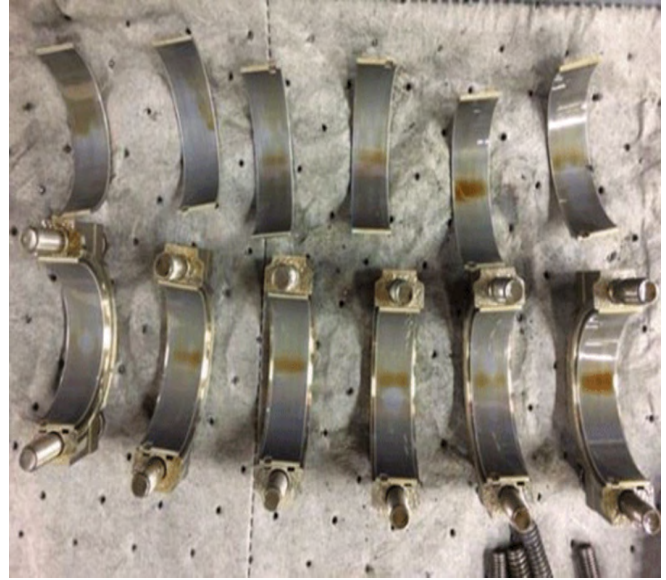
Review the following:

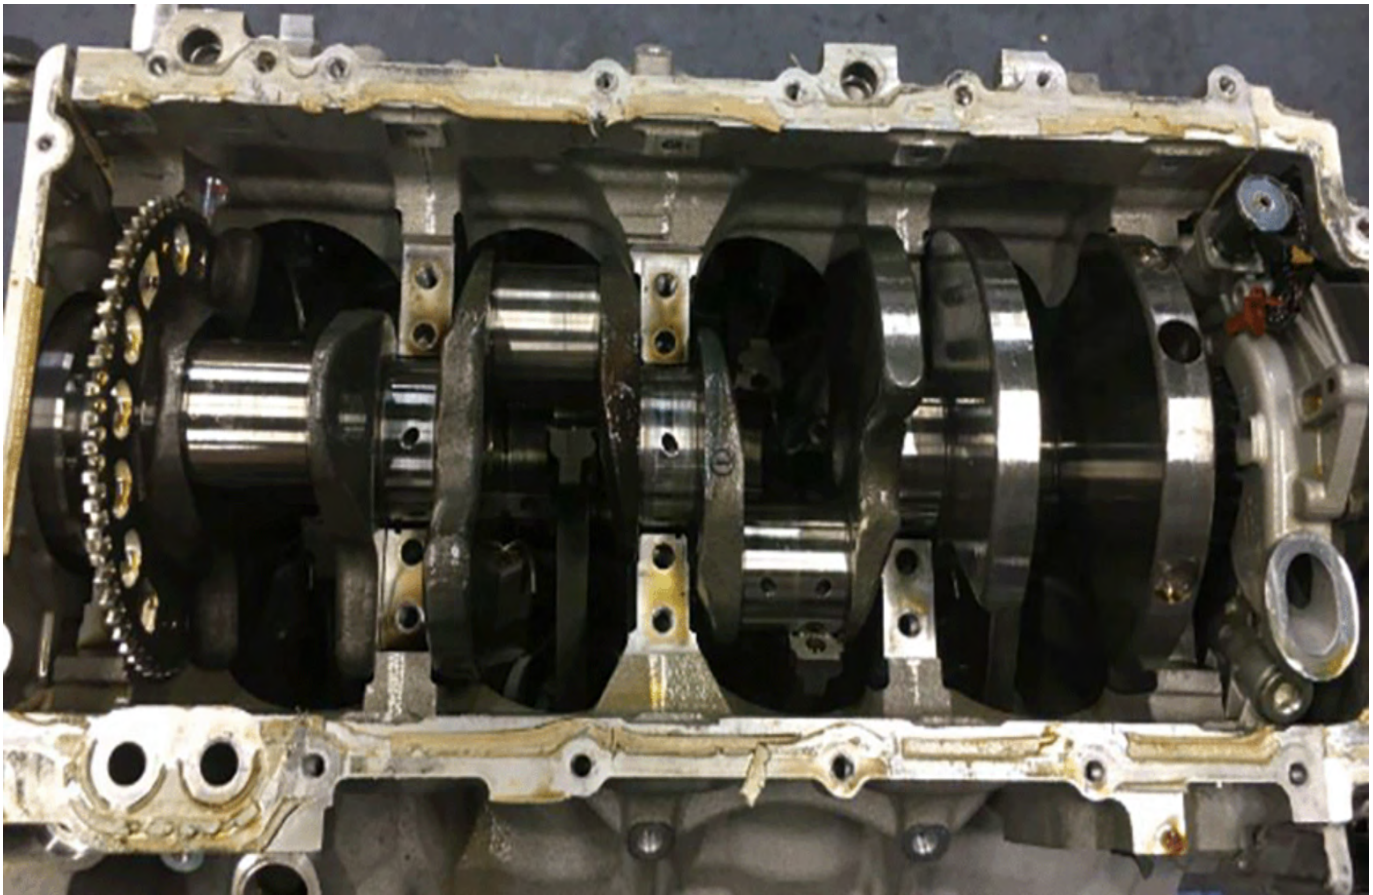
Review the following:

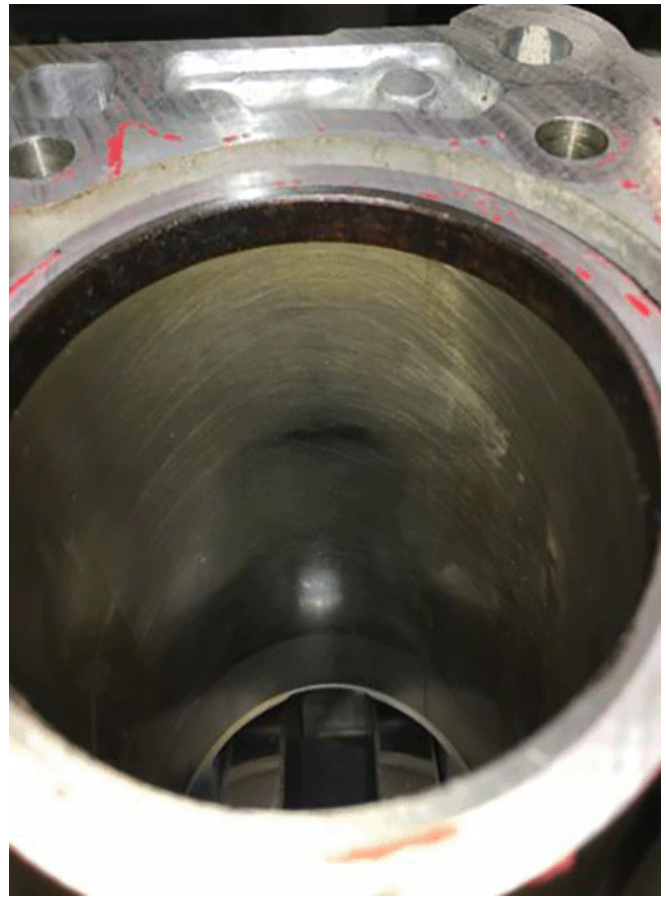
Review the following:

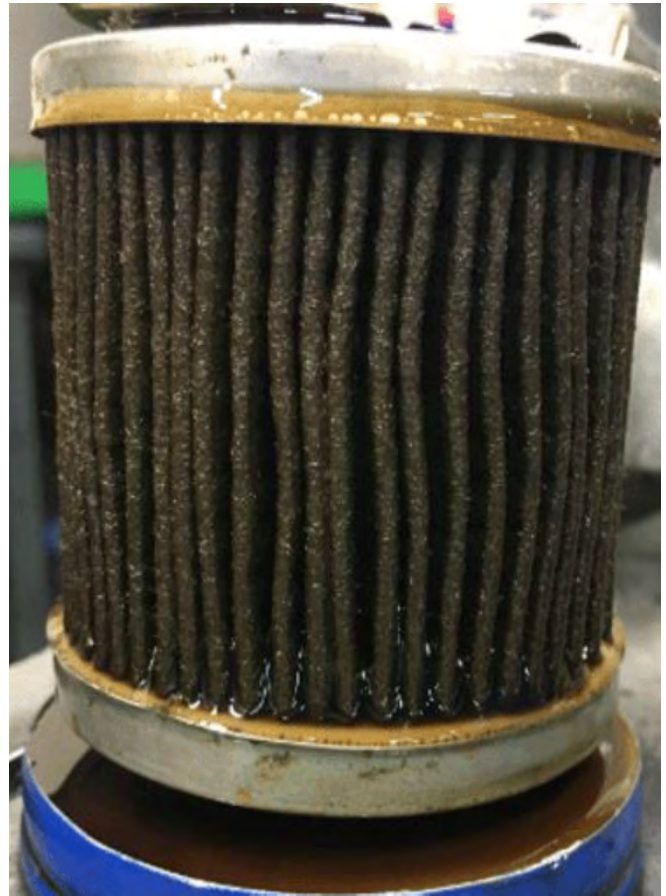
Review the following:
