Mack Chassis - Particulate Matter (PM) Sensor Diagnostic Trouble Codes (DTC) Illuminating The Malfunction Indicator Lamp (MIL); Tech Tip TT-014-2016 - US14+OBD16, US17+OBD16 And Newer Emissions, Common Model Year 2017 And Newer - To Be Used For EVERY

Release Date: 6/23/2016 Number: TT-014-2016 Function Group: 25 Title: Diagnosing OBD'2016 Vehicles with Particulate Matter Sensor DTCs

Problem – OBD2016 (MY2017) Trucks with Particulate Matter Sensor Fault Codes

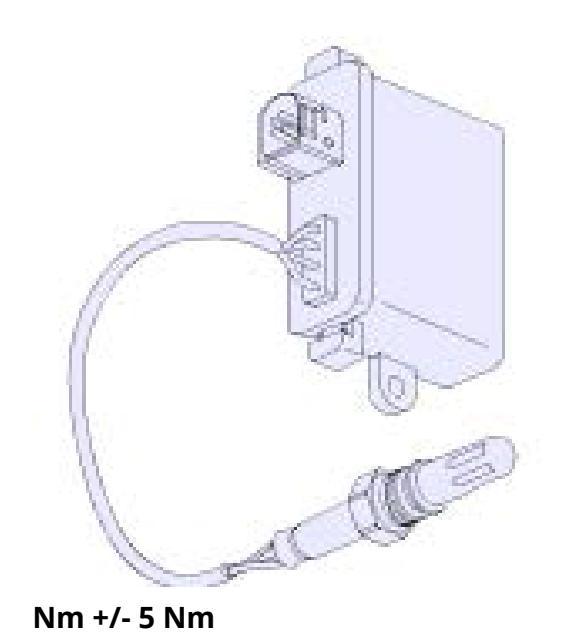
1. The PM sensor is a smart sensor (12V supply and CAN lines) **with an orientation tab as seen below:**

Installation torque of 50

3. NEVER (DO NOT) apply anti-seize to install the PM sensor. *If for some reason someone applied it before this repair, thoroughly clean the threads and sealing surfaces while replacing the sensor.*
