34 Transmission oil leak at the auxiliary hydraulic pump

34 21 52 2062540/1 March 10, 2021.

Model(s)	Year	VIN Range	Vehicle-Specific Equipment
A3	2017 - 2020	All	0GC transmission
TT	2019 - 2021	All	0GC transmission

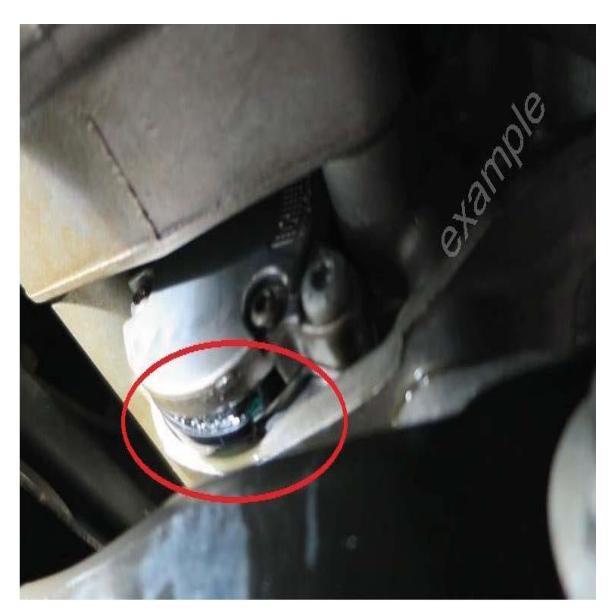
Oil leak confirmed from the area of the transmission auxiliary hydraulic pump (V475) and the transmission housing (Figures 1 - 2).

Figure 1. Oil leaking in area of the auxiliary hydraulic pump (V475).

There is an issue with O-ring of auxiliary hydraulic pump (V475).

Clean gearbox housing/perform short test drive to warm up gearbox/locate leak and (if necessary) replace O-ring for electric motor for auxiliary hydraulic pump 1 (V475).

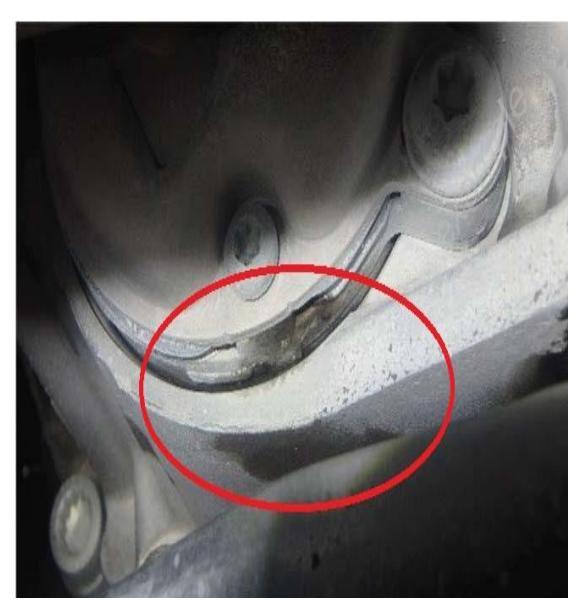
Figure 2. Oil leaking in area of the auxiliary hydraulic pump (V475) detail.

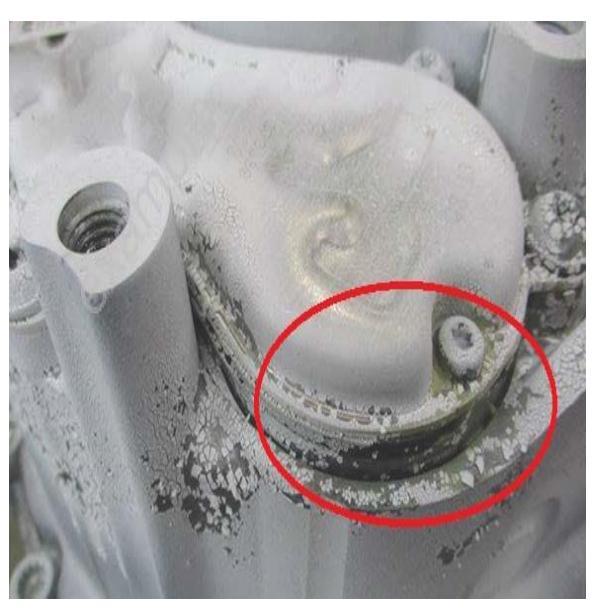
2. Spray oil leak detection spray (part number: G 001 900 A1 or equivalent) on the affected area and assess the leak again (Figure 3).

Figure 3. Example of gear oil leaking in area of auxiliary hydraulic pump (V475).

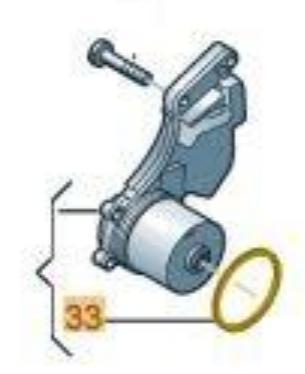
Figure 4. O-ring for electric motor for auxiliary hydraulic pump (V475).

The O-ring (item 33, highlighted in yellow in Figure 4) for the electric motor for auxiliary hydraulic pump 1 (V475) must then be replaced according to the repair manual.

Tip: Lubricate the O-ring and the area of the transmission that the seal contacts with ATF to prevent damage to the O-ring during installation.
