## Complaint - Warning Messages in the Instrument Cluster/Fault Memory Entries in the DME Control Unit: Re-Programming DME Control Unit (06/21)

Vehicle Type: 911 Carrera (992)/911 Carrera S (992)/911 Carrera 4 (992)/911 Carrera 4S (992)

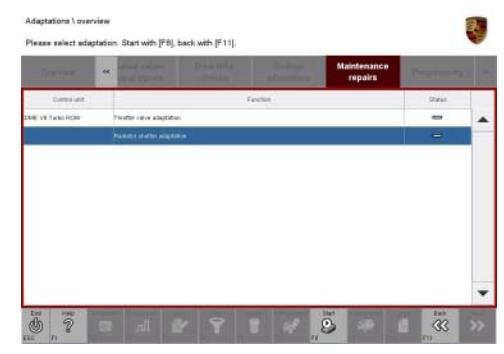
Radiator shutter adaptation

Once adaptation is complete, a tick will appear in the 'Value' field on the PIWIS Tester display.

If radiator shutter adaptation is **not** completed successfully, the adaptation must be **repeated**.
