Technical Information

101/20ENU 9152

Complaint - PCM Update Cannot be Performed or Stops. Observe Specified Procedure (101/20)

Model Line:
 Taycan (Y1A)

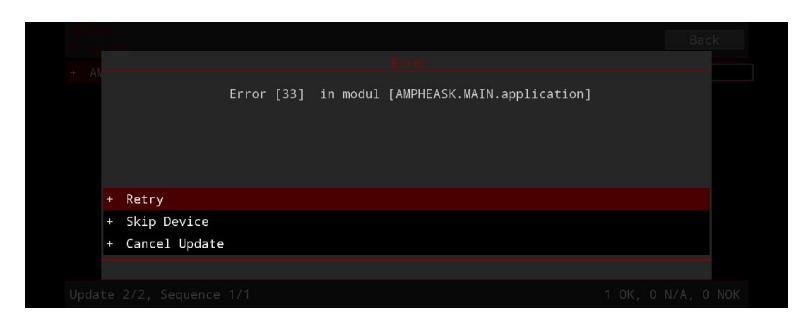
Error module (shown as an example)

2 First document the error message with a fault code (e.g. Error 33 in module [AMPHEASK.MAIN]). Then, click on **'Retry'** in the **'Error' module** \Rightarrow *Error module (shown as an example)*. Carry out the procedure several times if necessary if the update continues and then stops again.

The screen shot shown here (Error 33) is provided as an example. Other fault codes, e.g. Error 96;134, can also be displayed in the center display.

If programming is still not performed, remove and 3 re-insert the USB storage medium and carry out the procedure several times if necessary if the update continues and then stops again.

- 4 Subsequent procedure:
 - If the update is installed successfully, continue with Step $5 \Rightarrow$.
 - If the update is not installed successfully or if the central computer (PCM) no longer starts, contact your importer's Technical Support team to decide how to proceed. Also specify the documented error message with fault code (e.g. Error 33 in module [AMPHEASK.MAIN]) here.
- Select the 'PCM (central computer)' control unit on the PIWIS Tester and select the 'Automatic 5 coding' function in the 'Coding/programming' menu. Once coding has been completed successfully, read out and delete the fault memory.
