KS16-015C

NTB16-028C

March 15, 2021

# INTELLIGENT KEY BUTTONS INOPERATIVE **BUT REQUEST SWITCHES WORK**

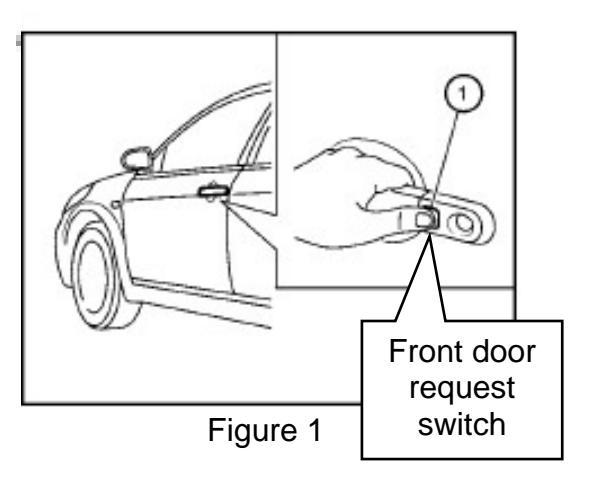
With the Intelligent Key in range, the doors will lock and unlock when pressing either front door request switch (see Figure 1),

That specific Intelligent Key may have become de-synchronized with the vehicle.
