## Technical Information

88/21 ENU 2796

## Complaint – Vehicle Plug does not Lock and the Charging Process Cannot be Started: Observe Specified Procedure (88/21)

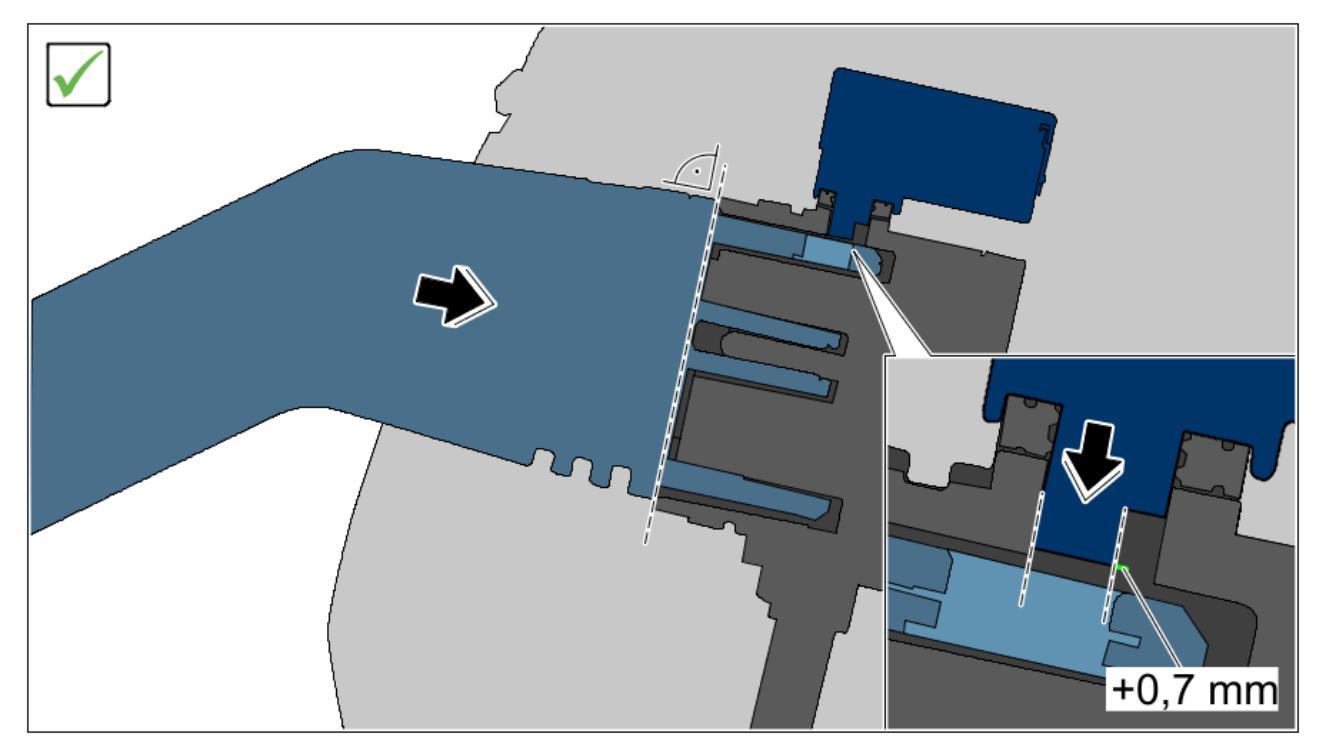
Correct position of vehicle plug

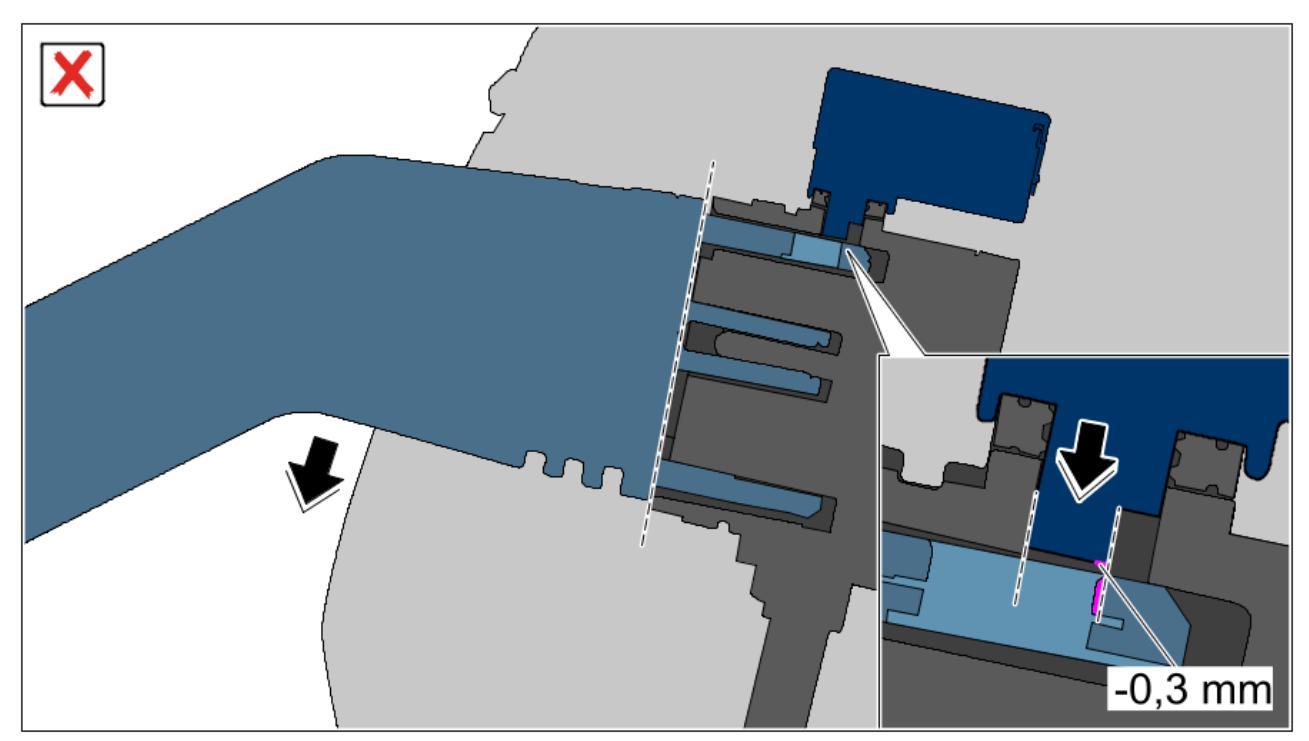
Model Line: Taycan (Y1A/Y1B) Model Year: As of 2020 Concerns: Locking mechanism for vehicle charge port Information: The vehicle plug does not interlock in the vehicle charge port. The release button on the vehicle lights up red and the charging process cannot be started. The reason for this is charge connector that is not correctly positioned. As a result, the charging plug cannot be locked and the charging process cannot be started. The use of heavy charging cables/charging plugs can cause this problem. One of the following entries is stored in the fault memory of the high-voltage charger (OBC) control unit: **P33E800** – AC charging socket, charging plug lock, mechanical fault (200302) **P33E900** – Charging socket combo, charging plug lock, mechanical fault (200312) Action required: The vehicle plug must be inserted fully and straight into the vehicle charge connection so that the locking mechanism can engage. If necessary, the procedure must be repeated and the vehicle plug may have to be held in position by hand. If the charging plug tilts down even slightly, this can be enough to prevent the actuator from locking the charging plug  $\Rightarrow$  *Incorrect position of vehicle plug.*

Incorrect position of vehicle plug

Further information can be found in section 'Plugging in vehicle plug on the vehicle charge connection and starting charging process' in the Driver's Manual.  $\Rightarrow$  Betriebsanleitung

Replacing the vehicle plug, wiring train or vehicle charging socket will not correct the problem.
