## Mack Chassis - Diagnostic Trouble Code ( DTC ) SPN4094, Check List - US10 Emissions

**Bulletin:** SNM 11-09a  
**Date:** Nov 14, 2012  
**Valid to:** Pending  
**Replaces:** N/A  
**Priority:** **HIGH**

**Subject:** EGR Delta P ports

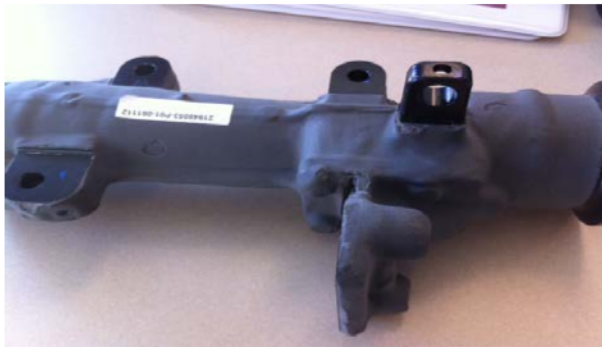
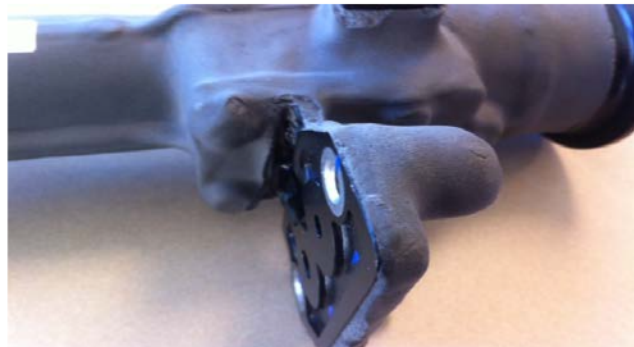
Mack Trucks has released an updated Venturi tube for the MP7, MP8 and MP10 engines that have been coated with a special coating, if you have the updated Venturi **DO NOT** remove the coating this is a non-serviceable part. If during your checks you need to confirm there are no restrictions in the ports use shop air to verify ports are free from restriction. If ports are found to be clogged then replacement of the coated Venturi is required. If your truck is equipped with the old style non-coated Venturi, proceed with cleaning as per directions.

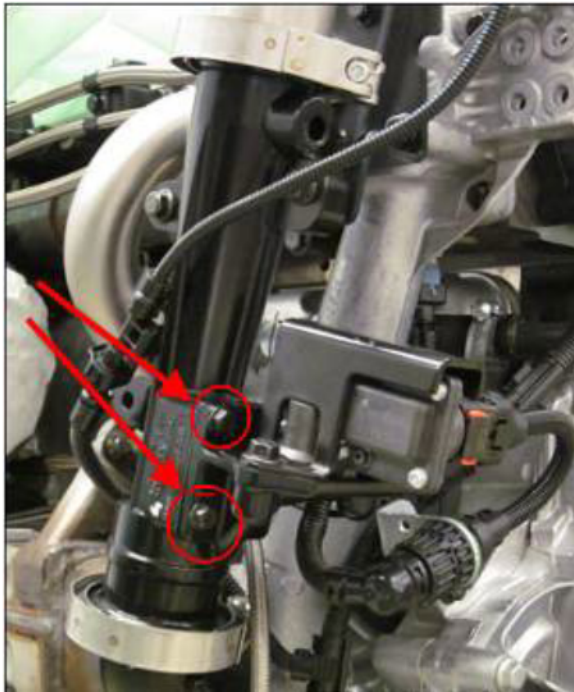
When removing the dP sensor and the mounting adaptor, the adaptor mounting bolts for the 13L and 16L engines have thread lock applied by the component manufacturer. This may contribute to bolt breakage. A gentle application of heat to the side of the Venturi from a propane torch will melt the thread lock and allow the bolt to be removed easily. Removal of the Venturi may be needed to avoid damage to wiring when the heat is applied.

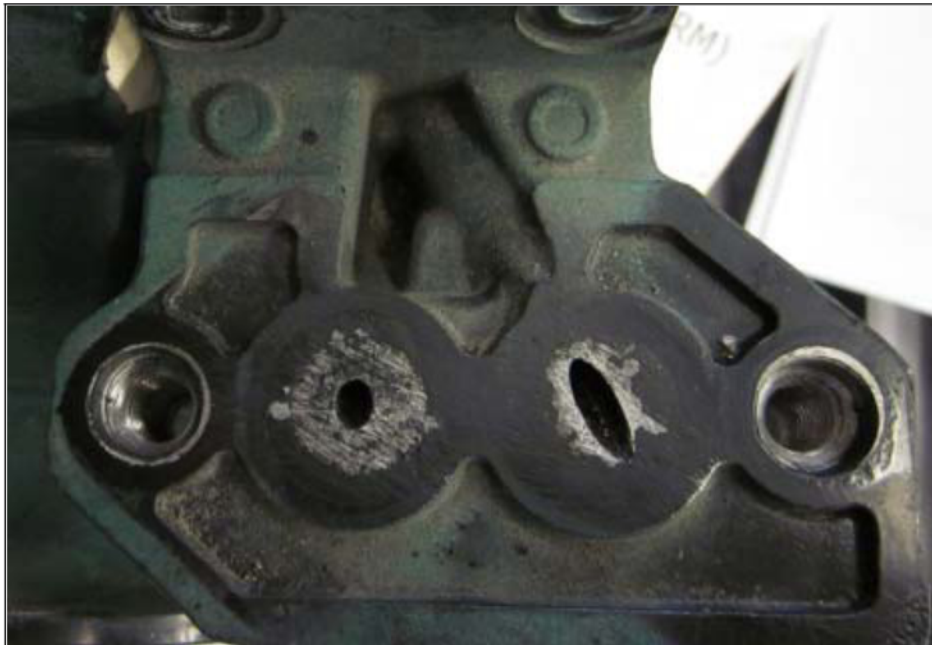
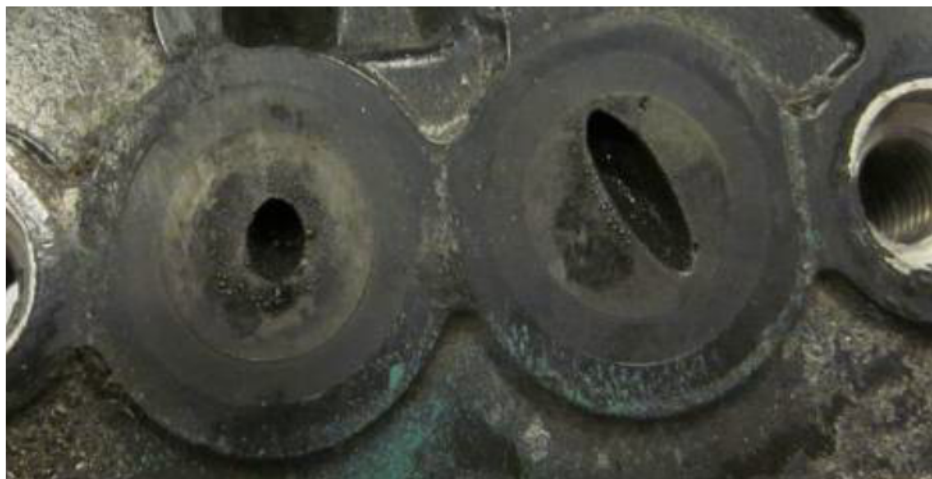
The mounting adaptor in the top picture is not to be reused. The mounting adaptor in the lower picture is borderline. If the coating comes off during proper cleaning then it must be replaced. The corrosive nature of EGR gases will attack the material now and may eventually cause a leak under the seals.

Clean the components with mineral spirits type parts cleaner and a rag. Carburetor cleaner can be used but must not be allowed to soak and must be blown dry after cleaning. For blockages use a Non-marring instrument like the end of a cotton swab, soft tooth brush (do not use a wire brush or scraper) to clear the ports. The dP tubes on the 11L engine can be cleaned with a piece of mechanics wire. If the blockages cannot be cleared or the coating is

damaged the component must be replaced. Mounting adaptor bolts for the 13L and 16L engines should be reassembled using Loctite 241 or 271 and torqued to proper specs 11L engines do not get Loctite applied.
