* * TECHNICAL INFORMATION NOTICE * *

DATE:	November 10, 2021
TO:	Mitsubishi Motors US & Puerto Rico Dealer Service and Parts Managers
RE:	Additional Details for Front Camera Unit Calibration
TIN NO.	TIN-21-54-006

AFFECTED VEHICLES: 2022 Outlander equipped with MI-Pilot system

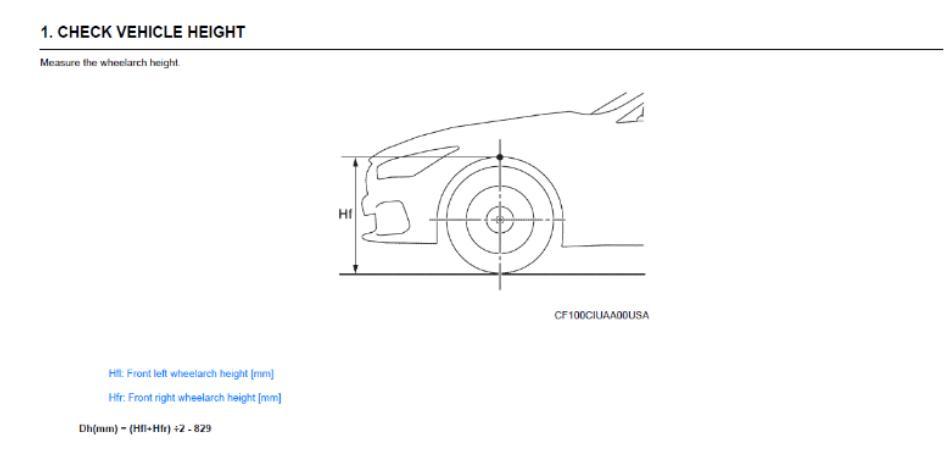
Take special notice of the CAMERA AIMING ADJUSTMENT Step 2 (page 400).

DH, is a calculated value and MUST be entered as an even number. Place this value in MUT-III SE first and then enter the remaining values as stated in the Service Manual (page 400).

Calculate the vehicle ride height (DH): Service Manual > Volume 5, Driver Assistance System > Page 399 (measures vehicle ride height). Measure the wheel arch to the ground at the left and right front of the Outlander and add both values (807mm + 810mm) = 1,617mm. Divide this by 2 = 808.5mm. Subtract 808.5mm from 829 (see image on bottom left of previous page) = -20.5. This number must be rounded to the nearest even number (up or down). In this example, we will round the value down. The number to enter for (DH) is (-20).
