NOVEMBER 2021	APPLICABLE VEHICLES BELOW
DATE	MODEL(S)
CAMPAIGN	21-01-066H
GROUP	NUMBER
	1

THETA GDI ENGINE DTC P1326 - ENGINE INSPECTION / REPLACEMENT (SERVICE CAMPAIGN T3G)

SUBJECT: DTC P1326 – ENGINE INSPECTION / REPLACEMENT (SERVICE CAMPAIGN T3G)

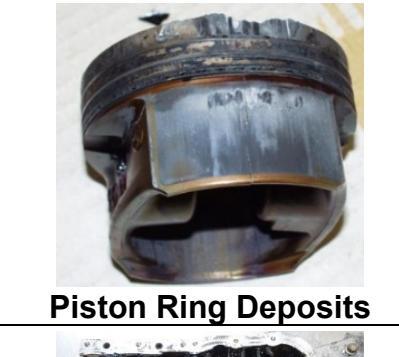
Poor oil maintenance reduces the engine oil lubrication and cooling capacities. As a result, internal engine parts can be damaged resulting in abnormal wear to internal engine parts, excessive carbon deposits, sludge, and other various conditions. An inspection for these conditions and others may be required prior to engine approval.

Oil Sludge

Excessive Wear
