## Electronic Log Devices (ELD): Qualcomm, PeopleNet, OmniTracs, GPS, Location Tracker, Etc. - Installation Instructions And Information - US17+OBD16 Emissions And Newer

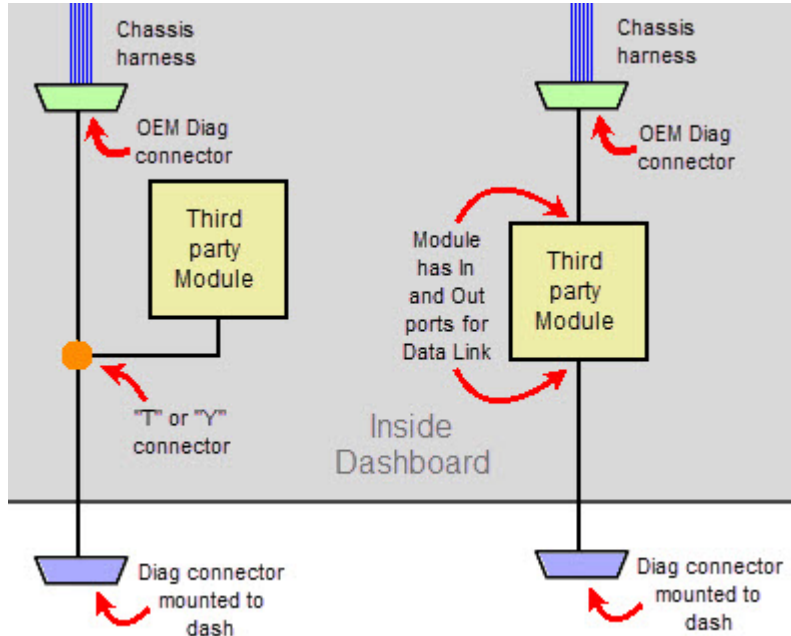
Recent models of third party devices in many cases utilize either a "T" or "Y" connector that connects to the OEM Diagnostic connector, or will place the module in-line so the diagnostic connector mounted to the dash is in fact a diagnostic connector from the third party device. A diagram showing these two situations can be seen below:
