GROUP ENGINE	NUMBER 22-EM-004H	
	ΗΥυπαρι	DATE	MODEL(S)	
Techni	cal Service Bulletin	JANUARY 2022	Santa Fe Sport (AN) Santa Fe (TM) Sonata (LF/YF) Veloster N (JSN)	
SUBJECT: THETA-II 2.0T TURBOCHARGER EWGA DIAGNOSIS AND SERVICE PART REPLACEMENT GUIDELINES			iosis Nes

This bulletin supersedes TSB 21-EM-009H to update turbocharger part number information.

Description: This bulletin provides additional service diagnostic information and repair procedures related to Electric Waste Gate Actuator (EWGA) equipped vehicles listed below.

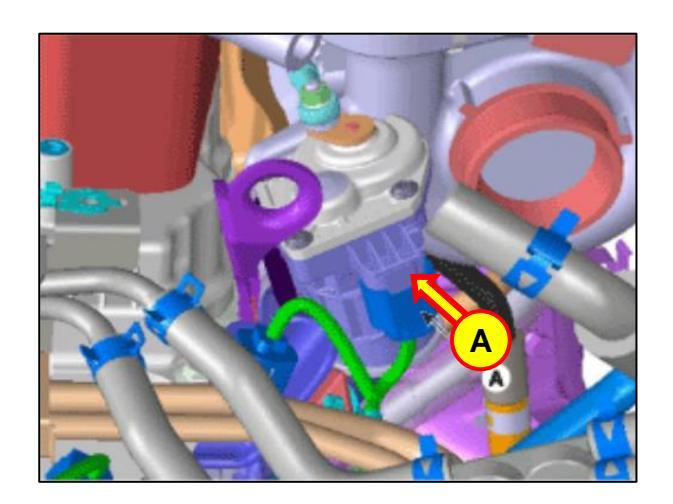
- 1. Turn ignition switch OFF.
- 2. Disconnect the EWGA connector (A).

- 3. Check that there are no obstructions preventing EWGA motor movement.
- 4. Measure resistance between the (+) and (-) terminals of the motor and check that it is within specification.

5. If the EWGA motor resistance is not within specification, replace the EWGA with the service procedure on page 7.

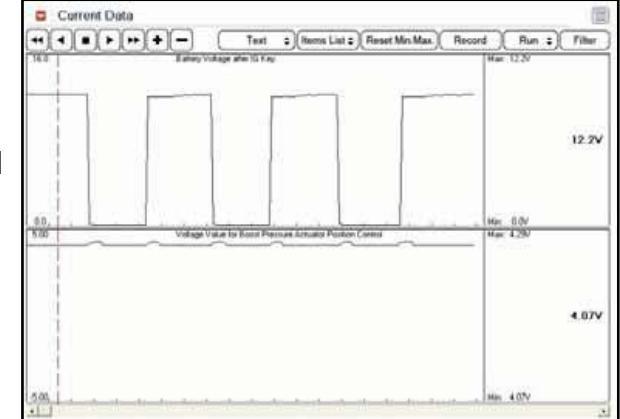
- 3. Choose the **Graph** and check the voltage.
 - Turn ignition ON/OFF three times, and then check the Max voltage value just as ignition ON state is about to change to ignition OFF state and vice versa. Refer to specified voltages on the following page.
 - If the EWGA position sensor is not within specified voltage, perform the following EWGA ADJUSTMENT PROCEDURE, and check that the same fault code is detected again before replacing the EWGA.

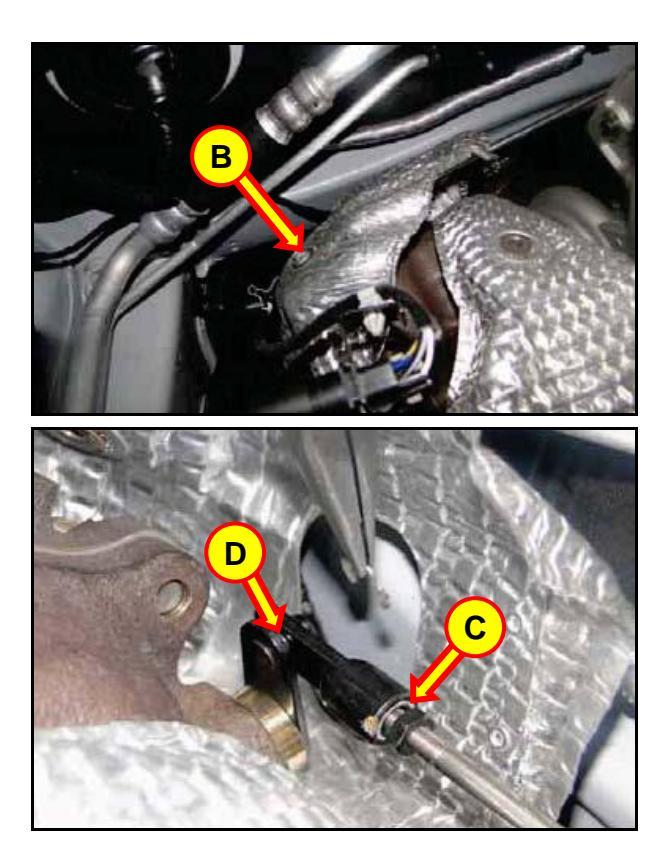
Loosen the turbocharger upper cover bolt (B) and remove cover.

Loosen the shaft end lock nut (C) and remove the retaining clip (D). Save the retaining clip for later use.

When loosening lock nut (C) securely hold the waste gate arm to prevent shaft bending.

Adjust the shaft end by rotating it clockwise or counterclockwise in ½ turn increments until voltage is within specification range.

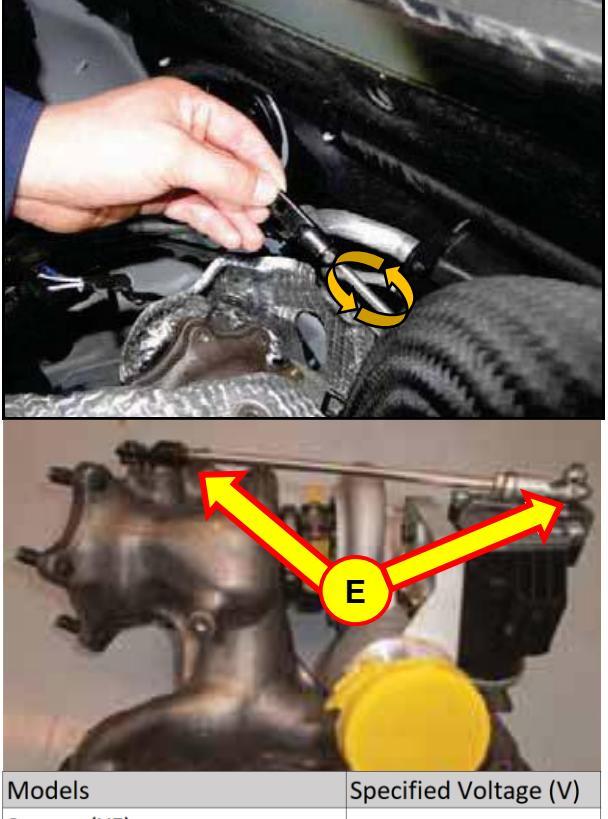
If unable to achieve proper voltage specification when the engine is cold, it may be necessary to rotate both EWGA shaft ends (E) to achieve proper voltage.

- If output voltage > Max. specified Voltage: Turn shaft ends clockwise (to shorten the ends)
- If output voltage < Min. specified Voltage: Turn shaft ends counterclockwise (to lengthen the ends).

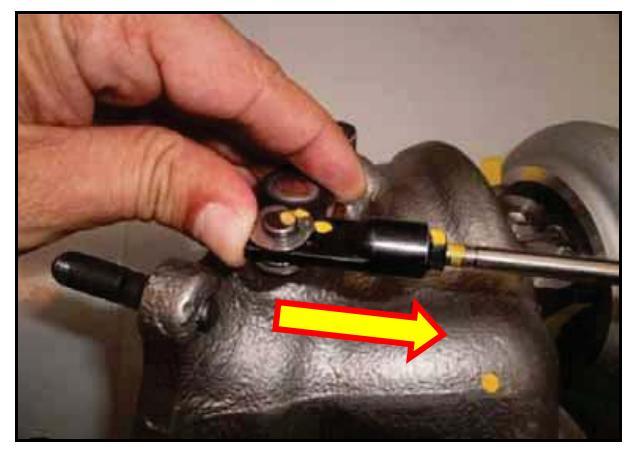
Recheck voltage while applying pressure on the EWGA lever to accurately measure output voltage as indicated in the photo on the right.

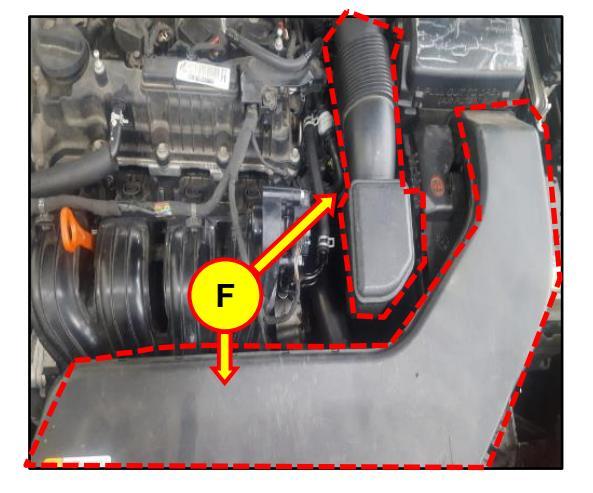
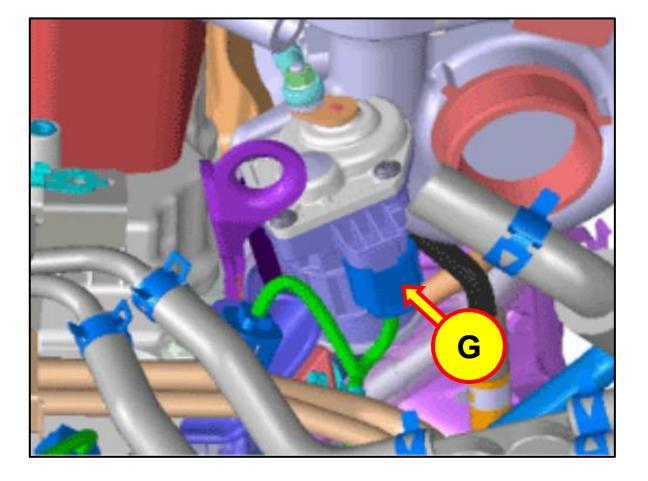
4. Disconnect the EWGA connector (G).

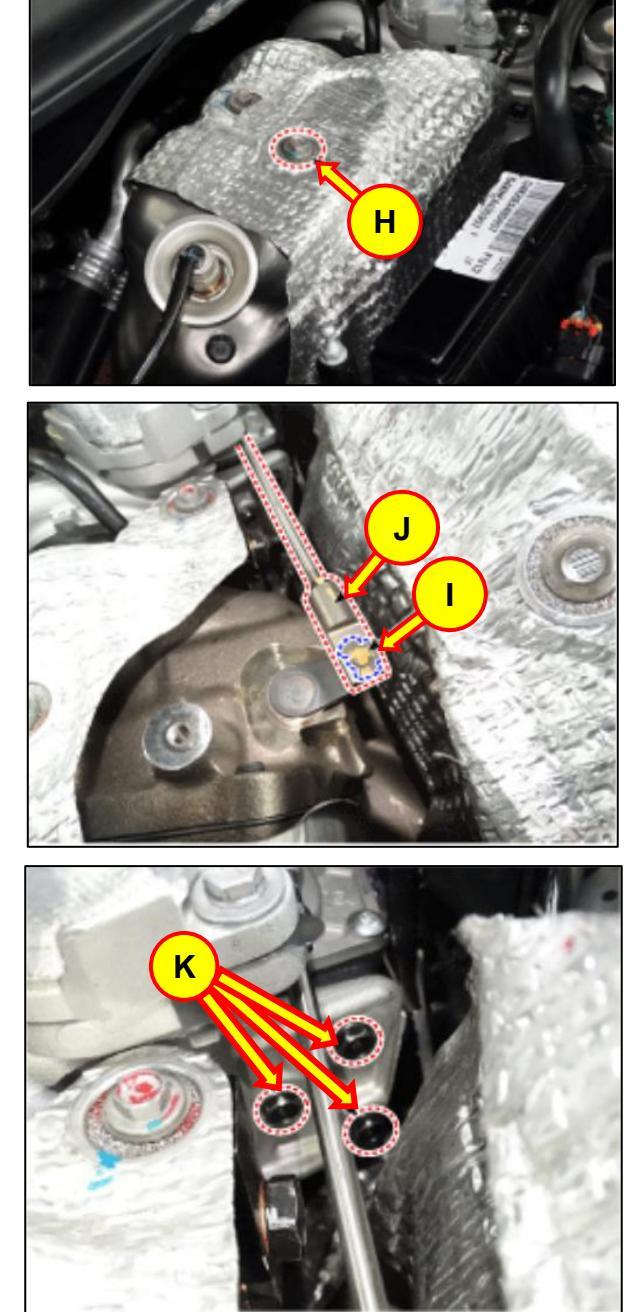
6. Remove the snap-ring (I) and remove the shaft linkage assembly (J).

7. Remove EWGA mounting bolts (K) and replace EWGA.

Tightening Torque: 9.4 lb-ft (12.75 Nm)
