Preliminary Information

PIT5832A Diagnostic Tip: No Start Or Unable To Perform Theft Relearn After Replacing Or Programming A Module / DTC U1962

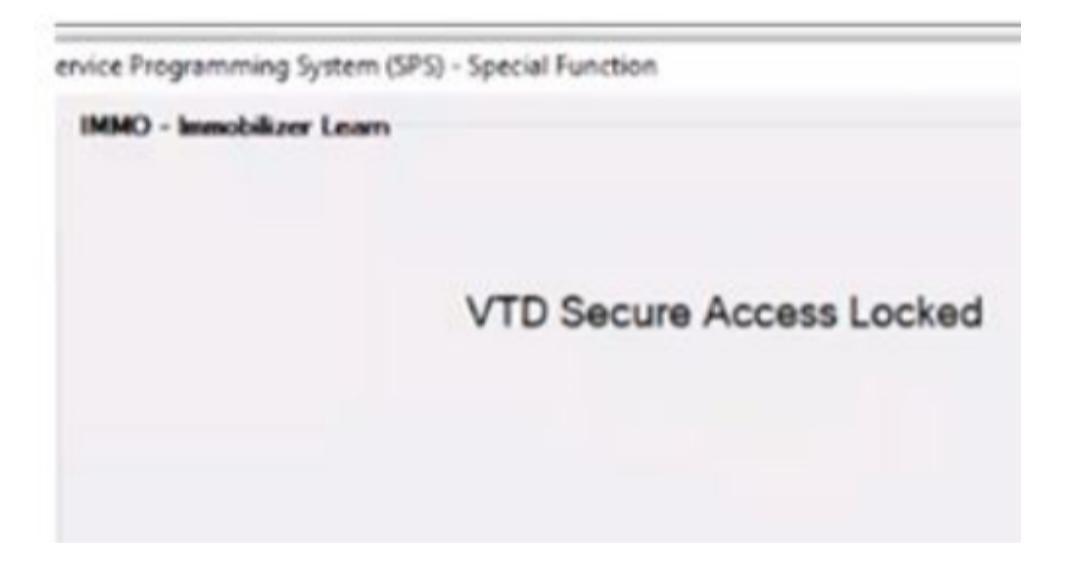
- 1. If a module was replaced, make sure the new module was SPS programmed correctly or the SDAC will fail and not complete correctly.
- 2. If a module such as the BCM is replaced, and the immobilizer learn needs to be completed after replacement, the tech needs to make sure that the SDAC completes correctly, or a pop-up message like the one below will be displayed:

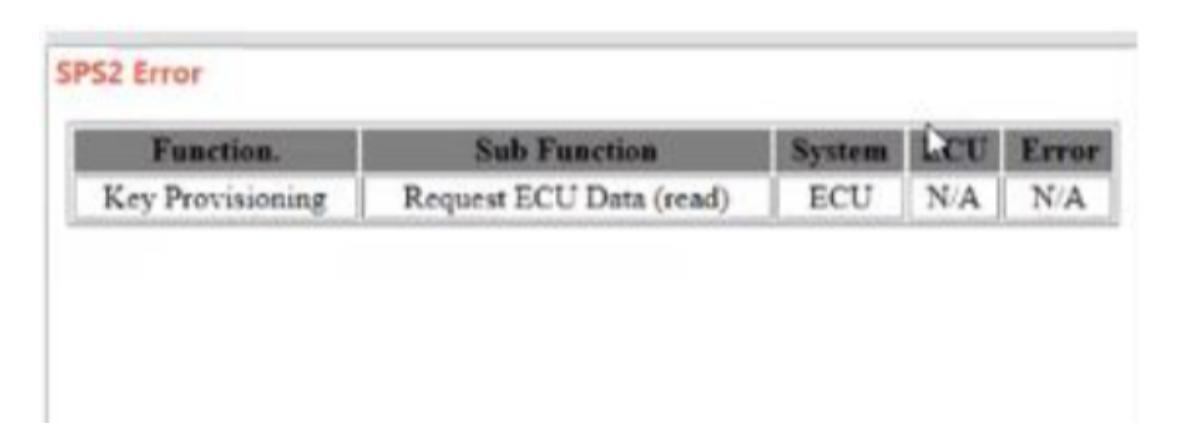
- 5. If the system box reads "ECU", then the Global ID of the module that is causing the concern should be able to be obtained. In the example below, the Global ID is listed as K36, which is for the SDM. The module's name can be found by looking at the global codes listed under "Control Module References" document in SI for the vehicle that is being working on.
- 6. Sometimes the pop-up box will read "ECU" but it will not give you a Module ID in the ECU box. In this case, the servicing dealer will have to contact Techline support and they will have to assist by getting a SPS log file from the dealership's system. If this is the case, they must be contacted right after the SDAC failure. If any other programming is attempted before contacting Techline, then the SPS log will be erased.

7. Once the module that caused the concern has been identified, pull the fuse that supplies battery power to that module. Sometimes the fuse is a three-prong fuse that feeds other modules. In this case, the servicing technician will need to find a two-prong fuse to power the other module that was not involved in the SDAC failure.

8. If the SDAC completes after removing battery power from the module in question, that module will need to be replaced. Afterwards, verify that the SDAC completes after SPS programming of the new module.
