**Document ID:** IK1600131

## Title: Cab Water Leak Troubleshooting Tips

**Applies To:** LT, RH, ProStar, HX Steel Cab, and Lonestar sleeper cabs. However some aspects may also apply to all cabs in the High Performance Vehicle family - MV, HV, LT, RH, ProStar, LoneStar, TransStar, WorkStar(HV), DuraStar(MV), and TerraStar. 9000i, PayStar(HX) Aluminum Cab, CityStar, CV, or LoadStar are not covered in this document.

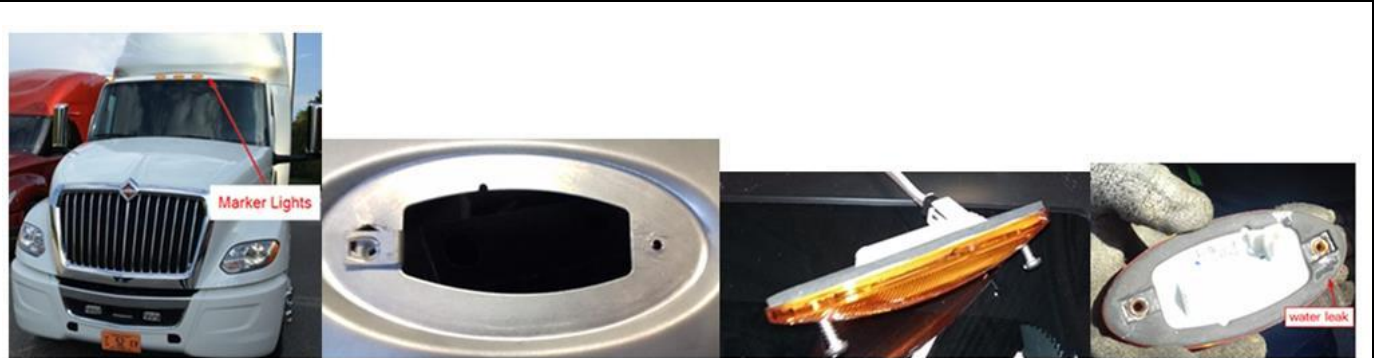
3. Roof marker lights
- Each marker light is held in place with two #8 SS sheet metal screws. Depending on the date of manufacture; one goes directly into the cab roof and the other goes into a U-nut clip. Sometimes the U-nut tears the foam gasket. Sometimes the screw that goes directly into the cab roof strips the hole and causes the gasket not to compress and seal. This design has had two updates. To resolve any marker light leak, replace/add two new flat U-nuts to each location.

- Remove each marker light to inspect and verify seal integrity. (See attached photos for example of defective seal.)
  - Check all five marker lights as more than one could be leaking. The small hole without a U-nut should be drilled out to approximately 10 mm and a new flat U-nuts added to achieve proper torque for sealing. A light coat of RTV sealant on the foam gasket can be used if needed. Be sure to coat the drilled hole to prevent rust and use the new flat U-nut P/N: 4325645C1 in all places.

Be sure to remove and inspect all five marker light seals and be careful to not over torque the fasteners upon reinstallation.

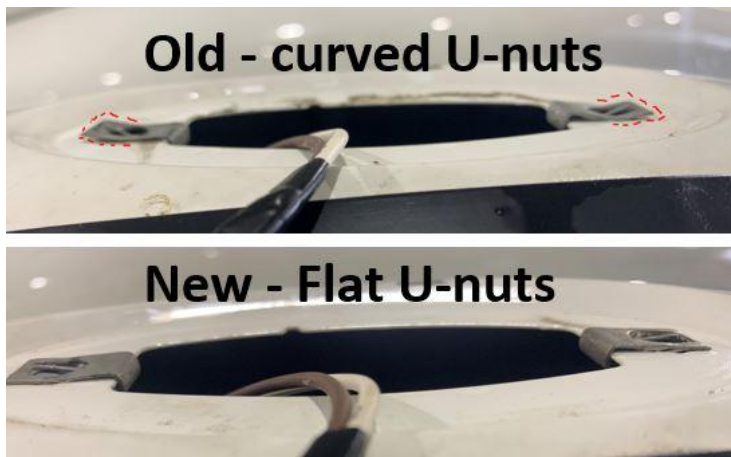
Images show the difference between the old and the new U-nut

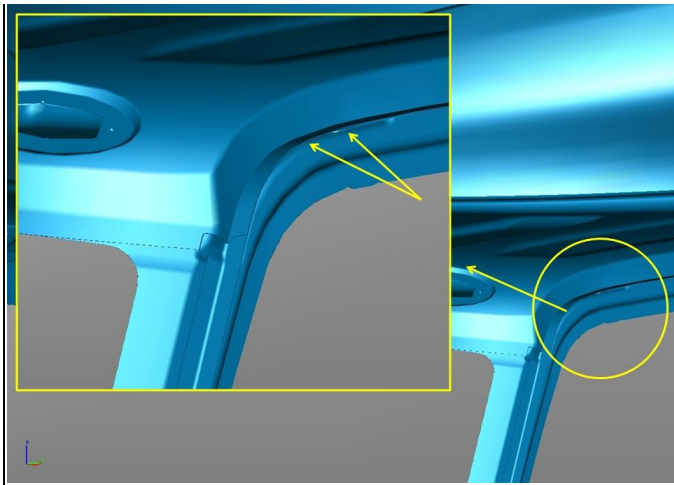
Although this seam is covered by the door seal, water can work its way under the seal and through this seam if this seam is not sealed properly at the factory.

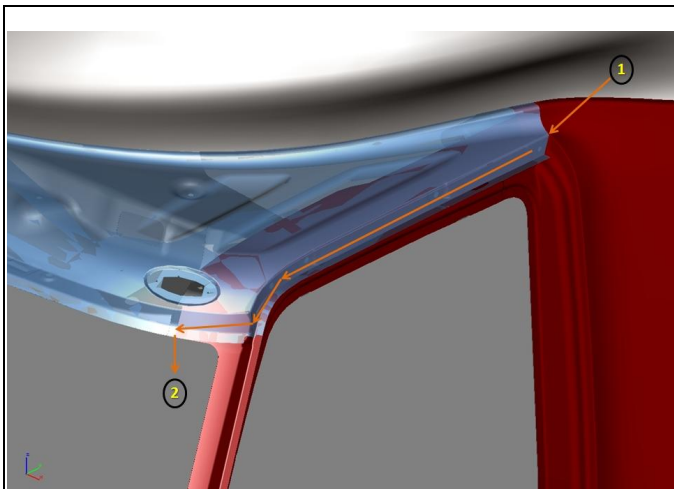
#### 5. Cab seam above the rear corner of the door

1. Water enters here.

2. Water exits here and drips down the inside of the windshield.

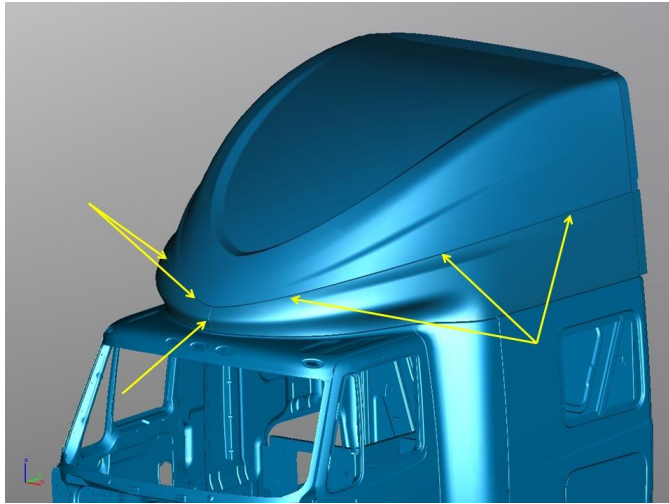
All roof seams should be checked for cracks or voids in the sealer.

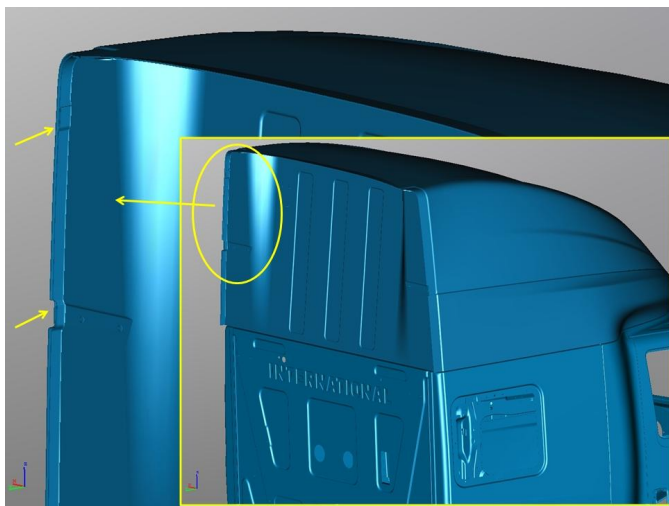
Seams at the rear corners of the Skyrise cab should be checked for voids.

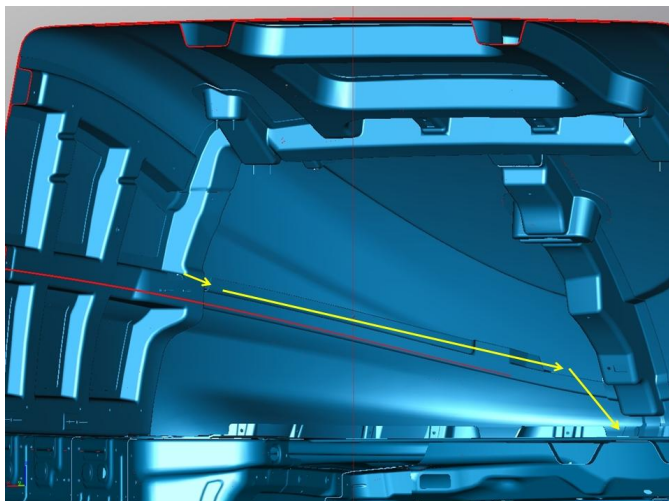
After penetrating the outer seams, water can travel along internal

reinforcement bond lines, ultimately draining into the trough formed by the lower roof panel and dumping near the front center of the driver compartment.

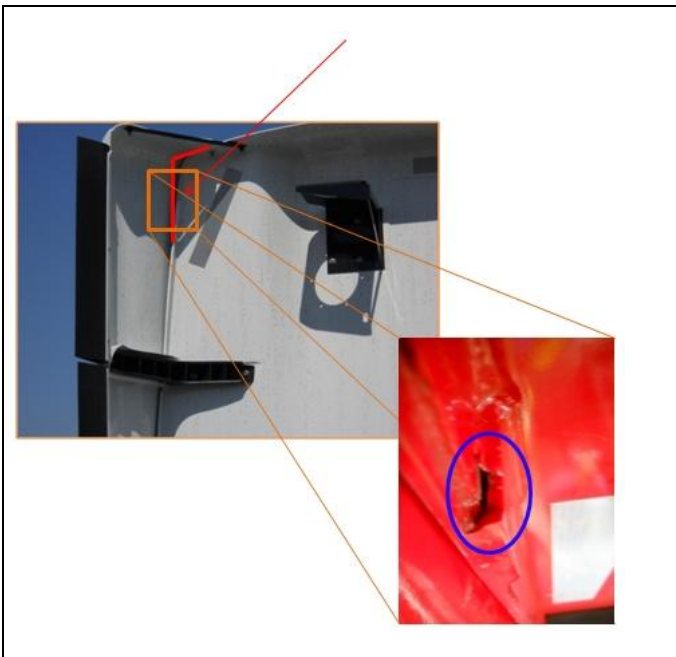
Top Photo - Driver side shown, passenger side symmetrically opposite.

This area is illustrated due to its obscurity as a water entry point. These instructions can be used on any roof seam that exhibits a void or inconsistency in sealer.

1. Using IPA (isopropyl alcohol) clean the seams/joints and any other suspect locations (visible voids/gaps) in the immediate area. Look to be sure the black plastic plug is not missing. If plug is missing replace with service part plug. (P/N: 498376C1)

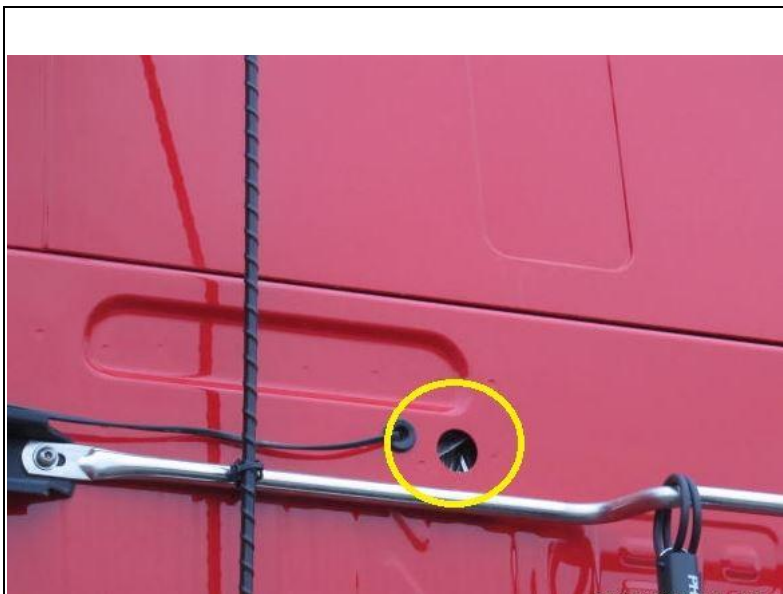
Example of missing plastic plug on BOC of most sleeper configurations. If this plug is missing; replace it with new one from service parts (p/n: 498376C1)

**Note: When inspecting BOC on Sleepers - Look to be sure the black plastic plug is not missing. If plug is missing replace with service part plug. (P/N: 498376C1)**
