# DEF Level (UQLS) Sensor Troubleshooting Guide - US17+OBD16 Emissions and Newer

## 25068-9 FSB 258-040, Aftertreatment Diesel Exhaust Fluid (DEF) Tank, Level Sensor, Replacement

(May 2021)

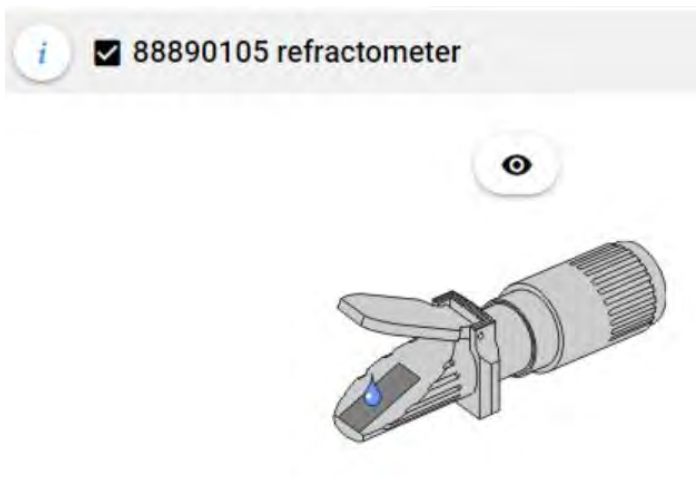
2. Verify the DEF quality is at an acceptable value.

- Use refractometer part number 88890105 to verify the DEF quality. See illustration below.

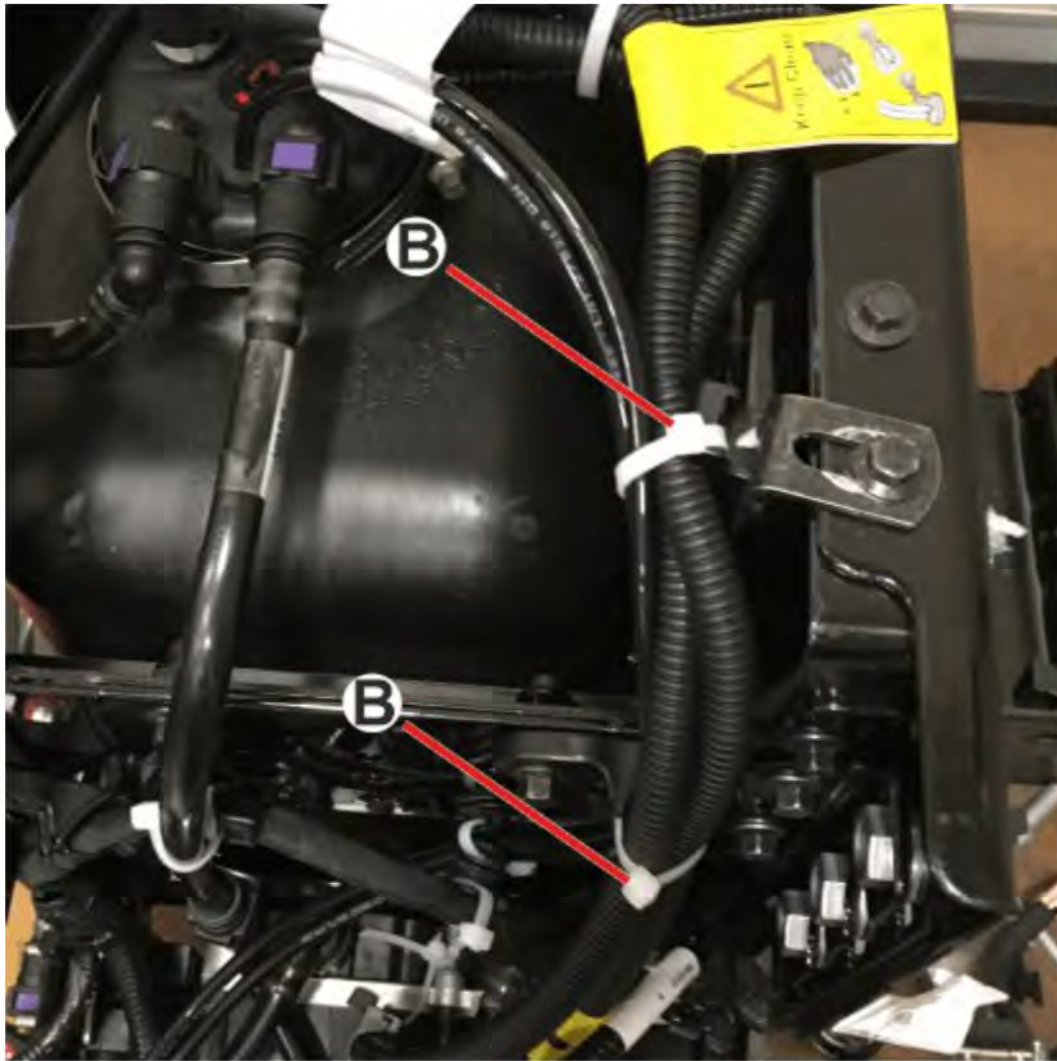
1. Maintain minimum 40 mm bend radius of UQLS (Urea Quality and Level Sensor) control module routing (A) at sensor head.

Note: Do not kink the UQLS control module routing.

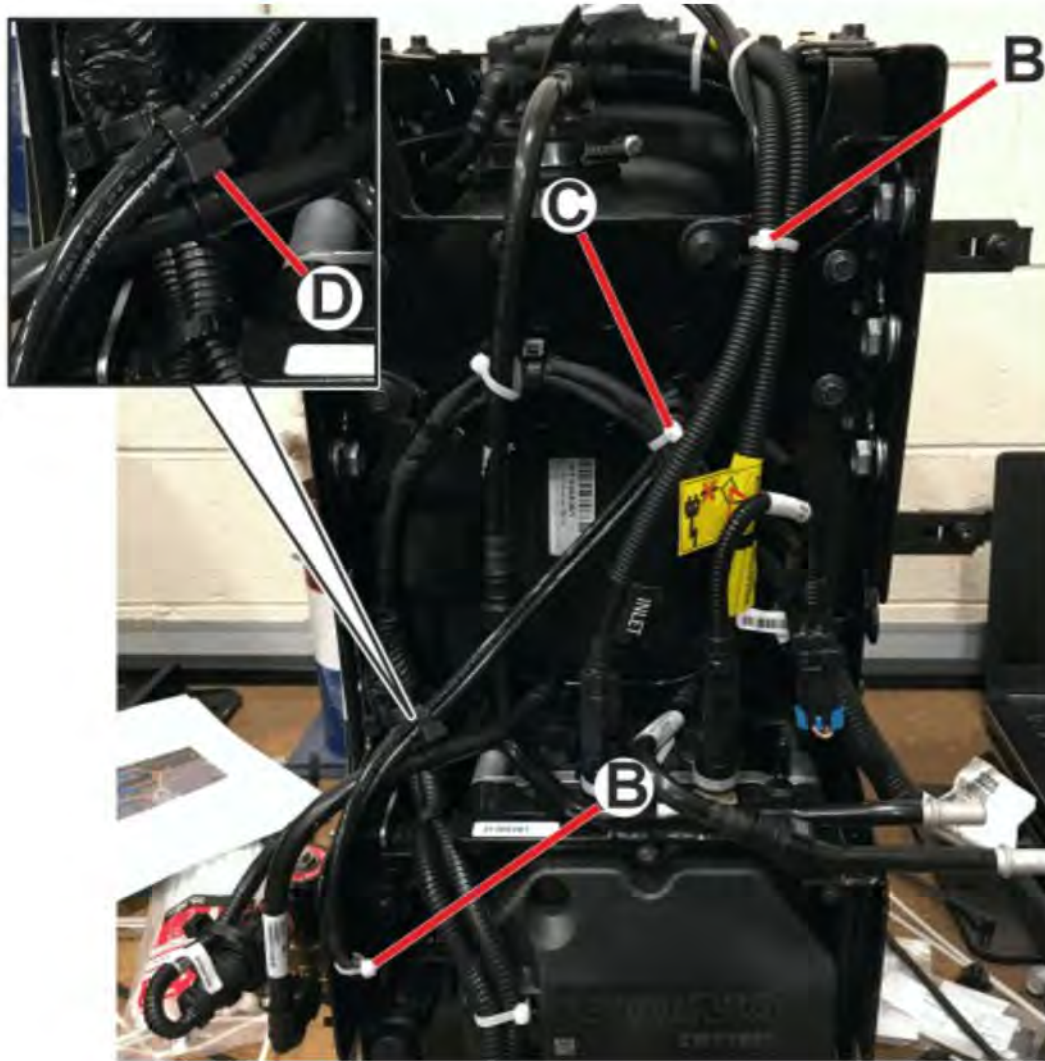
2. Route and tie the UQLS control module routing with the urea harness.

Note: Use regular cable tie (B).

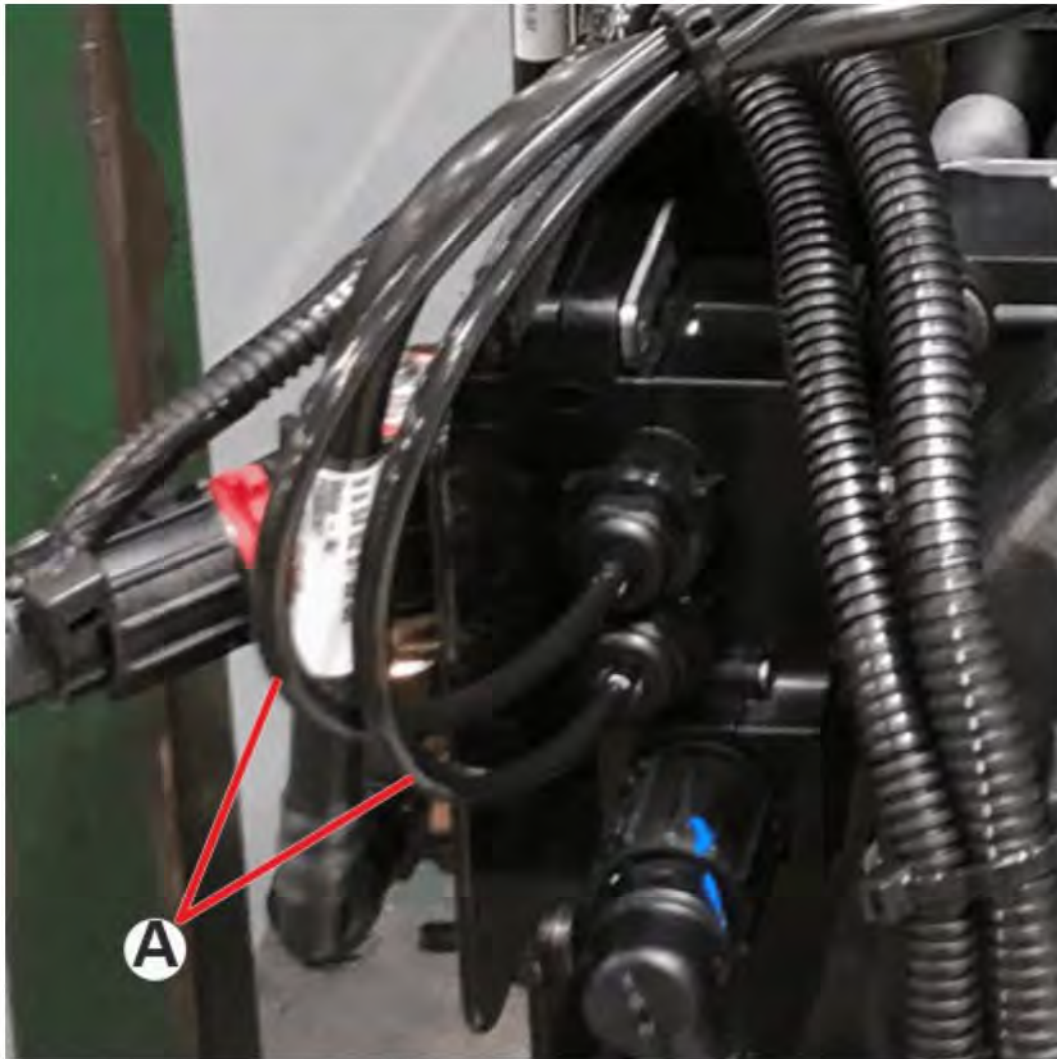
3. Route and tie the UQLS control module routing with the electrical harness.

Note: Use helicopter cable tie (C).

4. Route and tie UQLS control module routing with the coolant lines.

Note: Use double head cable tie (D).

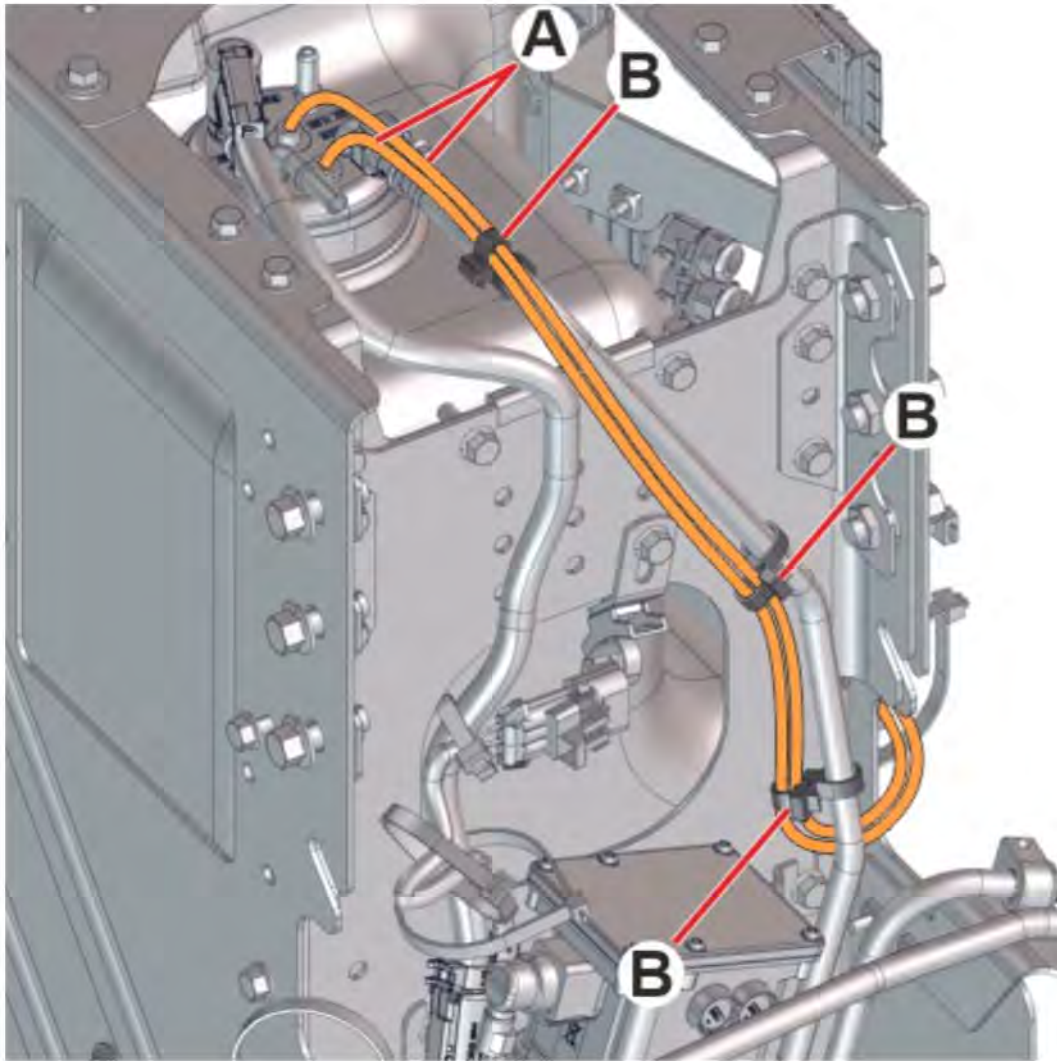
5. Maintain minimum 40 mm bend radius of UQLS control module routing(A) at electrical junction box.

Note: Do not kink the UQLS control module routing.

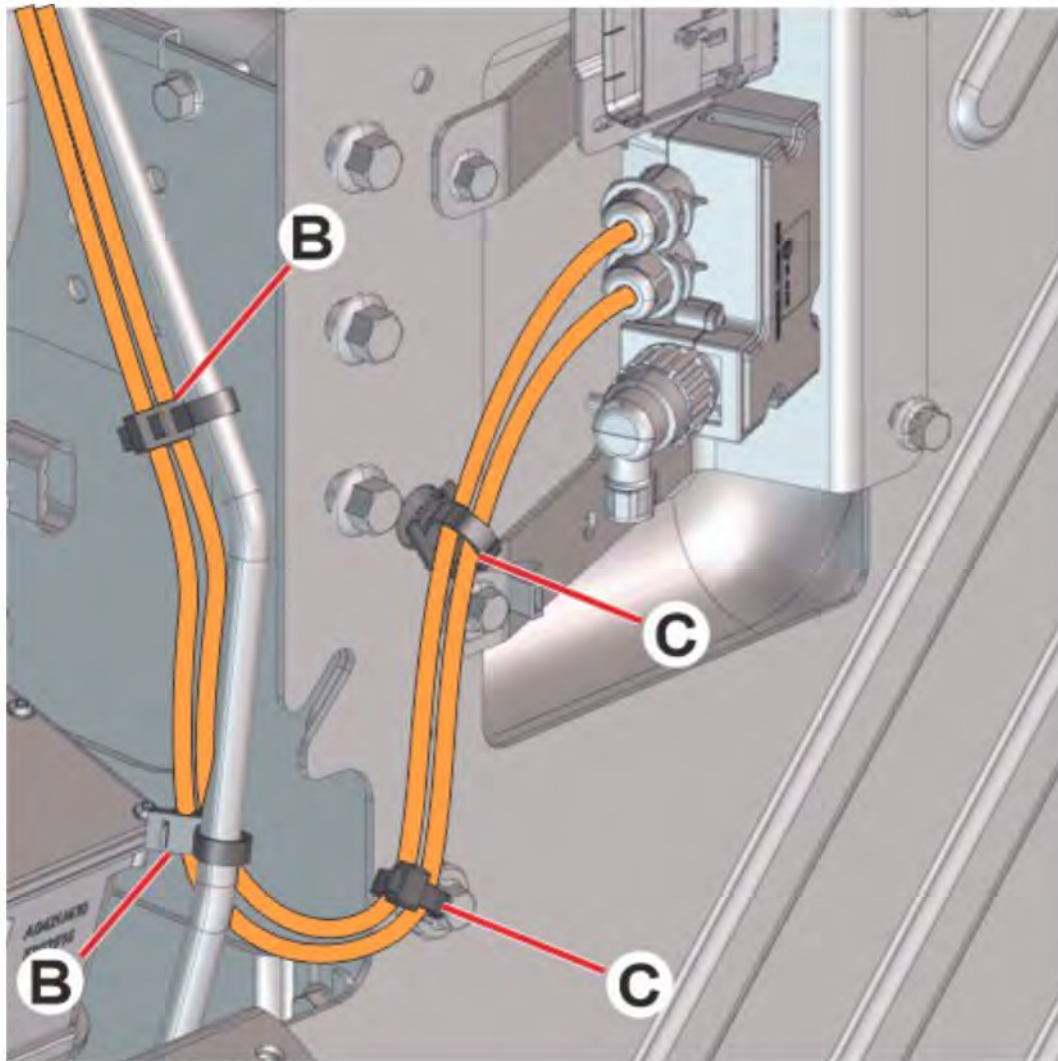
1. Maintain minimum 40 mm bend radius of UQLS (Urea Quality and Level Sensor) control module routing (A) at sensor head.

Note: Do not kink the UQLS control module routing.

2. Route and tie the UQLS (Urea Quality and Level Sensor) control module routing with the coolant pipe.

Note: Use double head tie (B).

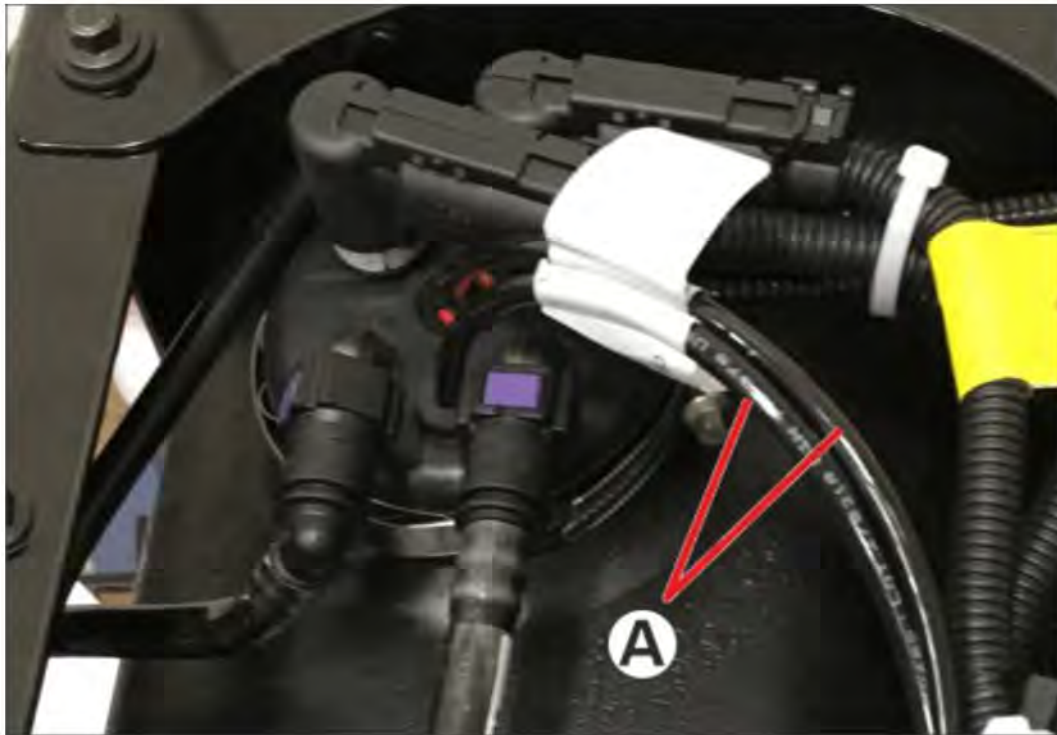
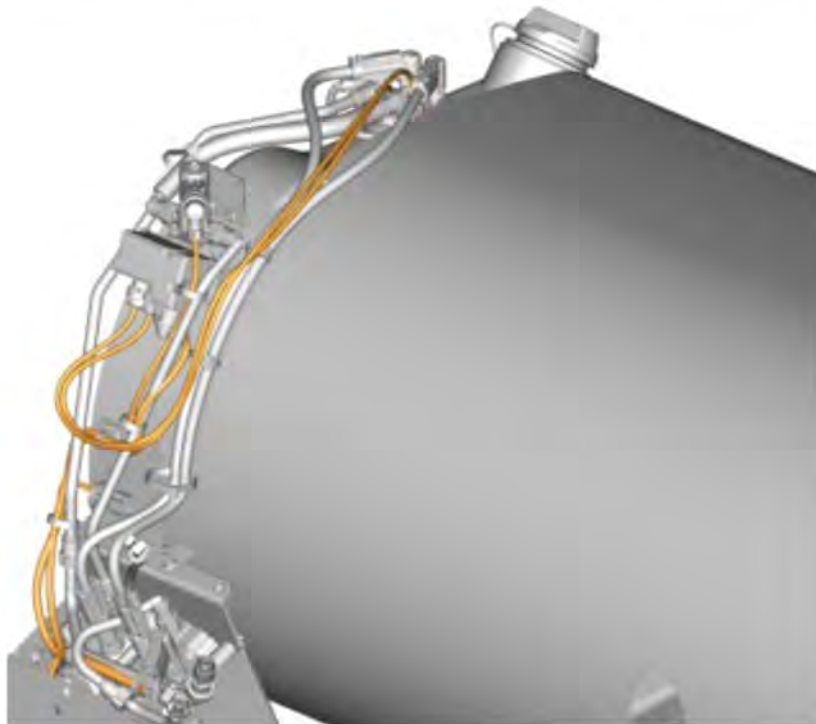
3. Route and tie the UQLS control module routing with the bracket.

Note: Use cable tie (C).
