Service Bulletin

Subject: Diagnostic Tips on GDS Graphing after Road-Test, for Shake and/or Shudder During Steady and/or Light Throttle Acceleration Between 25 and 50 MPH (40 and 80 KM/H) at Steady Speed, and Decel at approximately 15 MPH (24 KM/H).

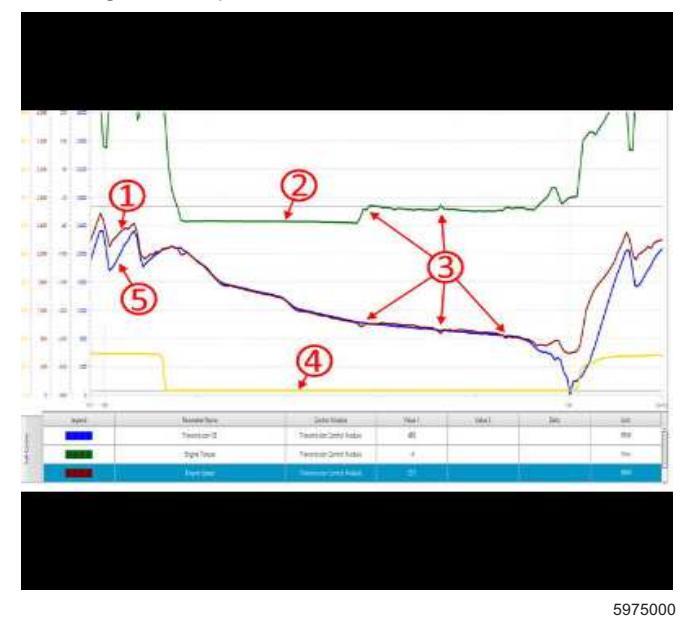
⇒ Diagnostic Tip Related Shutter: 21–NA-207

1. Engine Speed

- 2. Engine Torque
- 3. Vibration Felt after Engine Refuel, Should be in Reduced Firing Fraction
- 4. Pedal
- 5. Transmission Input Shaft Speed (ISS)

Diagnostic Tip Closed Throttle Shudder – TSB 21-NA-207: 2021 Silverado Sierra 5.3 (L84) 10 Speed (MQB) only.

The condition is only present at 0% throttle during a coast event at approximately 15 mph (24 km/h). Note the engine RPM and torque oscillations at engine refuel points.

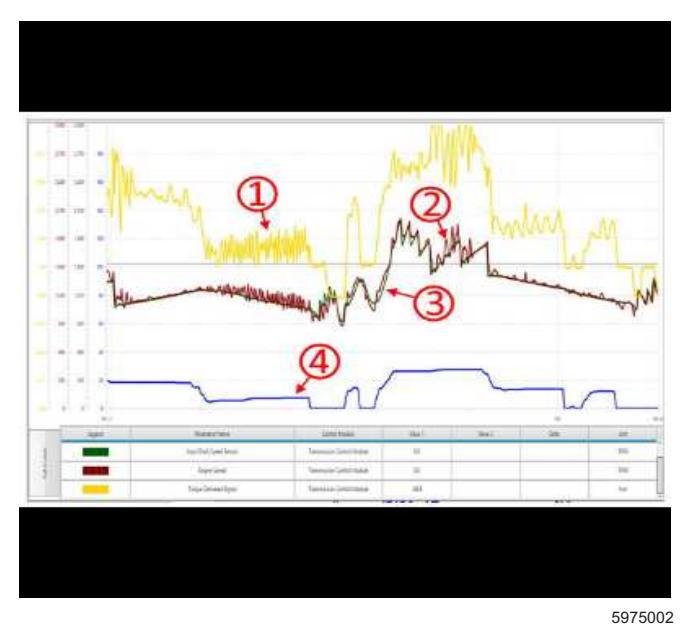
Diagnostic Tip Engine Related Shudder – PIP5794B Camshaft Actuator

- 1. Torque
- 2. Engine Speed
- 3. Transmission ISS
- 4. Pedal

Record a GDS session log and monitor engine speed, transmission input speed and engine torque. If engine torque is larger than +- 25 Nm while no gear shift is active, and throttle is relatively constant the issue most likely lies within the engine.

Observe the large variation in engine torque while engine speed and Transmission ISS follow each other more closely. Although this feels like shudder to the customer it is most likely an engine related concern.

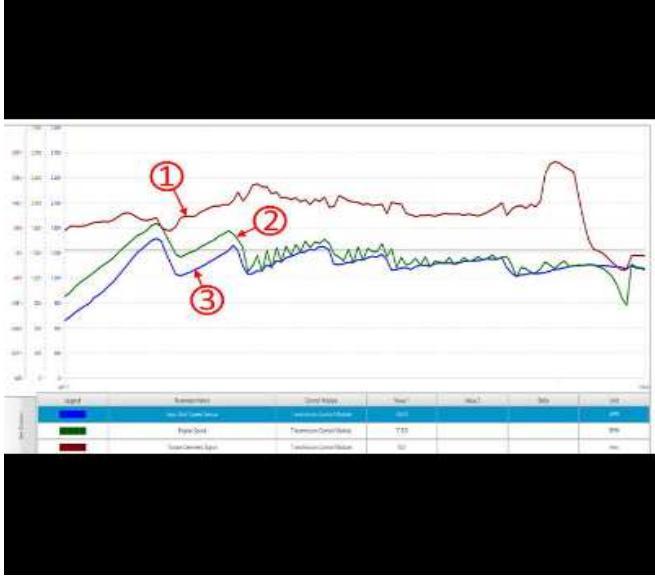
Diagnostic Tips TCC Solenoid – Valve Body

- 1. Torque
- 2. Engine Speed
- 3. Transmission ISS
- The shudder condition is present both in Drive "D" or Manual "L9".
- Typically occurs at less than 15,000 miles (24,000 km)
- Transmission ISS follows engine speed
- Relatively consistent engine torque. <+- 25 Nm

Engine torque remains relatively flat while engine speed rises and falls. The valve body should be replaced.

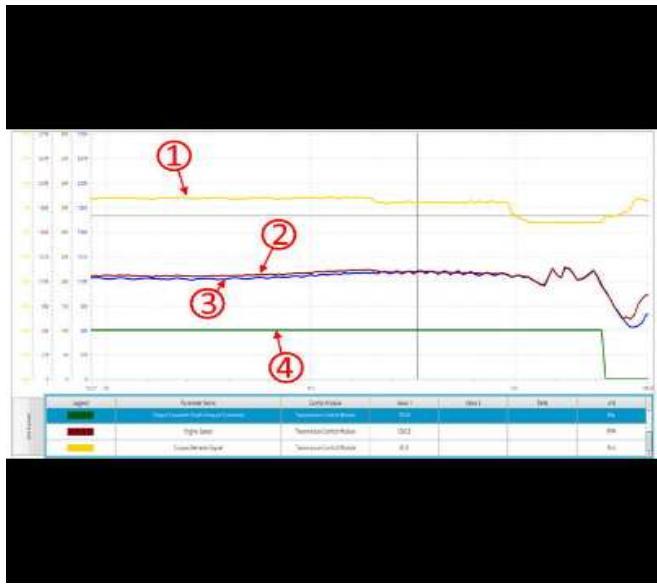
Diagnostic Tip TCC Solenoid (Drift) – Valve Body

- 1. Torque
- 2. Engine Speed
- 3. Transmission ISS
- 4. TCC Pressure
- Shudder condition is present in Drive "D" but NOT present in Manual "L9"
- Throttle would typically be less than 10% and engine torque less than 100 Nm
- TCC slip speed will be 0 or near 0
- TCC pressure command will remain at 100 kPa

The valve body should be replaced.

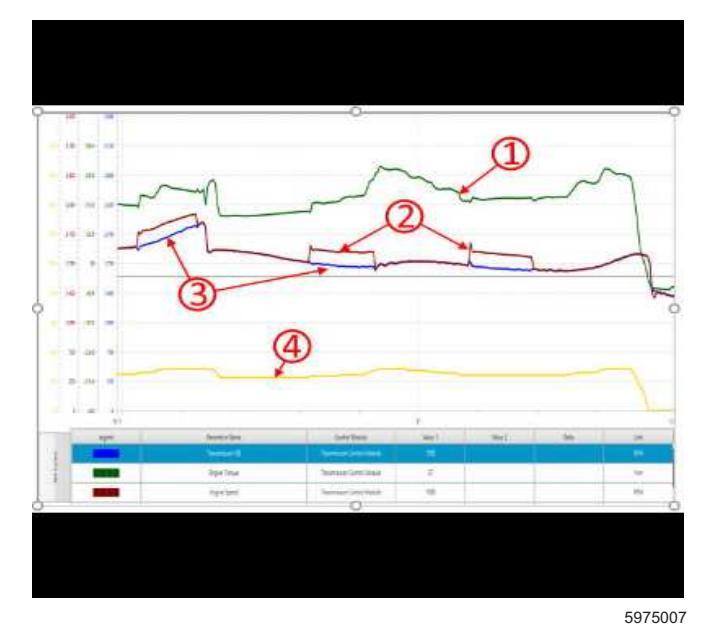
Diagnostic Tip TCC Shudder – Torque Converter

- 1. Torque
- 2. Engine Speed
- 3. Transmission ISS
- 4. Pedal
- TCC pressure control is steady
- TCC slip is elevated
- Engine RPM will increase at the shudder point while Transmission ISS remains steady
- Engine torque remains relatively steady during the shudder event
- Throttle angle remains steady during the shudder event

The torque converter should be replaced.
