#### 72 Noises from the second row seats

72 22 41 2060719/2 April 16, 2022. Supersedes Technical Service Bulletin Group 72 number 20-29 dated October 5, 2020, for reasons listed below.

Model(s)	Year	VIN Range	Vehicle-Specific Equipment	
Q7	2017 – 2023	All	Neternieskis	
SQ7	2020 – 2023	All	Not applicable

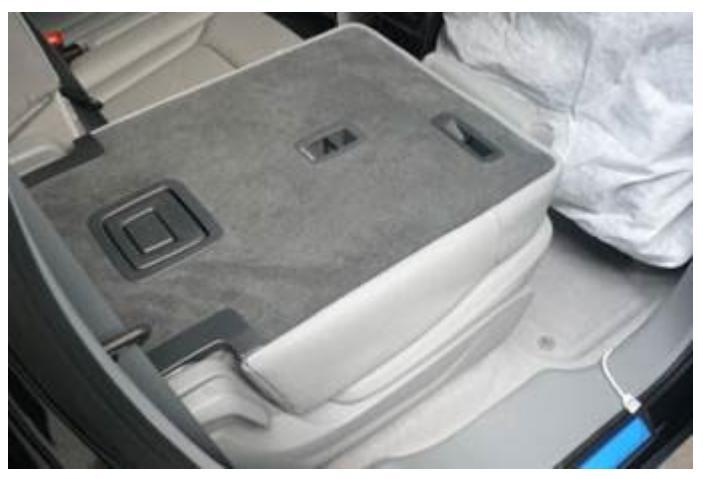
Figure 1. Affected second-row seat.

Fold and tilt the affected seat forward to gain access to the outer locking plate (Figures 1 – 2).

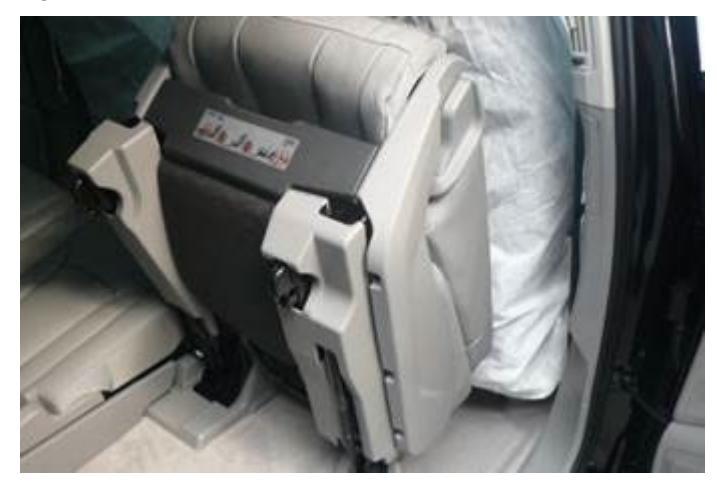
Figure 2. Affected seat unlatched and tilted forward.

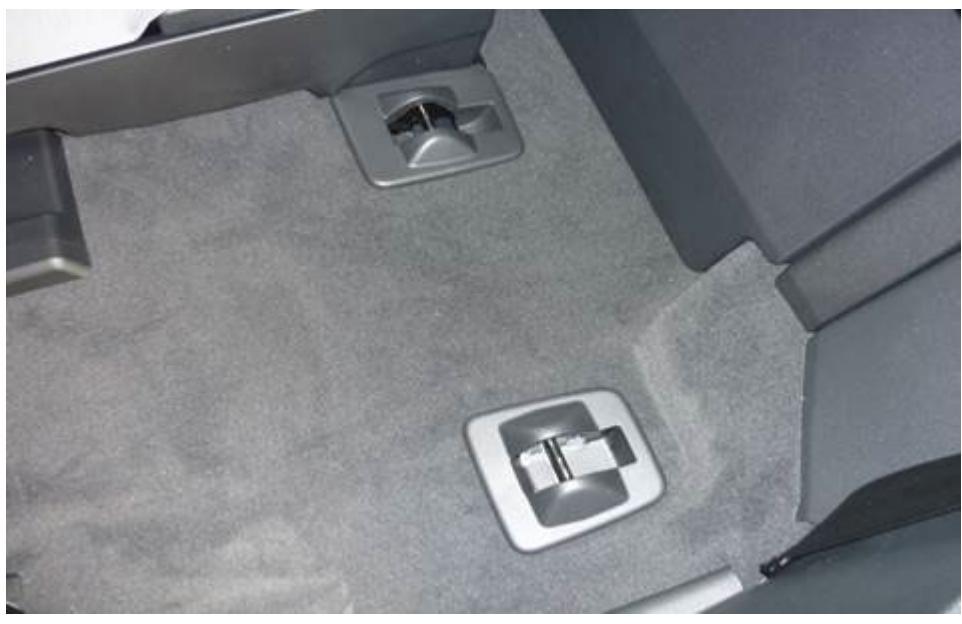
Figure 3. Outer and inner locking plate with trim installed.

2 Remove the
trim of the
outer locking
plate (door
side) by
following the
repair
manuals in
Elsa (Figures
3 - 4).

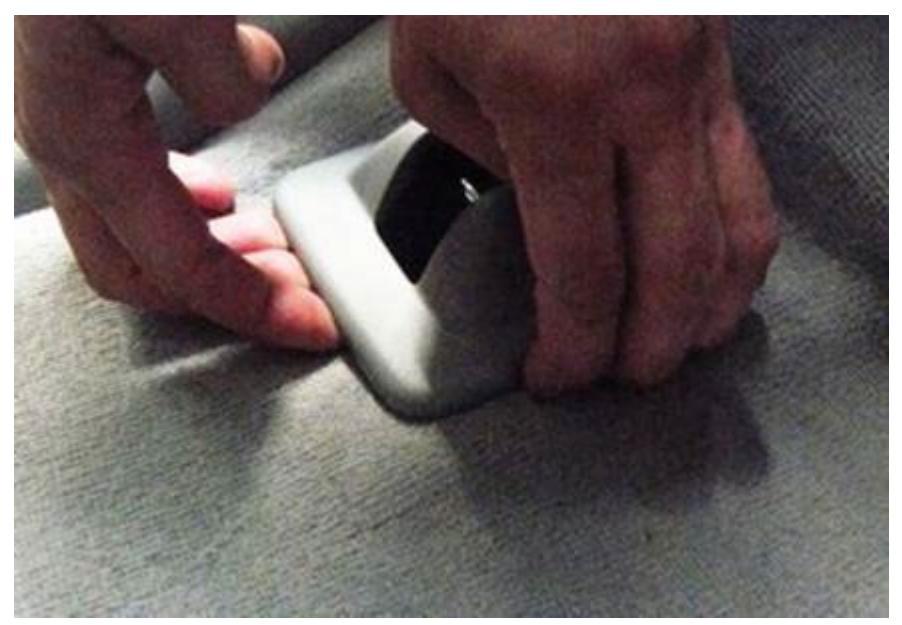
Figure 4. Outer locking plate trim removal.

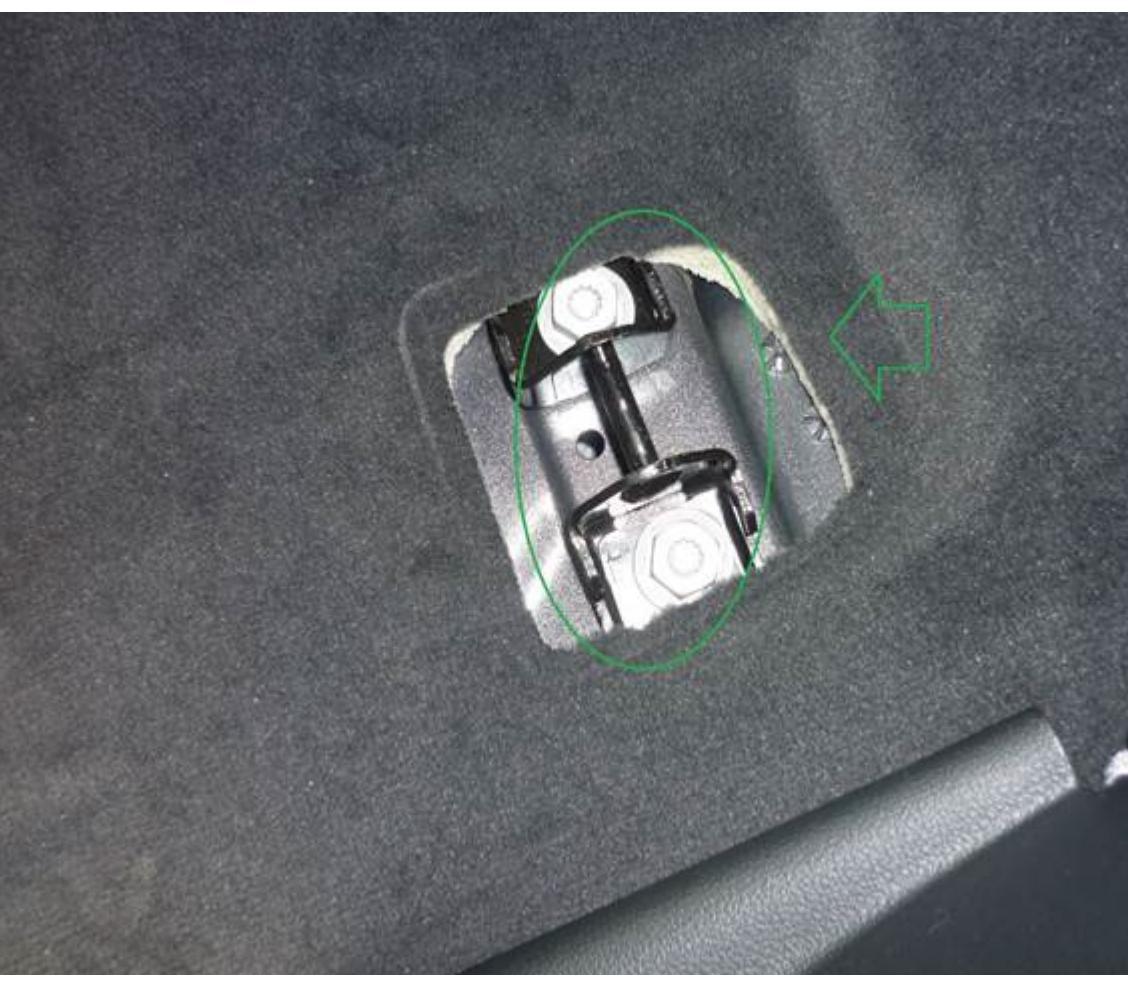
Figure 5. Outer locking plate with trim removed.

3 Loosen both
bolts of the locking plate and then move the locking plate evenly towards the rear of the vehicle by approximatel y 1.2mm (~ 3/64 inches) (Figures 5 -6).

> **Tip:** Mark the location of the locking plate prior to loosening the bolts.

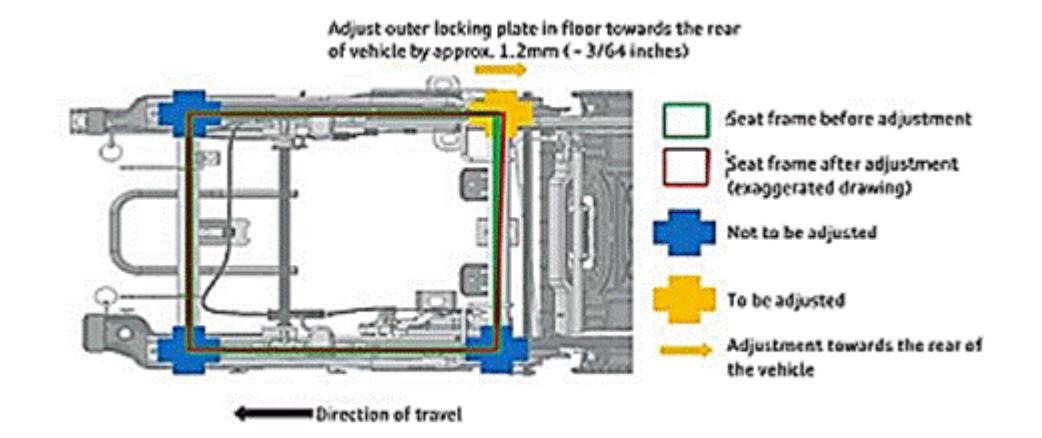
### Figure 6. Adjustment of outer locking plate.

4 Tighten the locking plate bolts according to the repair manuals and reinstall the locking plate trim.
